10 Pine Avenue, Takoma Pk.
Preliminary Consultation

HISTORIC PRESERVATION COMMISSION STAFF REPORT

Address: 10 Pine Avenue

PROPOSAL: Demolish garage/build new garage

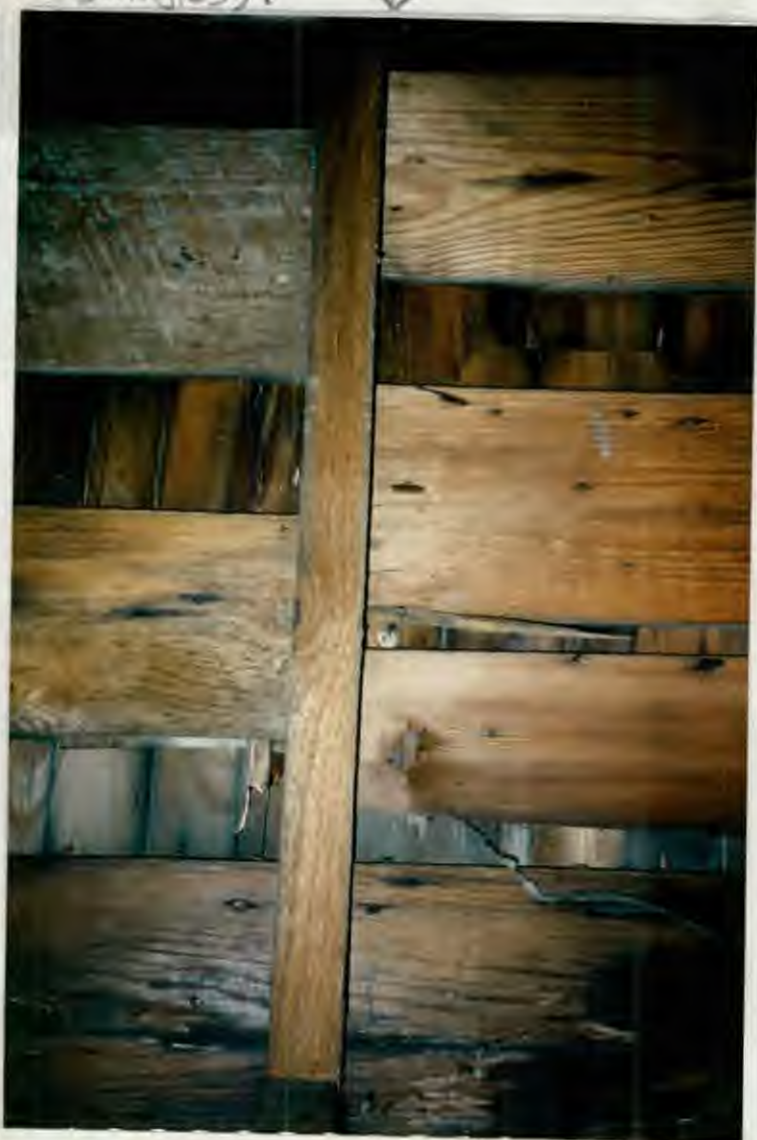
(41) Roof on south side viewed
from interior. (Note wood shingles
overlapping -- under newer asphalt
shingles). ↓
