Corby Estate / Strathmore Hall

30/012-96A

Window Rehab. HPC 7/10/96

Re: Easement Committee Review
Strathmore Hall
Montgomery County

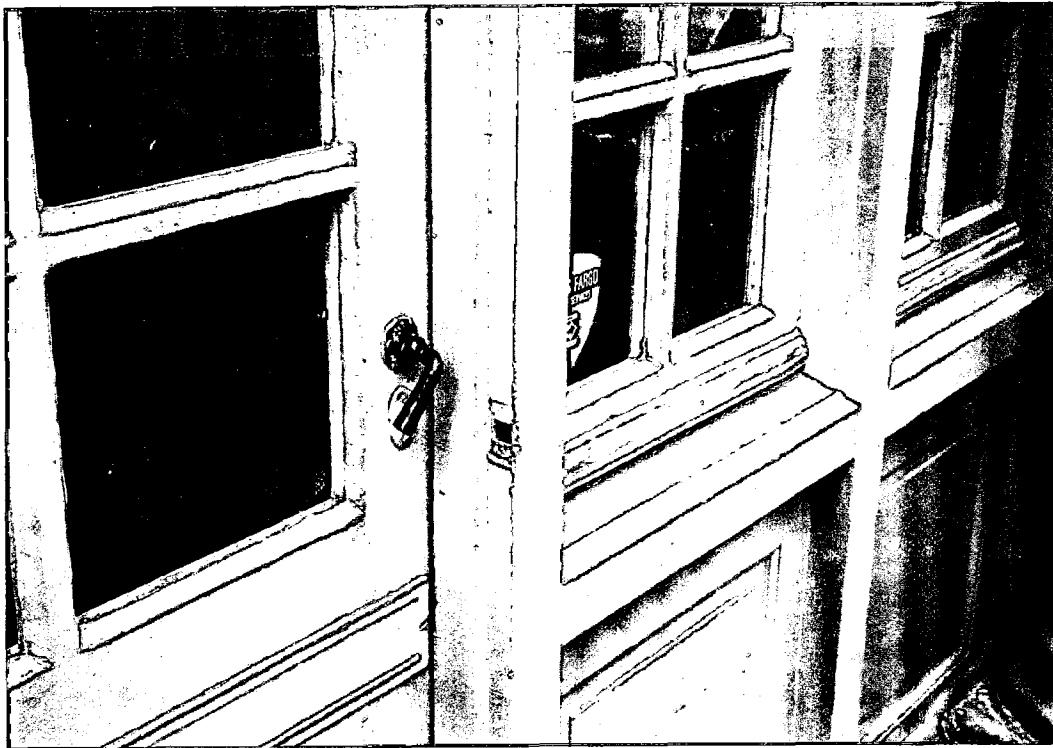
Photo #13: Detail view of window and door jambs at sun room. Exterior window mullions are already detailed (rabbeted) to receive exterior storm sash.

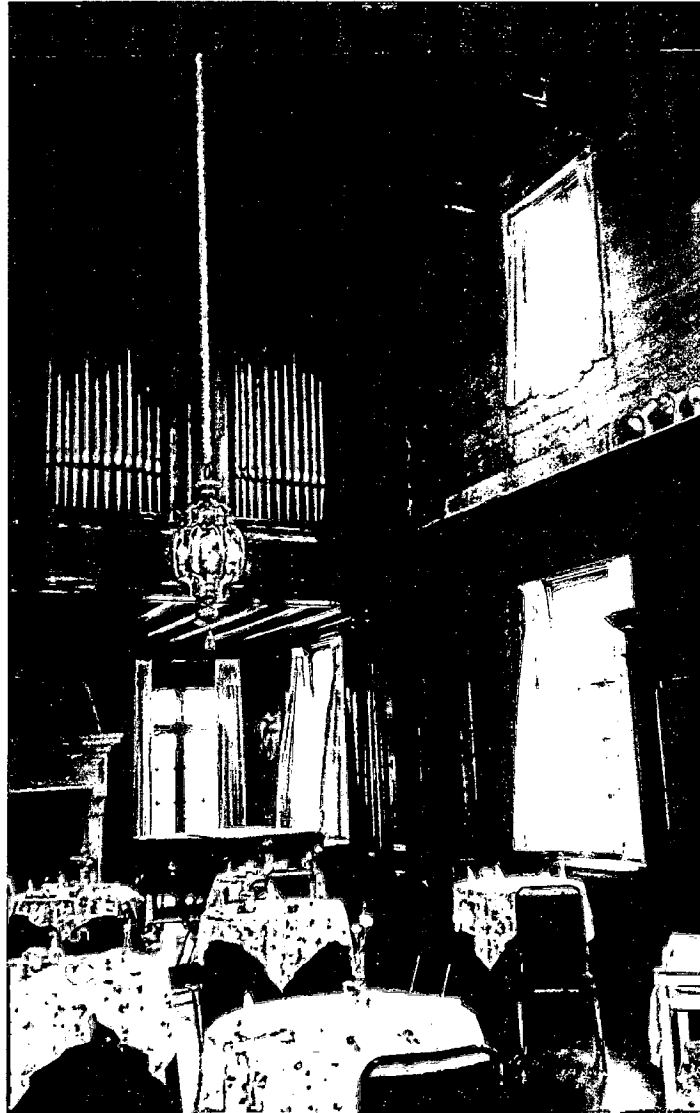
Photo #1: Interior view of music room. 8/12 Faux-finish double-hung sash are at lower level. 8x8 casement sash are at upper level.

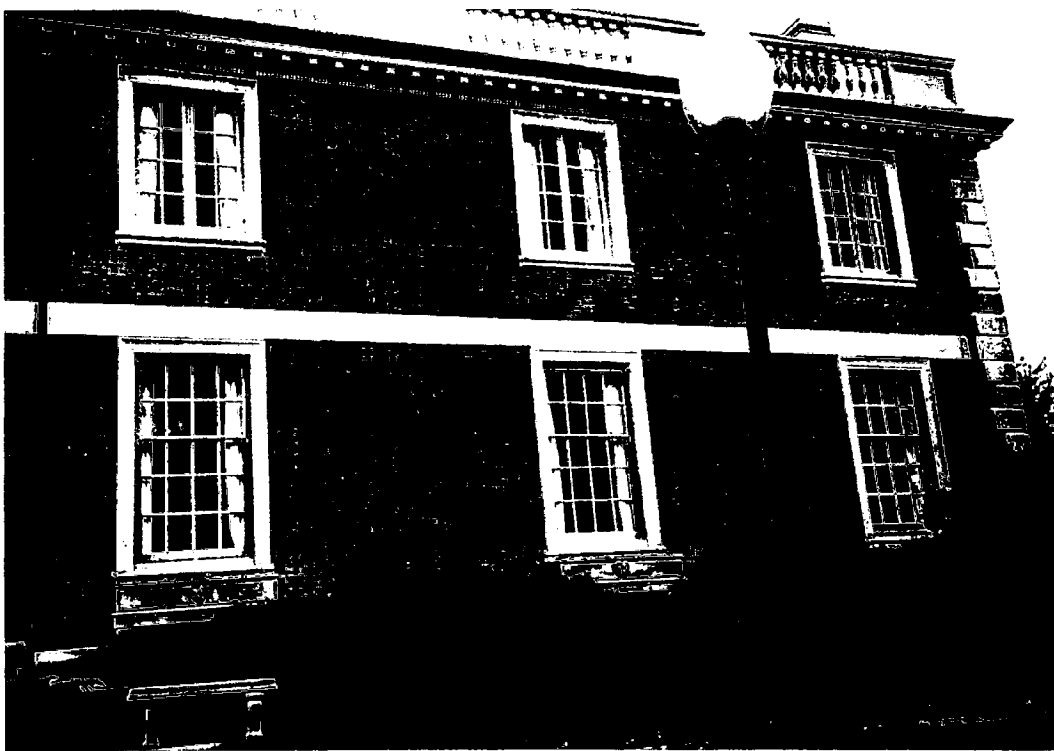
Photo #2: Exterior view of sash at Music Room.

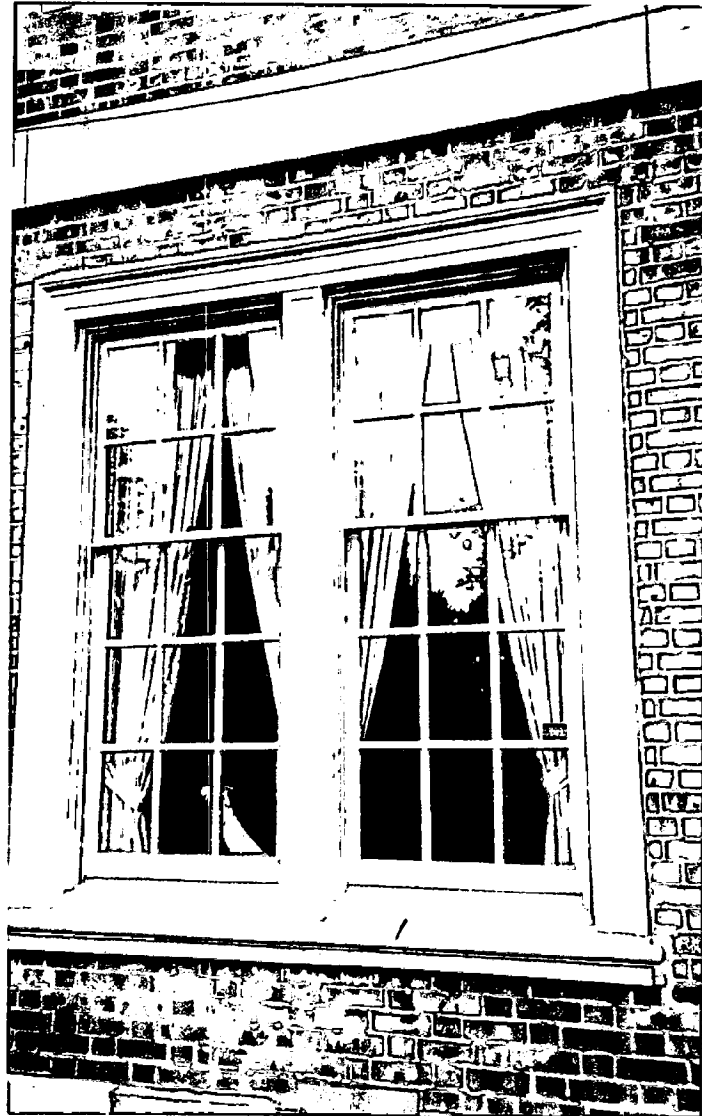
Photo #4: Exterior view of sash at Library. Window No.s 212 and 213.

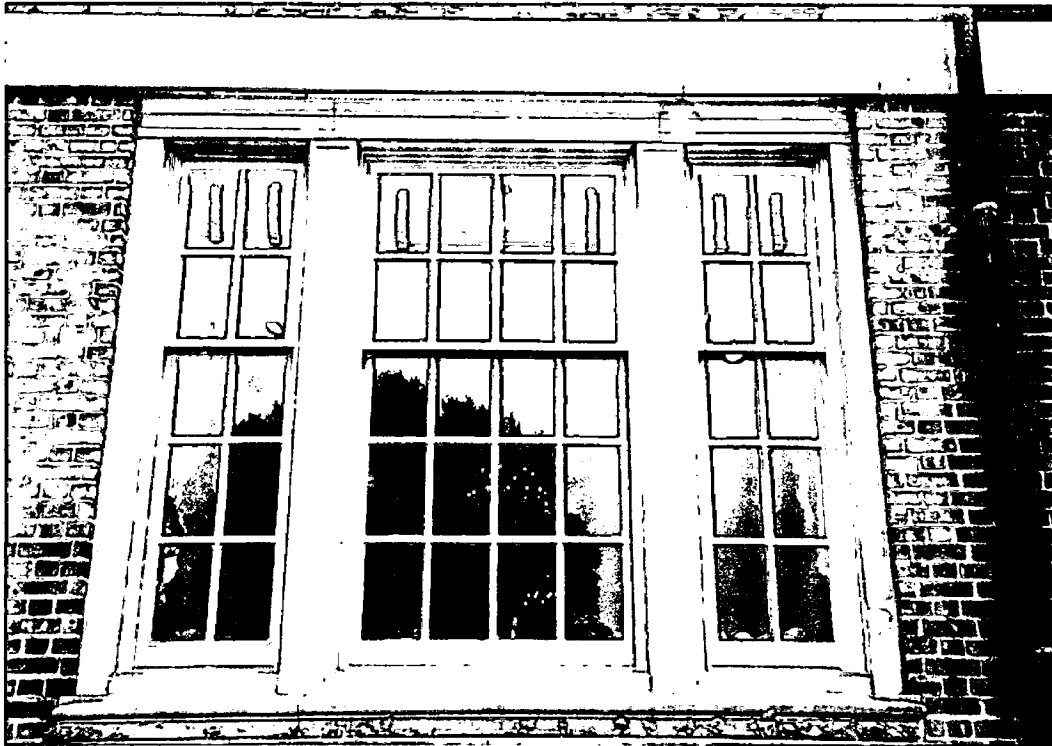
Photo #5: Exterior view of sash at Gallery (Rm. 110).

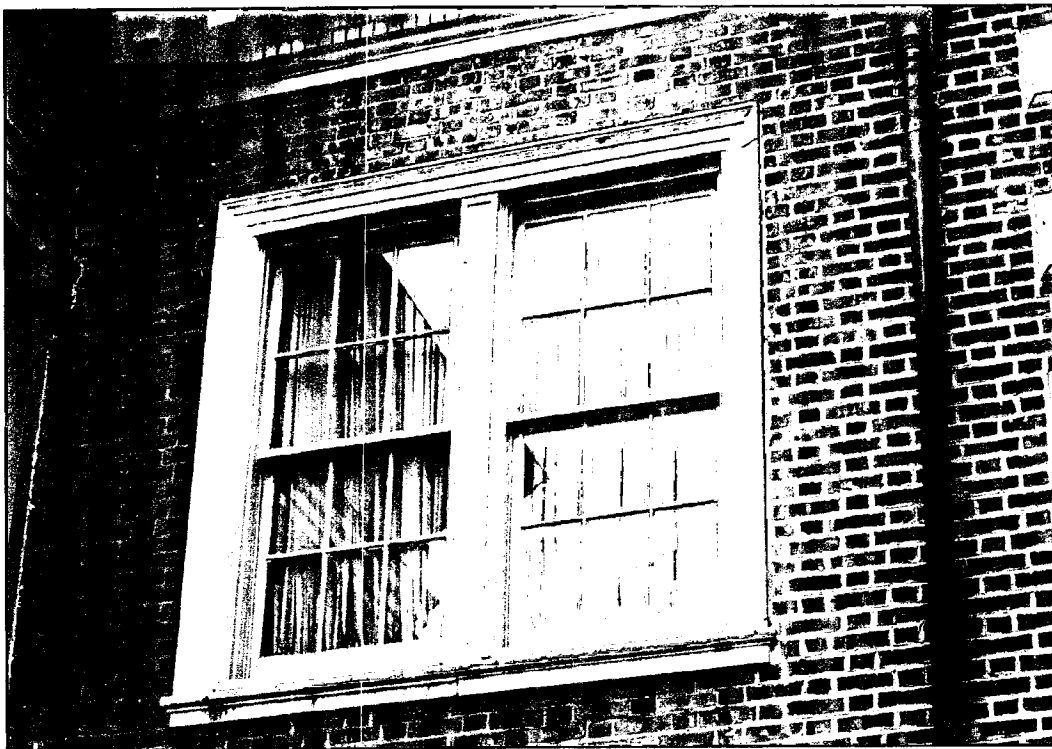
Photo #7: Exterior view of sash at second floor Gallery (Sash No.s 212, 213).
Note narrow muntins (Type 3) at this sash.

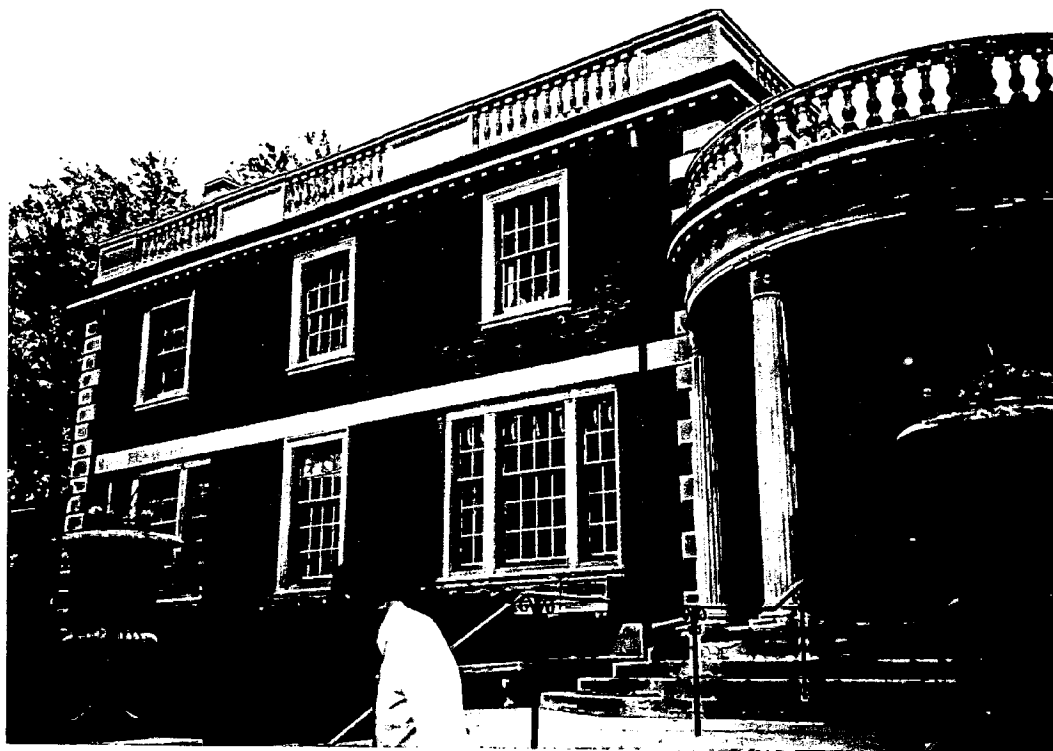
Photo #10: Exterior view of sash at first floor Gallery and kitchen, and second floor offices.
The sash at the kitchen and offices must remain operable.

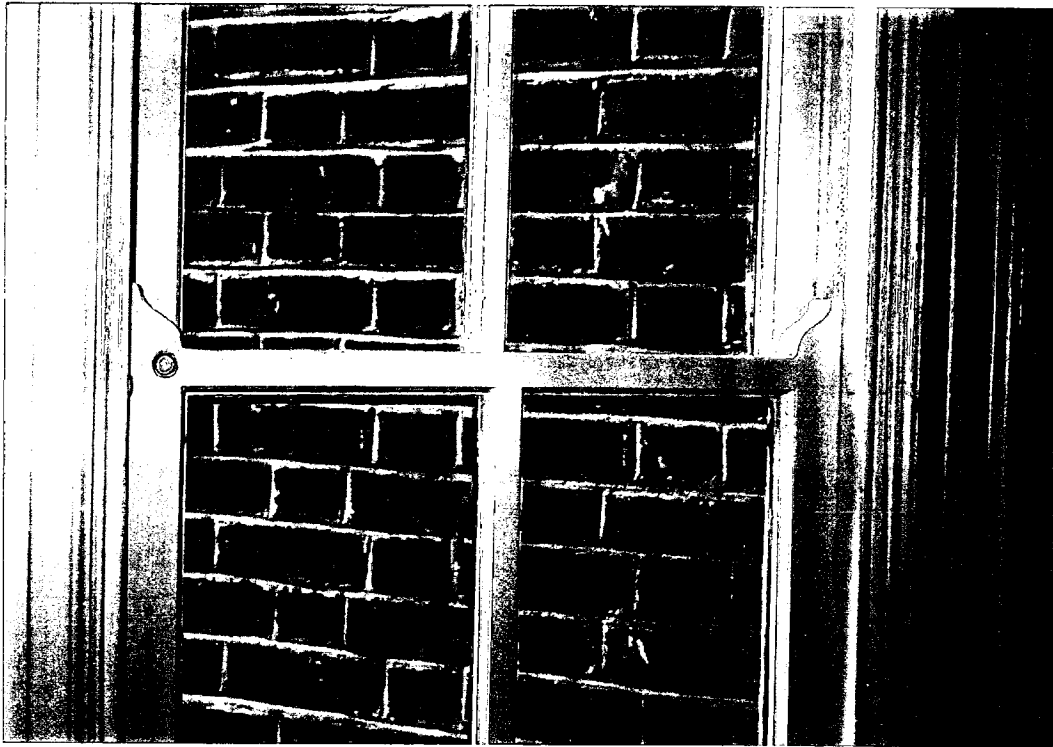
Photo #11: Interior detail view of meeting rail with tailpieces. Window No. 205.

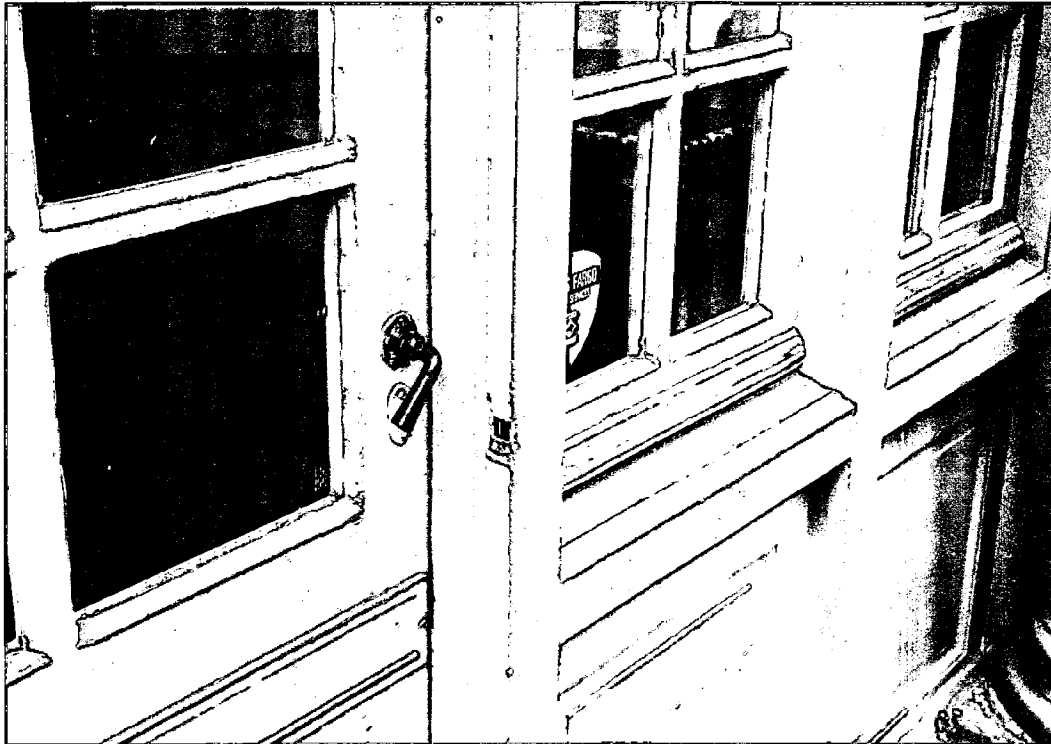
Photo #13: Detail view of window and door jambs at sun room. Exterior window mullions are already detailed (rabbeted) to receive exterior storm sash.

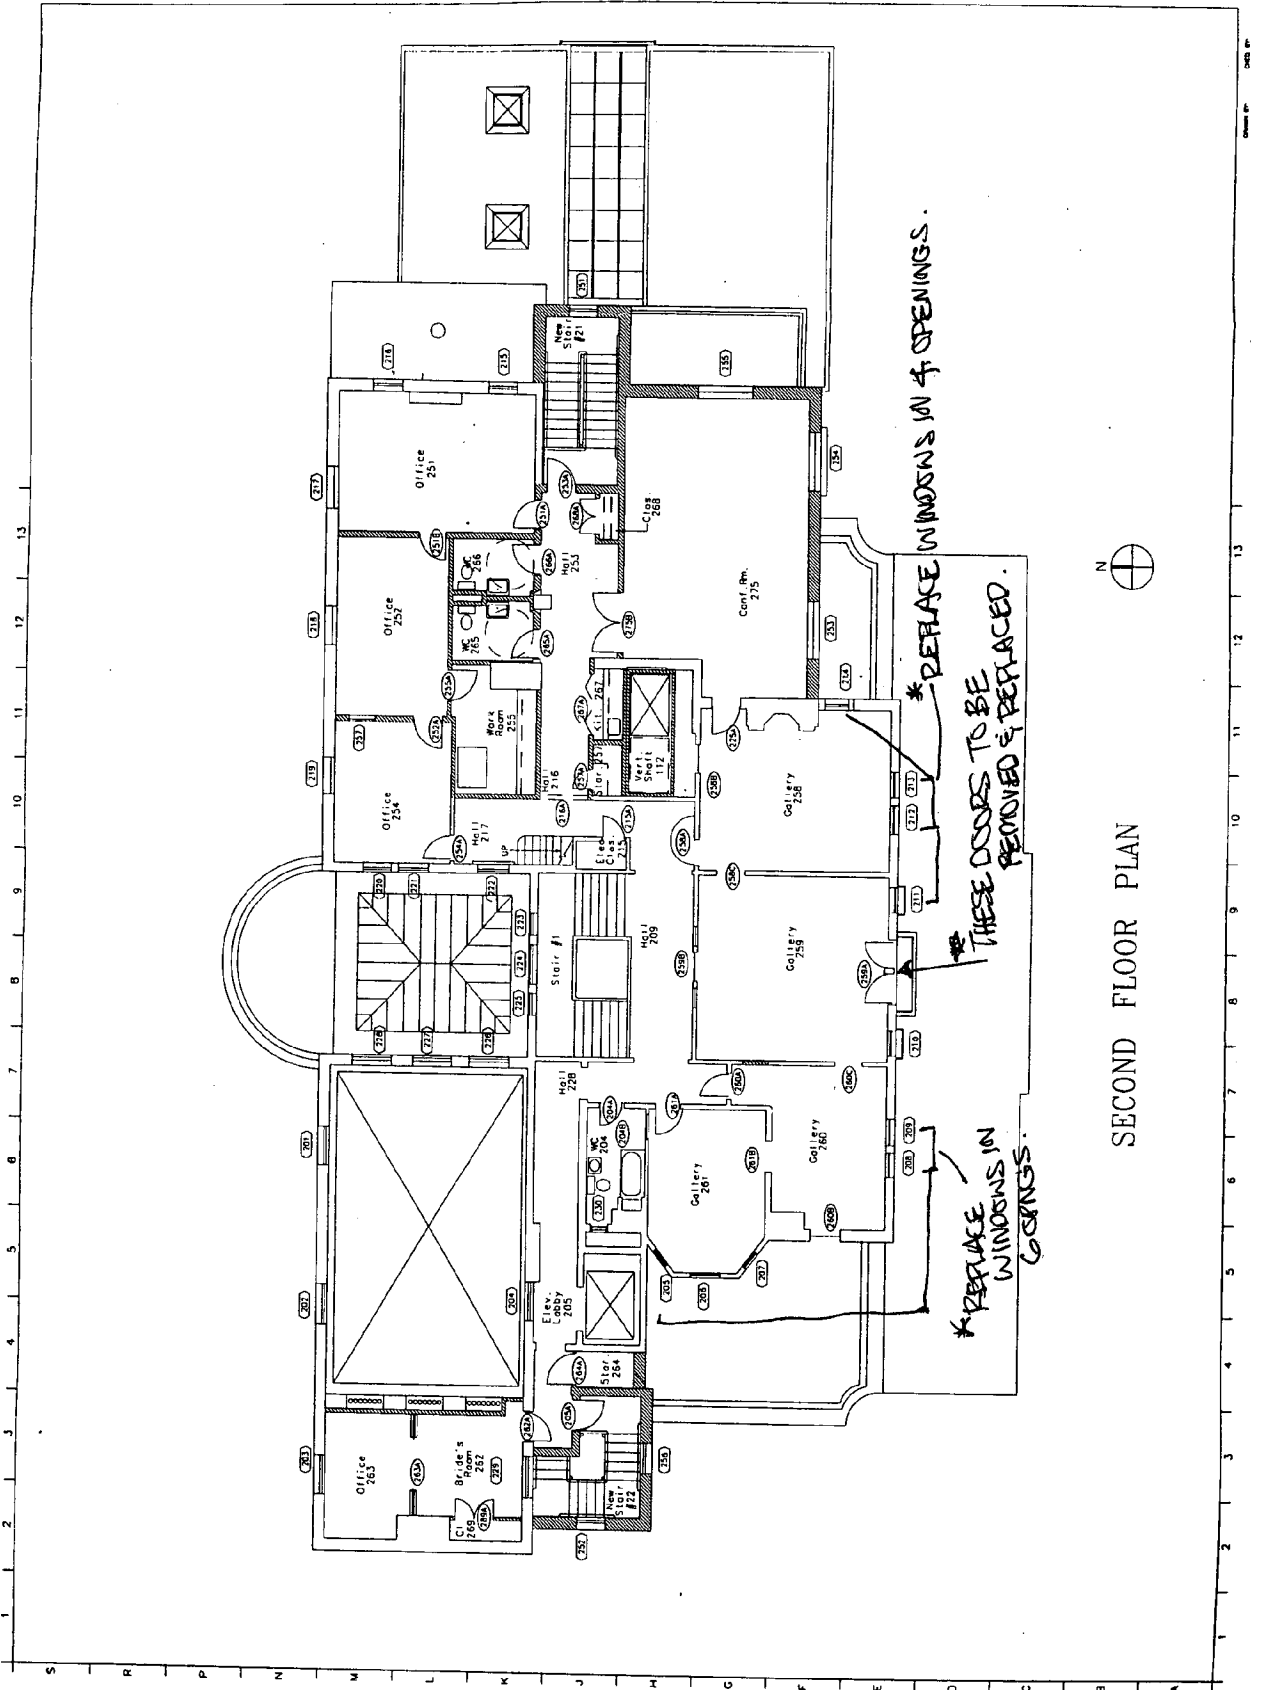
SECOND FLOOR PLAN

* REFRAKE WINDOWS IN 4 OPENINGS.

THESE DOORS TO BE REMOVED & REPLACED.

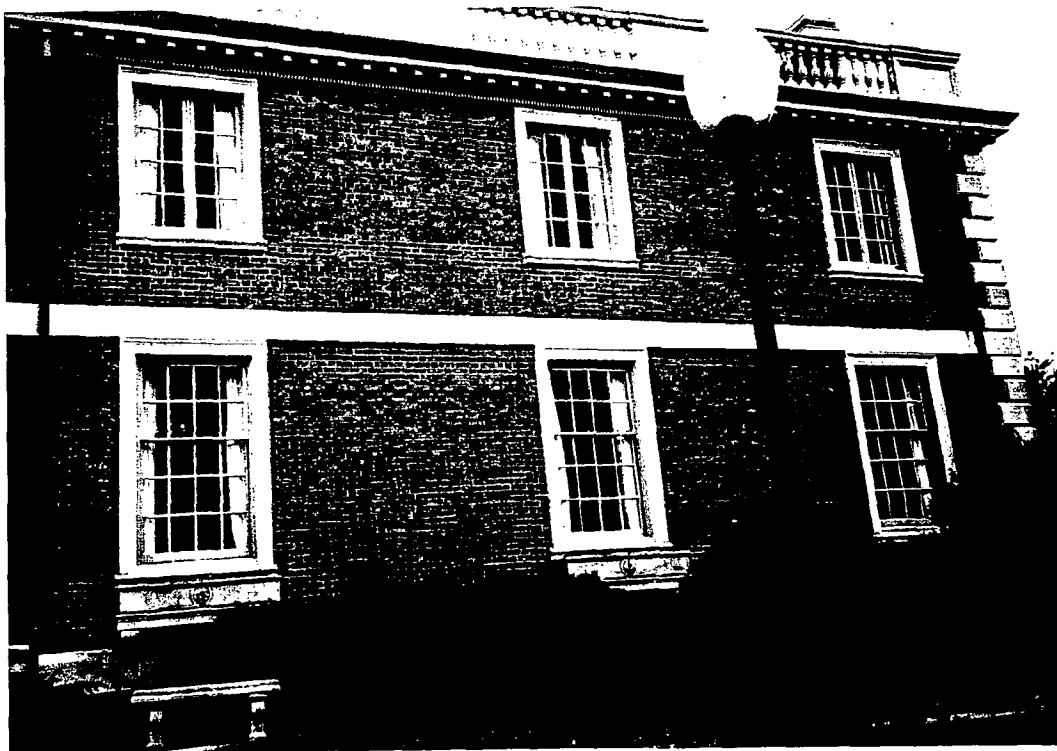
Photo #2: Exterior view of sash at Music Room.

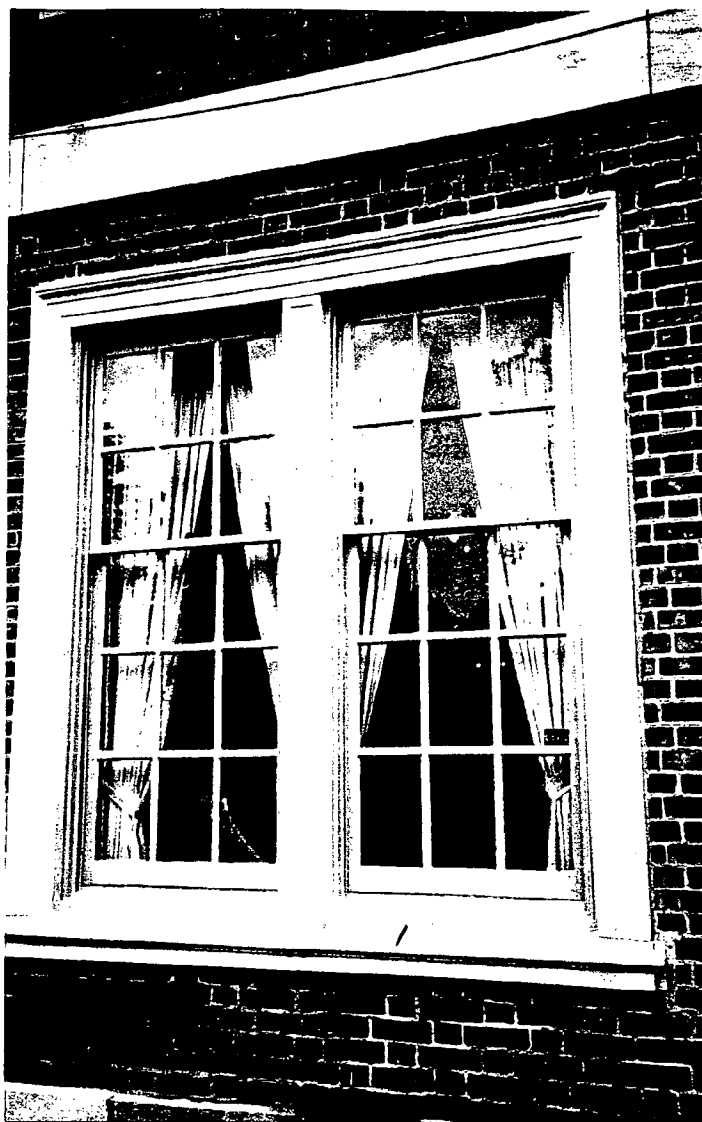
Photo #4: Exterior view of sash at Library. Window No.s 212 and 213.

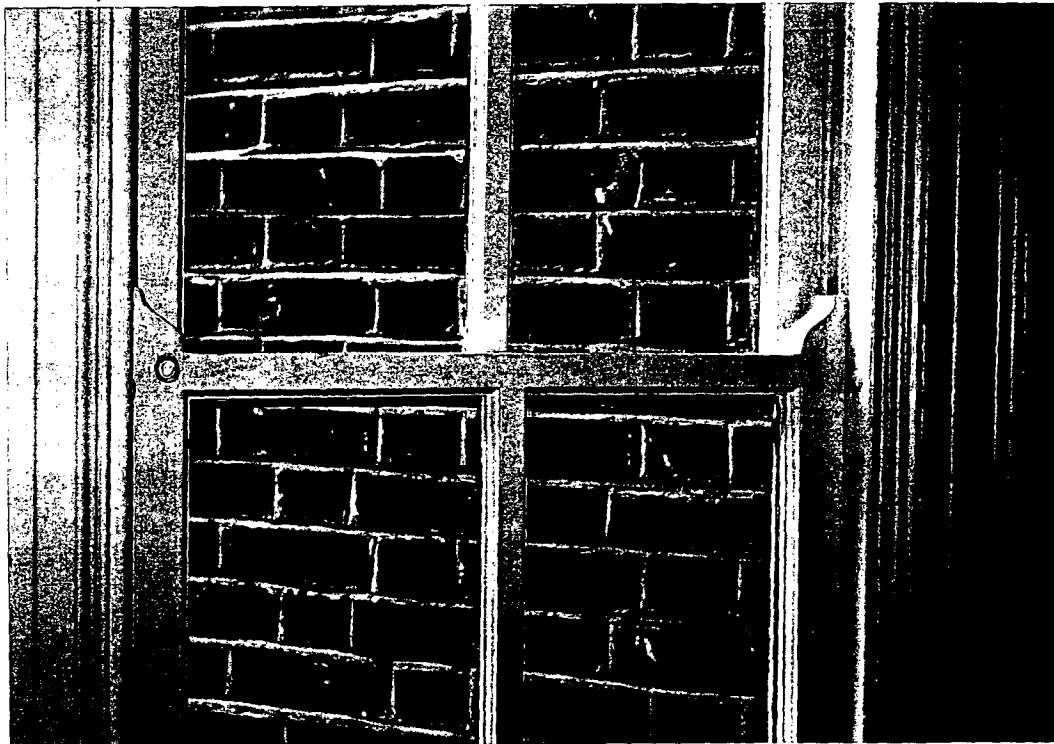
Photo #11: Interior detail view of meeting rail with tailpieces. Window No. 205.

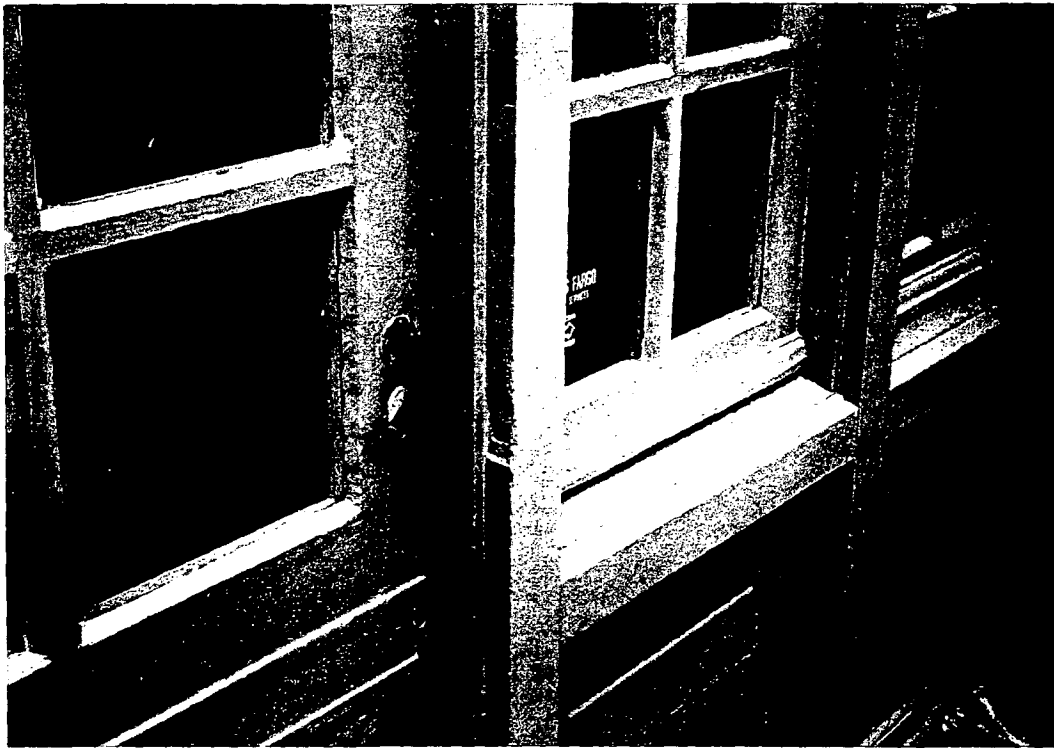
Photo #13: Detail view of window and door jambs at sun room. Exterior window mullions are already detailed (rabbeted) to receive exterior storm sash.
