36/7-3-98A 8619 Colesville Rd. S. Sp.  
(MP #36/7-7 Silver Theatre Shopping  
Center)

**ROOF REPLACEMENT  
 MASONRY RESTORATION  
 SILVER THEATRE  
 SILVER SPRING, MARYLAND**

**REPORT OF EXISTING CONDITIONS  
AND FINDINGS  
REGARDING THE RESTORATION OF  
THE ROOF OF THE SILVER THEATER**

**SILVER SPRING  
MONTGOMERY COUNTY  
MARYLAND**

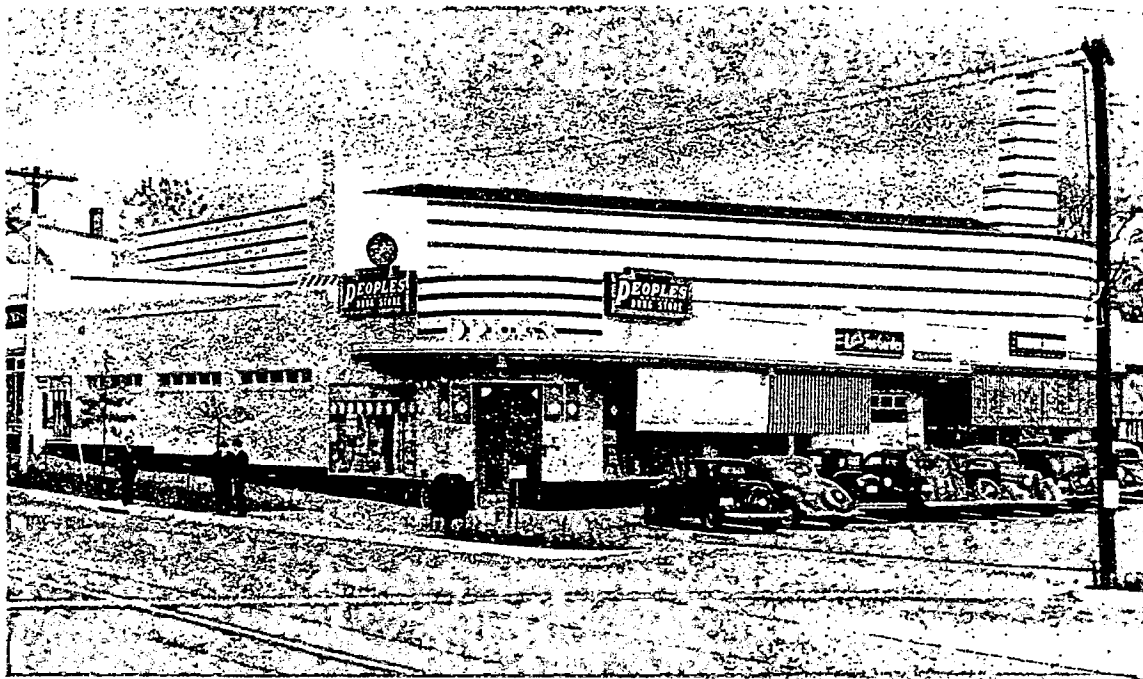
002 1938 photograph taken from the west showing asphalt sheet roofing on the west facing mansard slope of the of the auditorium and the original chimney to the left.

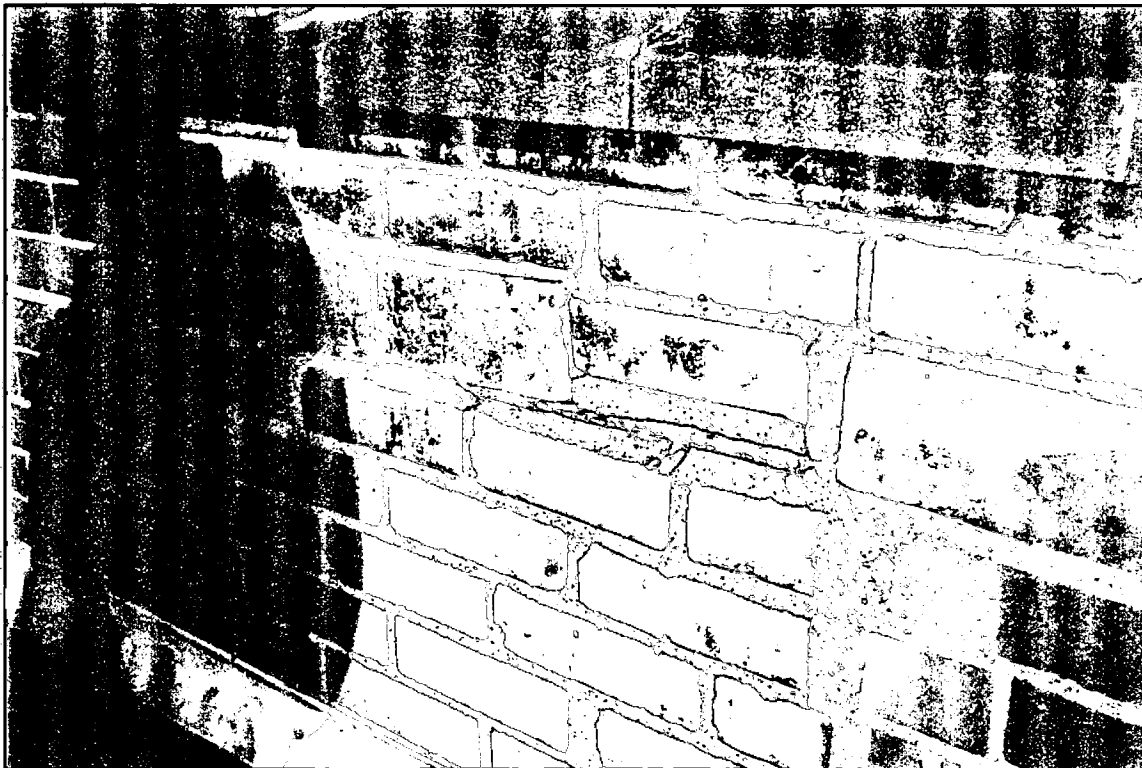
006 Detail of west face of the east parapet wall showing mortar joints and the steel plate exposed (1998 photograph).

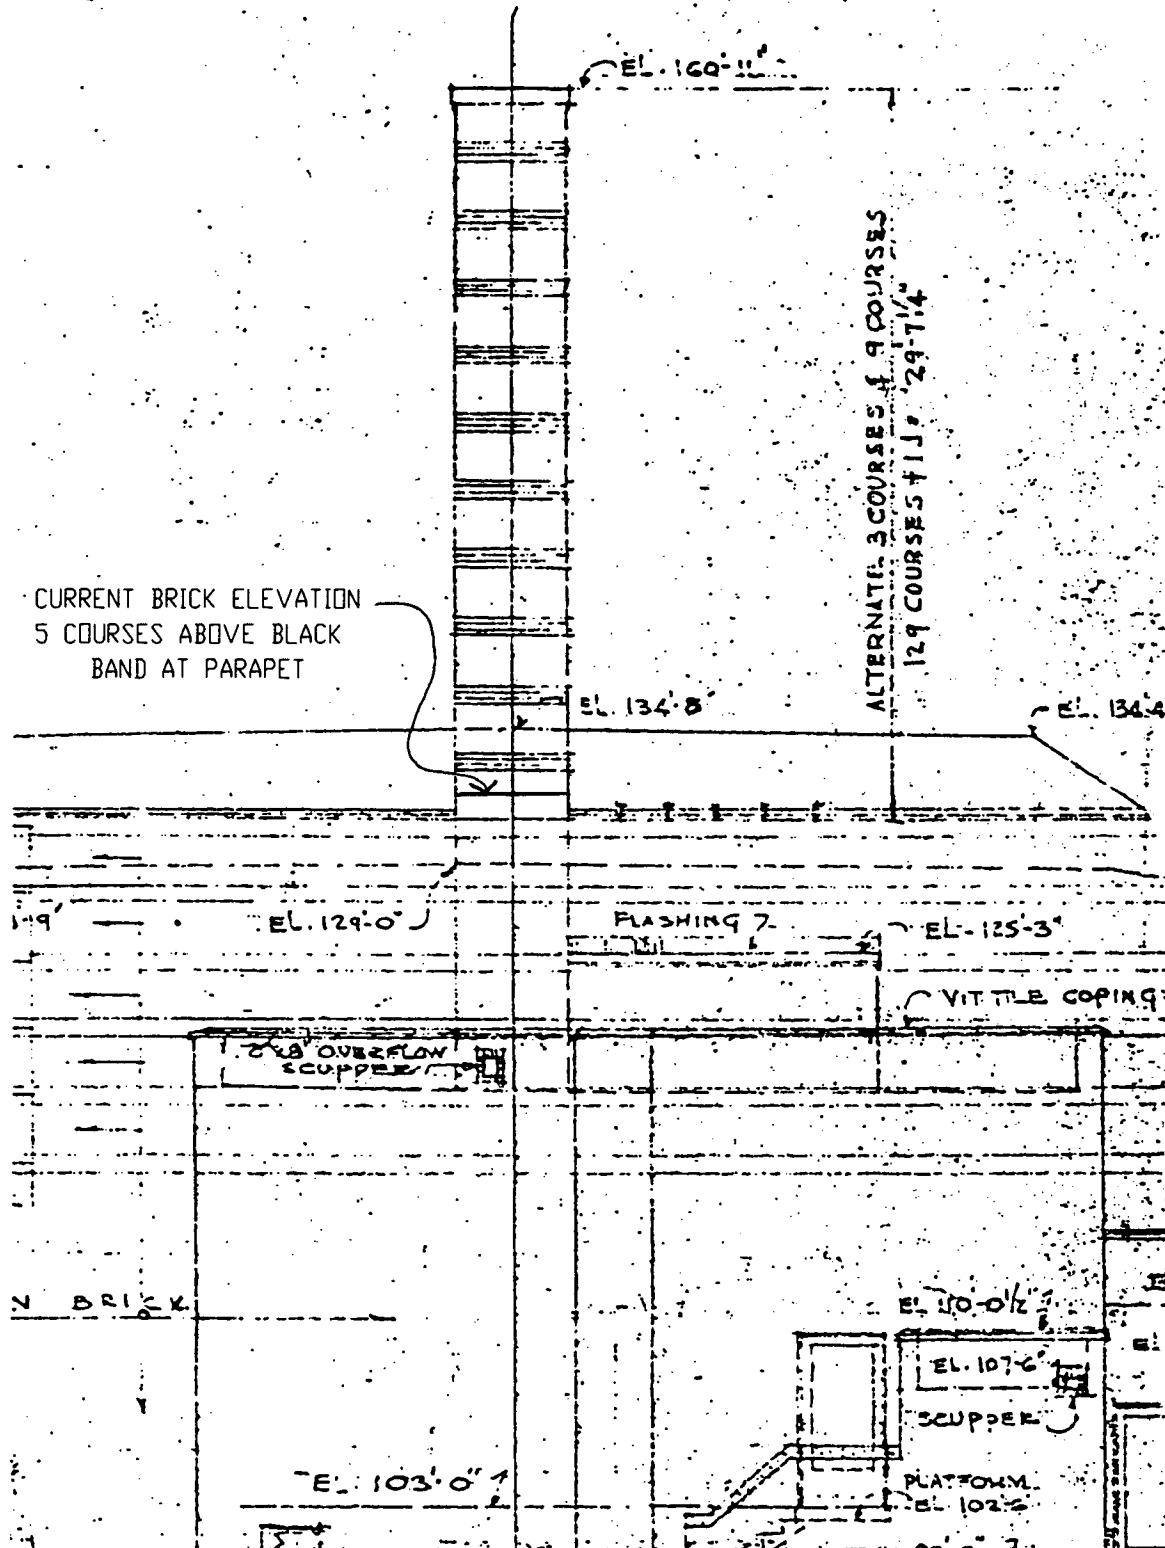
EAST ELEVATION

ALTERNATE BANDS OF BRICK

10 FULL BANDS - CREAM BRICK  
 10 FULL BANDS - BLACK BRICK  
 4 COURSES - CREAM BRICK

TOTAL REPLACEMENT OF 124 COURSES OF BRICK

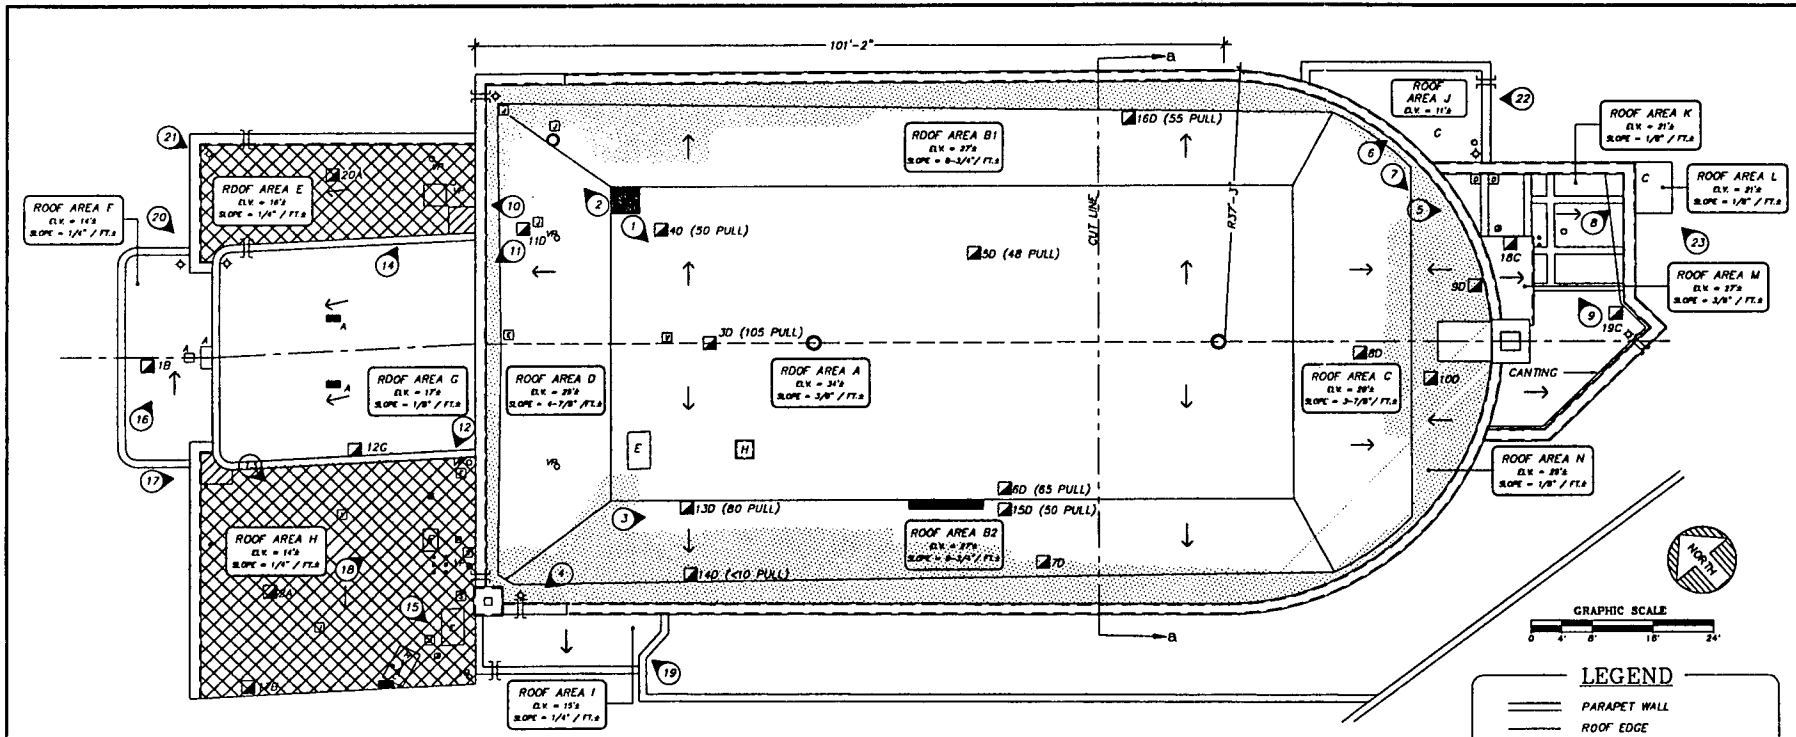
DESIGN BY: OWS	DRAWN BY: LSA	REVIEWED BY: ISK	CAD FILE: 523108P7
<b>DECK REPLACEMENT PLAN</b>			
<b>SILVER SPRING SHOPPING CENTER</b>			
<b>SILVER SPRING, MARYLAND</b>			
DATE: MARCH 1998			
DATE IN: 632810			
SCALE: 1" = 8'-0"			
SHEET: <b>A2</b>			
2 OF 2

The areas of deteriorated gypsum decking are primarily found in the valley sections and portions of the steep slope area of the main roof. Also, the wood decking on the roof areas E and H (see attached plan) are saturated. The test pulls, where applicable, are shown on the attached log and are referenced on the roof plan.

<u>TEST CUT NUMBER</u>		<u>ROOF TYPE</u>		<u>ROOF AREA</u>
1	Verification Cut	B	Dry to touch	F
2	Verification Cut	A	Moist to touch	H
3	Verification Cut	D	(105 pull value) dry	A
4	Verification Cut	D	(50 pull value) dry	A
5	Verification Cut	D	(48 pull value) dry	A
6	Verification Cut	D	(65 pull value) dry	A
7	Verification Cut	D	Saturated	B2
8	Verification Cut	D	Moist to touch	C
9	Roof to Wall	D	Wet to touch	N
10	Verification Cut	D	Wet to touch	N
11	Verification Cut	D	Dry to touch	D
12	Roof to Wall	C	Dry to touch	G
13	Verification Cut	D	(80 pull value) dry	B2
14	Verification Cut	D	(40 pull value) dry	B2
15	Verification Cut	D	(50 pull value) dry	B2
16	Verification Cut	D	(55 pull value) dry	B1
17	Edge Cut	A		H
18	Edge Cut	C		M
19	Verification Cut	C	Dry to touch	K
20	Verification Cut	A	Saturated	E

New decking materials will be required in the locations shown on the roof plan. GALE recommends that a plank type material is installed to replace the gypsum. The planks must be able to span the distance between the existing bulb tees. Additionally, the existing reinforced deck spans from support to support utilizing wire mesh. The new decking should be specified to span at least this distance. Cementitious woodfiber (CWF) by Tectum, Inc. or concrete planks (e.g. MidCon metal edge of Hortonville, WI or Steel Edge Crete-plank by Martin Fireproofing of Buffalo, NY) are examples of potential deck replacement materials. Since the concrete planks do not tout the acoustical properties of their material as Tectum does, GALE assumes that CWF will act as a better sound insulator than the concrete planks. Note that this assumption is based on observation and not empirical data, so we will be willing to discuss the design parameters with all parties as the project progresses.

1. REMOVE EXISTING ASPHALT BUILT-UP AND MODIFIED BITUMEN MEMBRANES, METAL ROOFING, BITUMINOUS AND SHEET METAL FLASHINGS, ABANDONED POURABLE SEALER POCKETS, ROOFTOP INSULATION AND ASSOCIATED APPURTENANCES THROUGHOUT THE ROOF AREAS DOWN TO THE STRUCTURAL ROOF DECK.

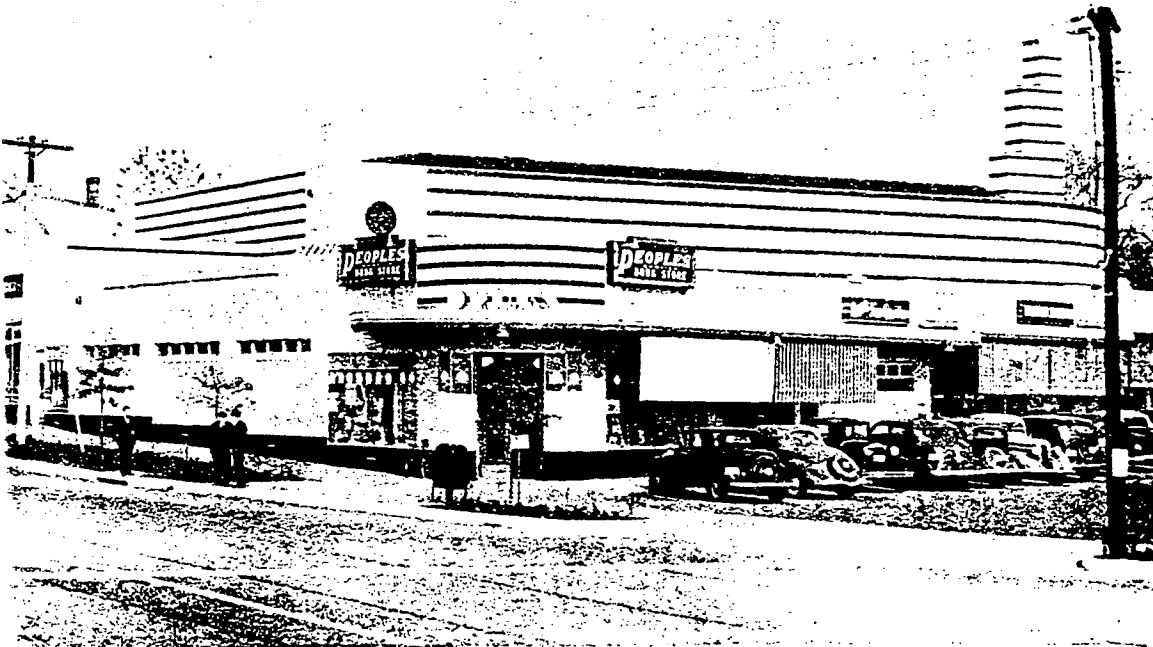
002 1938 photograph taken from the west showing asphalt sheet roofing on the west facing mansard slope of the of the auditorium and the original chimney to the left.

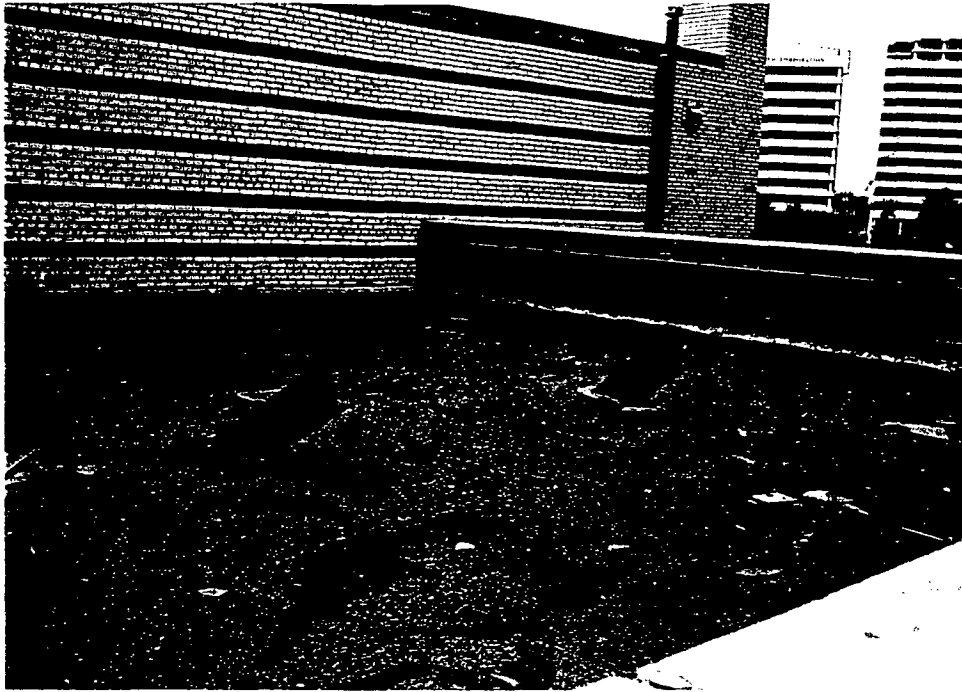
009 Exterior view of original parapet wall scupper in the auditorium parapet wall to the right in the distance (1995 photograph).

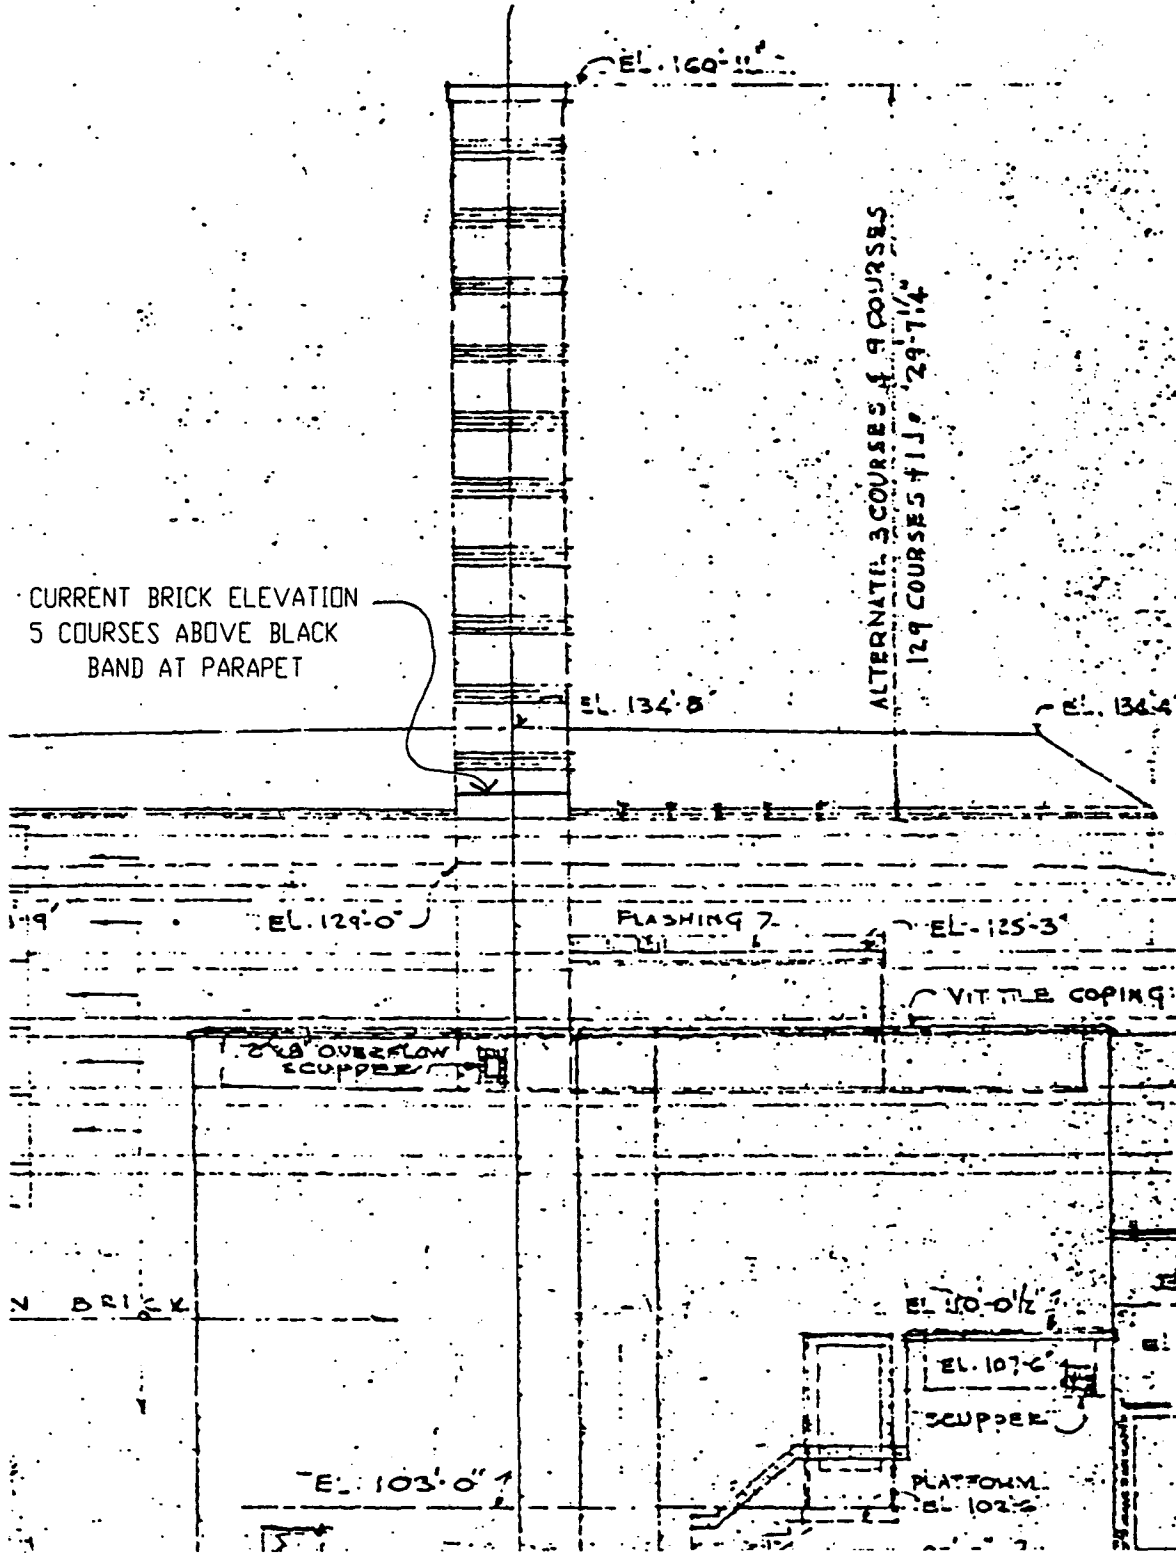
EAST ELEVATION

ALTERNATE BANDS OF BRICK

10 FULL BANDS - CREAM BRICK  
10 FULL BANDS - BLACK BRICK  
4 COURSES - CREAM BRICK

TOTAL REPLACEMENT OF 124 COURSES OF BRICK
