13/14-04A 22900 Whelan Lane

MP Site 13/14 Moneysworth Farm

SUBJECT: Historic Area Work Permit

# APPLICATION FOR HISTORIC AREA WORK PERMIT

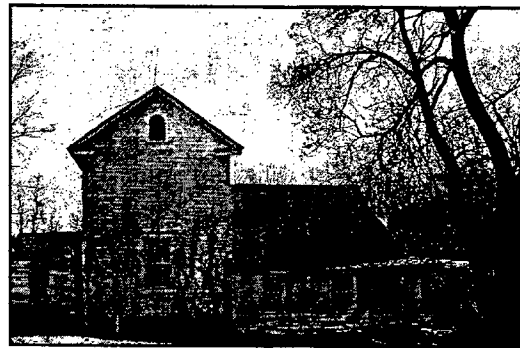
1 NORTH ELEVATION (EXIST.)  
SCALE: NONE

REMOVE METAL ROOFING ENTIRELY IN PREPARATION FOR NEW CEDAR SHAKE ROOF.  
MUD ROOM ENCLOSURE TO BE REMOVED ENTIRELY

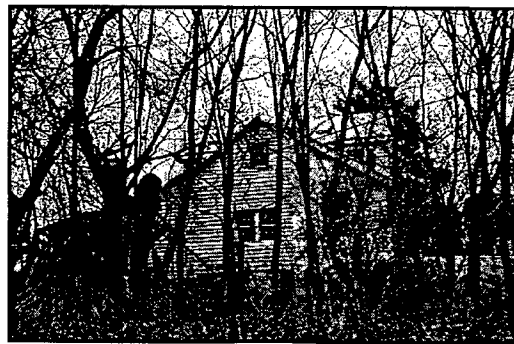
6 WEST ELEVATION (EXIST.)  
SCALE: NONE

RESTORE WINDOWS AND TRIM.  
REMOVE TREES

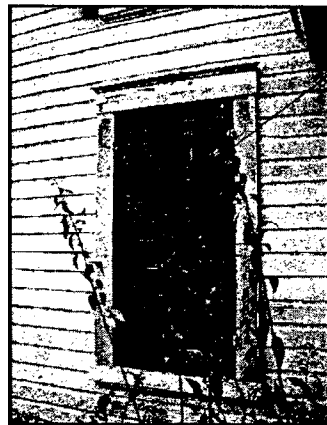
RESTORE SHUTTERS

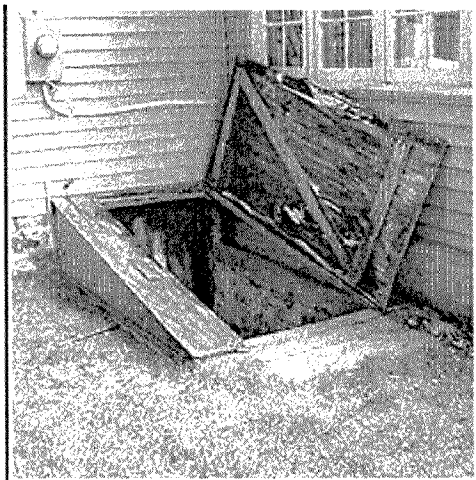
The underside of the door was badly decayed. All those white patches are fungal growth.

There were holes in the plywood door, and moss was growing on the wood. Moss growth is not a good sign, especially when it's on the *south* side of the house.

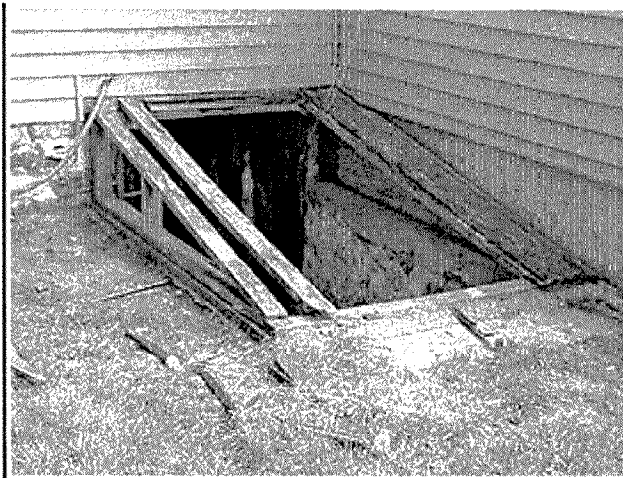
At this point I realized that the plywood and lumber was all pressure treated. This told me that the door was probably less than 30 years old.

In spite of this preservative, the wood managed to rot in places where it was exposed to the elements.

I suspect that the Chromated Copper Arsenate (CCA) preservative got washed away from years of rain dripping on the plywood door.

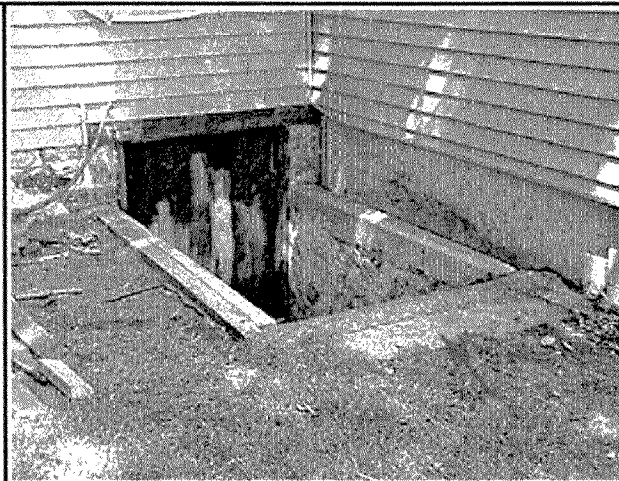
The good news: The **side foundations** were in excellent condition.

The bad news: The **front foundation** (red arrow) was thin, weak, and cracked. It also sloped sharply away from the side foundations, which meant that the new Bilco door would not have a uniform and flush surface to rest on.

The side walls of the entry foundation were made from stone rubble, just like the rest of the foundation. Most of this foundation was intact.

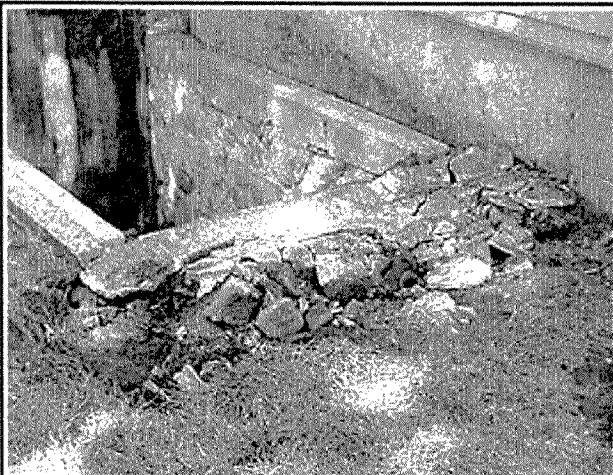
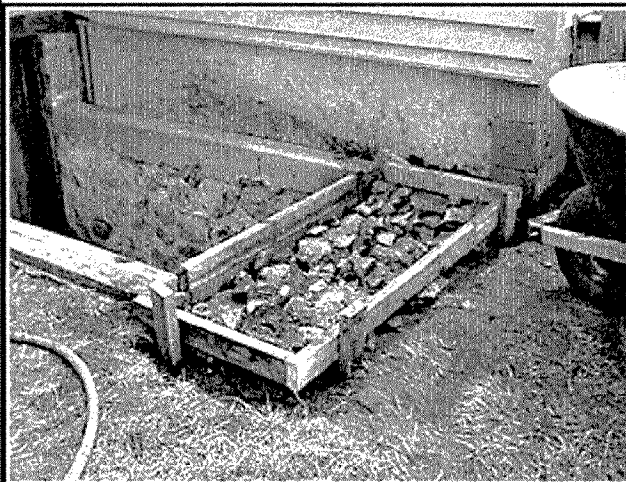
This front slab was basically a pile of rocks with mortar smoothed over the top.

I used a sledge hammer to break up the front slab part of the foundation, being careful not to damage the stone rubble wall that extends a couple of feet below grade.

I made some concrete forms from 2x4's (the lumber from the old door frame).

I placed some of the rocks from the old front slab into the forms, to reduce the volume of concrete I would need.

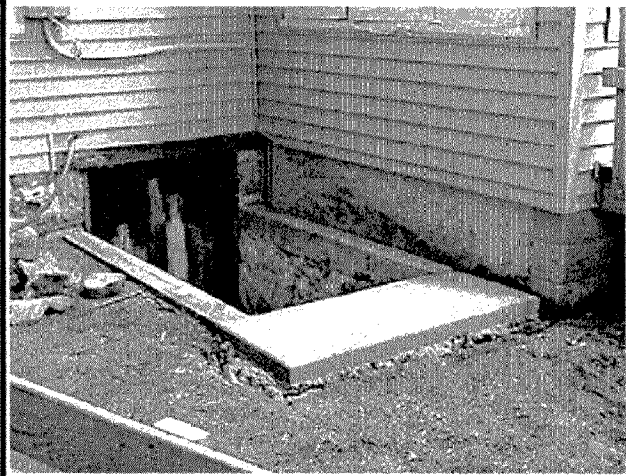
**The next day** the slab was hard enough to walk on, though still soft enough that it could be chipped if I wasn't careful.

I could tell that the rough surface of the stone wall was going to keep the Bilco door from meeting the house correctly. There were a couple of high spots, which I shaded in black with a marker pen (red arrow).
