29/38-05A 8311 Comanche Court  
MP Site #29/38 **Glenmore**

SUBJECT: Historic Area Work Permit #378988

Address: 8311 Comanche Court, Bethesda; *Master Plan* Site # 29/38, **Glenmore**

<b>Address:</b>	8311 Comanche Court, Bethesda	<b>Meeting Date:</b>	05/11/05
<b>Applicant:</b>	Nancy Everett and Mike Nannes	<b>Report Date:</b>	05/04/05
<b>Resource:</b>	<i>Master Plan</i> Site #29/38 <b>Glenmore</b>	<b>Public Notice:</b>	04/27/05
<b>Review:</b>	HAWP	<b>Tax Credit:</b>	Partial
<b>Case Number:</b>	29/38-05A	<b>Staff:</b>	Michele Oaks
<b>PROPOSAL:</b>	Rehabilitate and Replace Windows

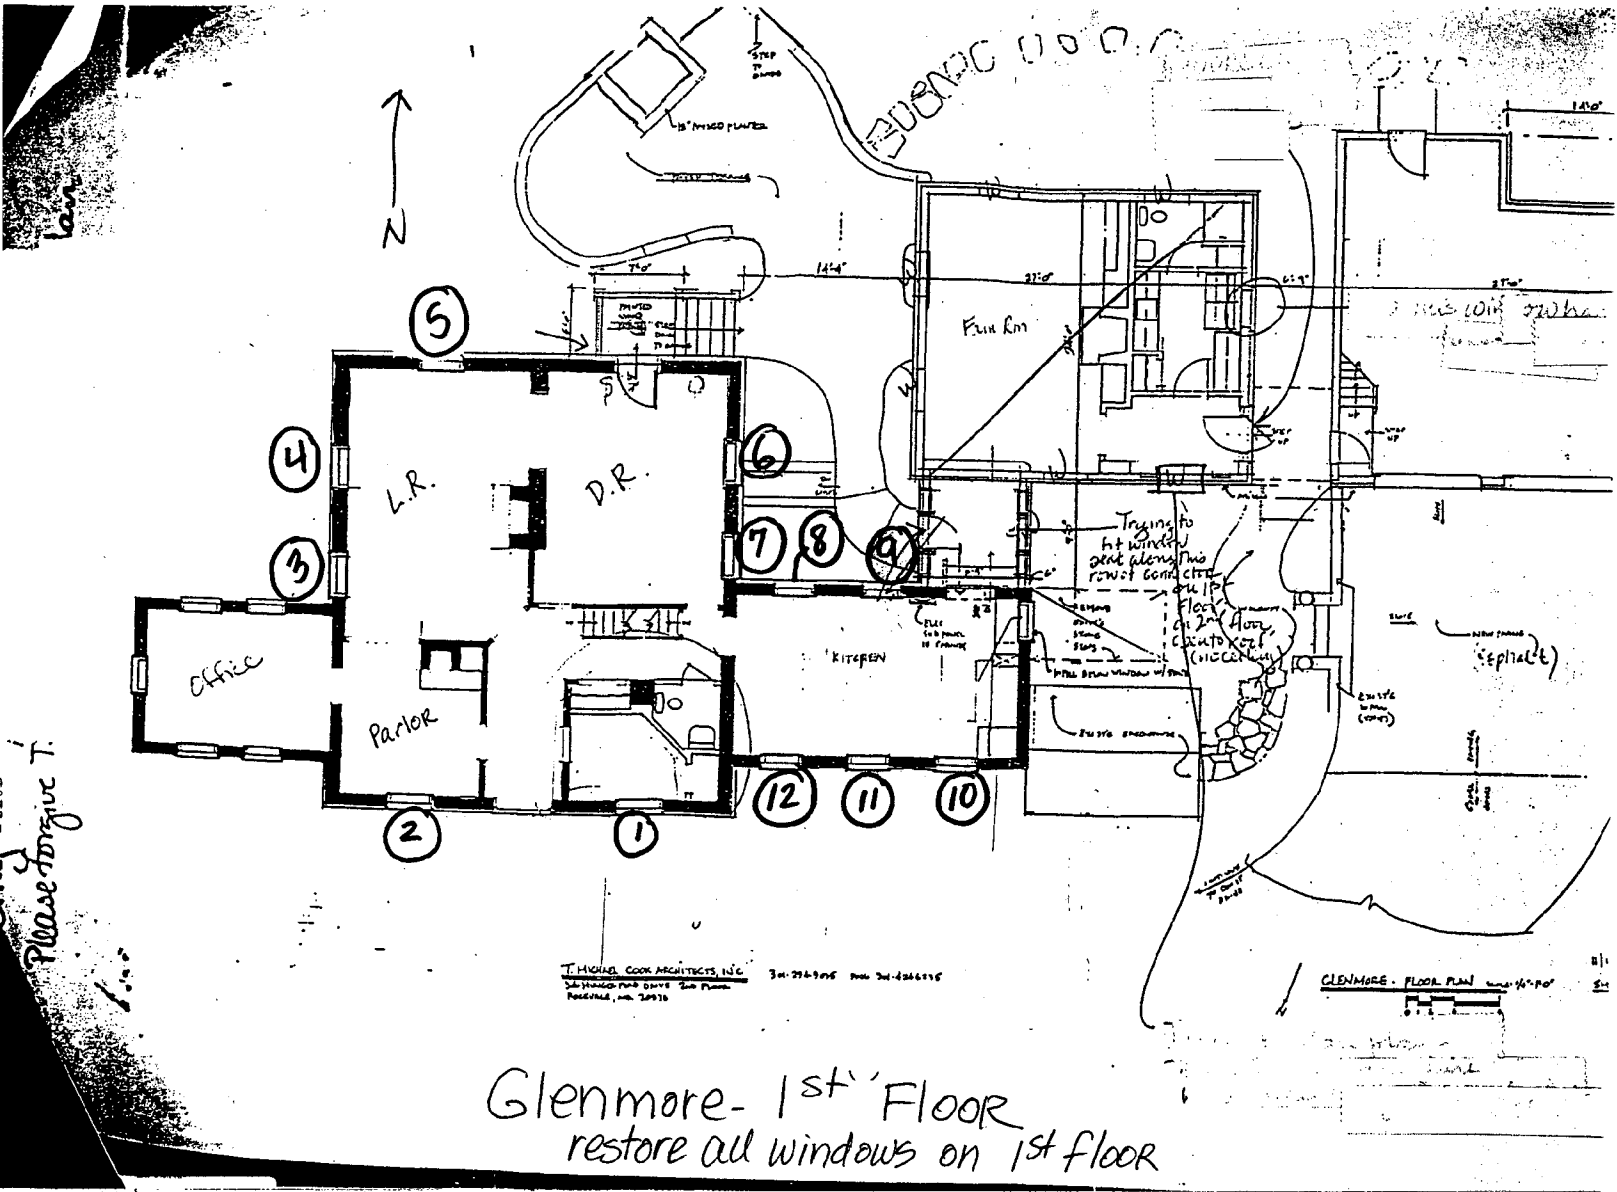
Glenmore - 1st Floor  
 restore all windows on 1st floor

15	3/4 inch	yes	no	6/6; original; fair to poor condition; <b>restore</b> (main front block of house)
<del>16</del>	3/4 inch	yes	yes	6/6; original; fair to poor condition but most old glass of any window; <b>restore</b> and move to front of house in place of 13 or 14
<del>17</del>	1-1/8 inch	no	no	6/6; good condition; 20 <sup>th</sup> -century window; west side of house; <b>replace</b>
<del>18</del>	1-1/16 inch	no	no	Same as 17; fair condition; <b>replace</b>
<del>19</del>	3/4 inch	yes	Yes(1 pane?)	6/6; window old but not original to frame; poor condition; extra wood pieced in on either side; sashes crooked in frame; very leaky; back of house; use muntins and parts to restore other original windows; <b>replace</b>
<del>20</del>	3/4 inch	yes	Yes but broken	6/6; original; fair condition but considerable restoration necessary; muntins gouged and missing; <b>restore</b> and move to front of house (13 or 14)

X <del>21</del>	3/4 inch	yes	no	6/6; original; fair to poor condition; rotted sill; muntins gouged; on interior side of house; use parts for salvage of other original windows on front block; <b>replace</b>
<del>22</del>	1-1/16 inch	no	no	6/6; not original; badly rotted sill and bad fit; side of house; <b>replace</b>
23	3/4 inch	yes	yes	6/6; original; bad condition; rot; <b>restore</b> due to amount of wavy glass
<del>24</del>	1-1/8 inch	no	no	6/6; not original; <b>replace</b>
X <del>25</del>	7/8 inch	yes	no	6/6; may be original; inoperable; very poor condition; large chunk of sash missing + some muntins are only putty; some parts already utilized to restore # 12 on first floor; <b>replace</b>
X <del>26</del>	7/8 inch	yes	no	6/6; may be original; very poor condition; muntins gouged, and unconnected to window; sill rotted; <b>replace</b>
