37/03-06F 511 Philadelphia Ave

Takoma Park Historic District, 37/03

**Subject:** 511 Philadelphia Avenue - window survey  
**Location:** Takoma Park  
**Start:** Tue 3/14/2006 9:30 AM  
**End:** Tue 3/14/2006 10:00 AM  
**Recurrence:** (none)  
**Categories:** Site Visit

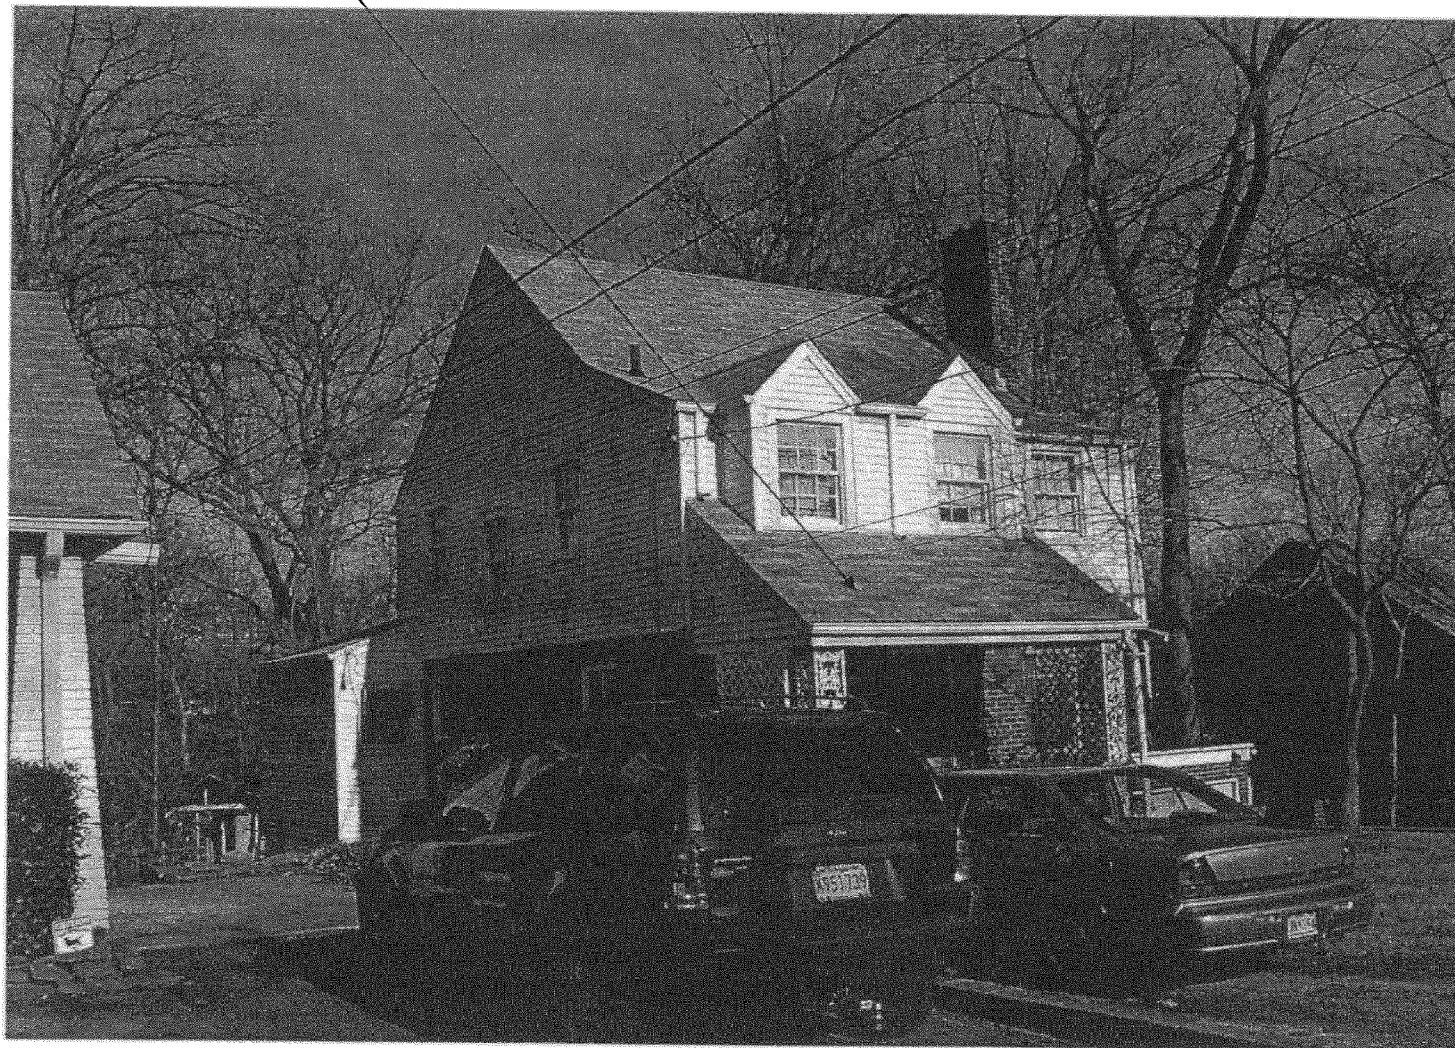
509 PHILADELPHIA AVENUE – Dorothy Brown

Replace this window
