306 Market Street  
Brookville

HAWP 23/65-08A

SUBJECT: **Stop Work Order:** Historic Area Work Permit #518318 - 306 Market Street, Brookeville.

**PROPOSAL:** Window and door replacement and other alterations

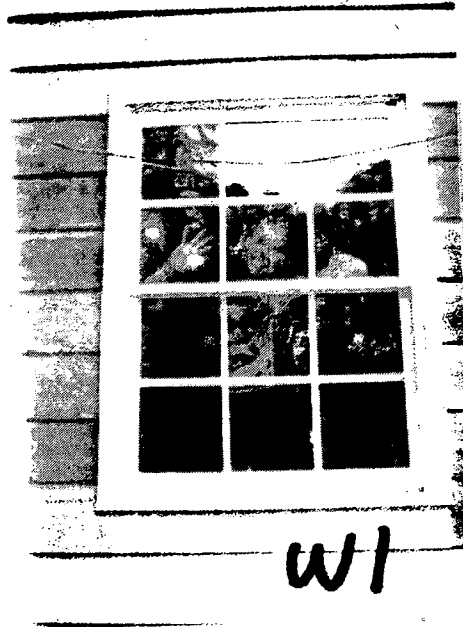
**W1 3' 5 3/8" x 4' 8"**

The window was a metal and glass framed window (not historically or structurally significant) that did not close completely and the glass was cracked. The window was replaced by a 6 over 6 paned wood and glass Jeldwen Energy Star simulated divided light window without screen. The wood will be stained cedar to match the cedar siding.

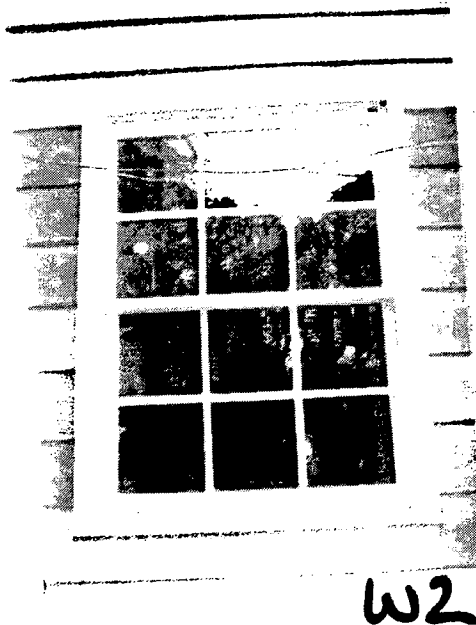
**W2 3' 5 3/8" X 4' 8"**

The wood and glass door (not original to the house or historically significant) had swelled shut and was replaced by a 6 over 6 wood and glass Jeldwen Energy Star simulated divided light window without screen. The wood will be stained cedar to match the cedar siding.

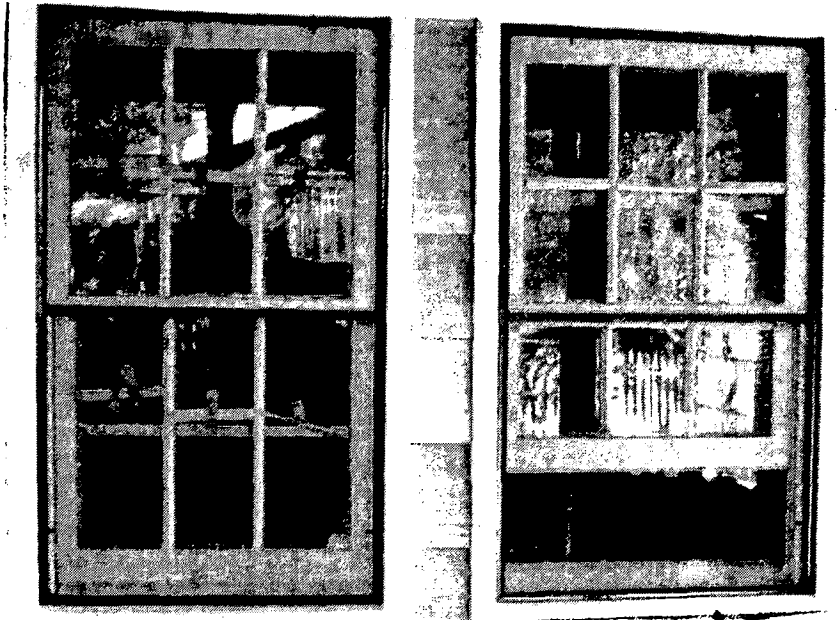
W3 2' 5 3/8" x 4 1/2" (2 each)

The 6 x 6 true divided light wood and glass framed windows were broken and did not open. There were also large gaps between window and frame that allowed cold air & insects inside. The windows were replaced by a 6 over 6 paned wood and glass Jeldwen Energy Star simulated divided light windows with screen. The wood will be stained cedar to match the cedar siding.

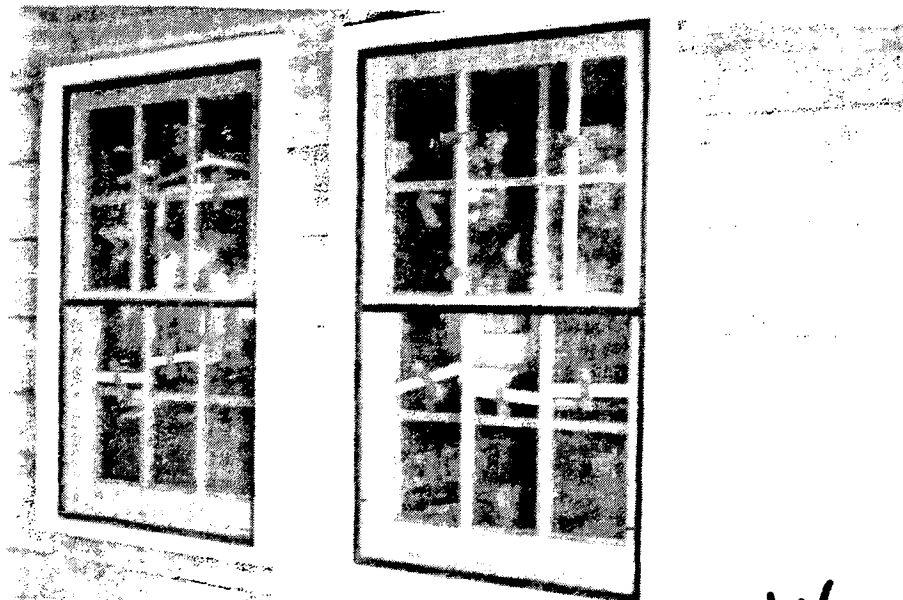
W4

The 6 x 6 true divided light wood and glass framed windows were damaged and one of the windows did not open. The second was held together by duct tape on the inside. There were also large gaps between window and frame that allowed cold air & insects inside. The windows were replaced by a 6 over 6 wood and glass Jeldwen Energy Star simulated divided light windows with screen. The wood will be stained cedar to match the cedar siding.

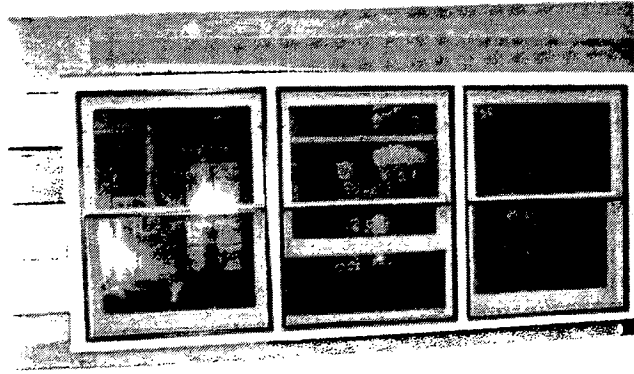
W5

The wood and glass window did not have true divided light. The window was added during an addition that was built in the 1950's. This window had 3 attached windows in one unit and was replaced by 3 attached windows in one unit. Each window has 6 over 6 wood and glass Jeldwen Energy Star simulated divided light windows with screen. The wood will be stained cedar to match the cedar siding.

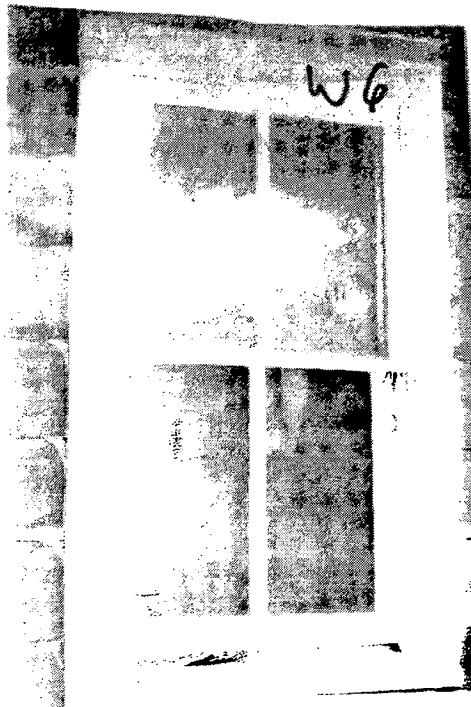
W6 2' 5 3/8" x 4 1/2"

The wood and glass window has true divided light (2 over 2) is damaged and does not close properly or lock. The window will be replaced by a 6 over 6 wood and glass Jeldwen Energy Star simulated divided light windows with screen. The wood will be stained cedar to match the cedar siding.

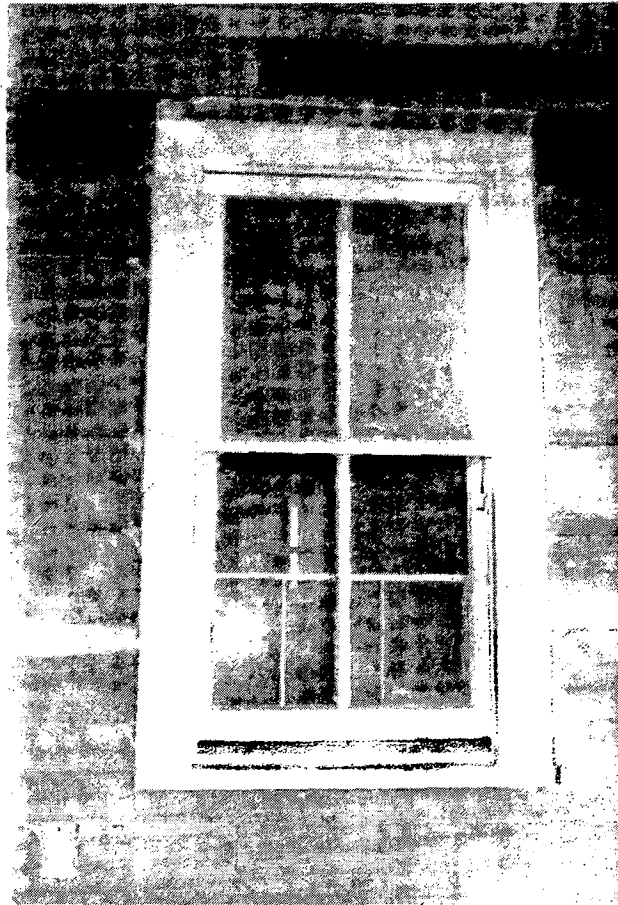
W8 2' 5 3/8" x 4 1/2"

The wood and glass window has true divided light (2 over 2 paned), is damaged and does not close properly or lock. The window will be replaced by a 6 over 6 paned simulated divided light, wood and glass Jeldwen Energy Star with screen. The wood will be stained cedar to match the cedar siding.

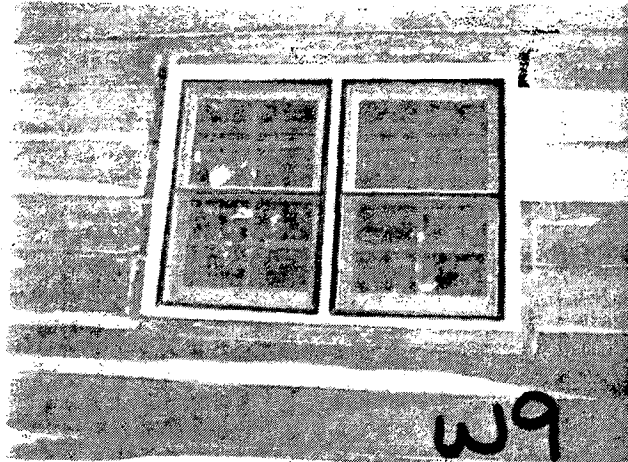
W9 35" x 50"

The metal and glass window (not historically significant) did not close properly and actually cut a guest because the window was cracked. The window was replaced by 4 over 4 paned glass Jeldwen Energy Star simulated divided light windows with screen. The wood will be stained cedar to match the cedar siding.

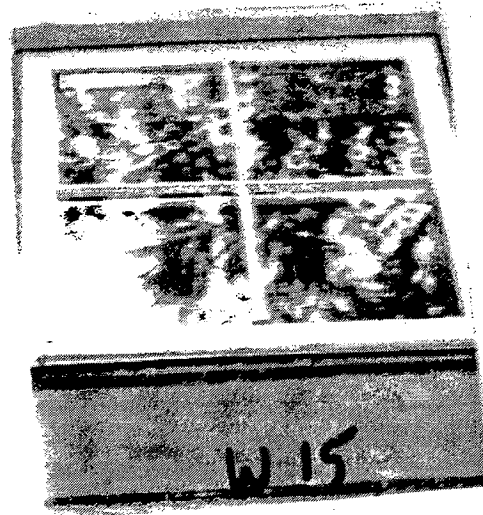
W15 2' x 2'

The 4 paned true divided light wood and glass framed window was broken and did not close. There were also large gaps between window and frame that allowed cold air & insects inside. The windows were replaced by a 4 paned wood and glass Jeldwen Energy Star simulated divided light windows without screen. The wood will be stained cedar to match the cedar siding.

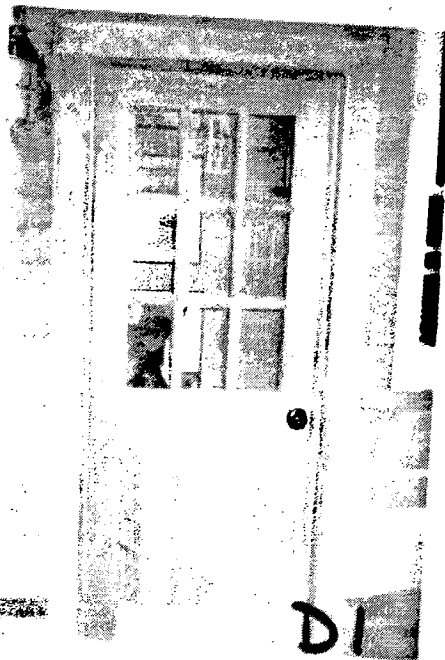
D1 32" x 80"

The 3 paned glass wood and glass door was in poor condition and was replaced by a 9 paned glass true divided light on top of door.

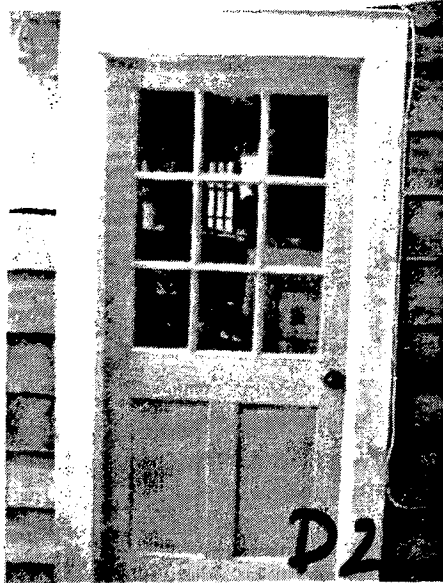
D2 32" x 80"

The 3 paned glass wood and glass door was in poor condition and was replaced by a 9 paned glass true divided light on top of door. The wood will be stained to match the cedar siding.

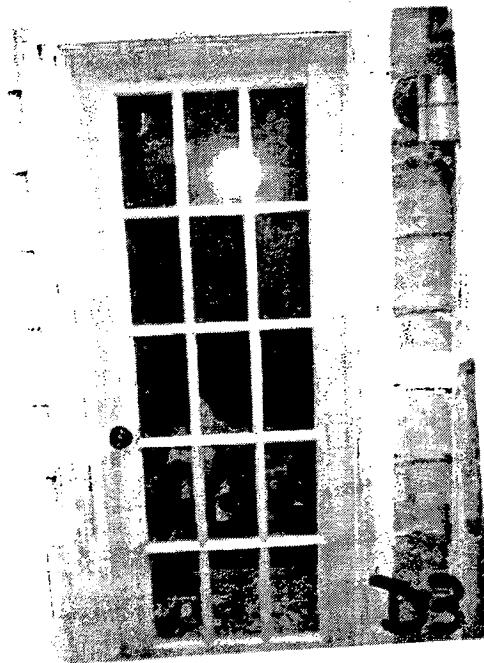
D3 32" x 80"

The 3 paned glass wood and glass door was in poor condition and was replaced by a 9 paned glass true divided light on top of door. The wood will be stained to match the cedar siding.

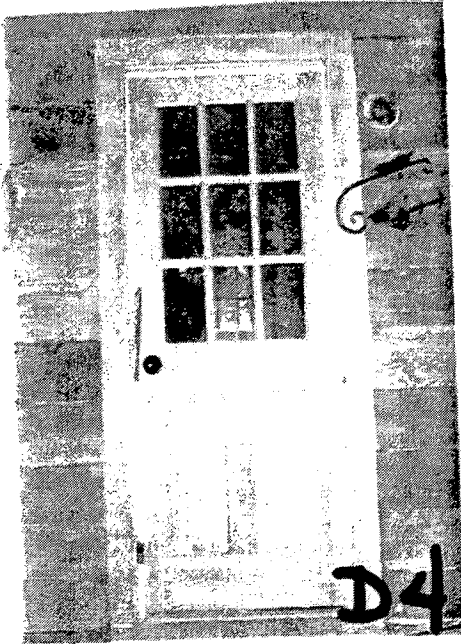
D4 32" x 80"

The 3 paned glass wood and glass door was in poor condition and was replaced by a 9 paned glass true divided light on top of door. The wood will be stained to match the cedar siding.

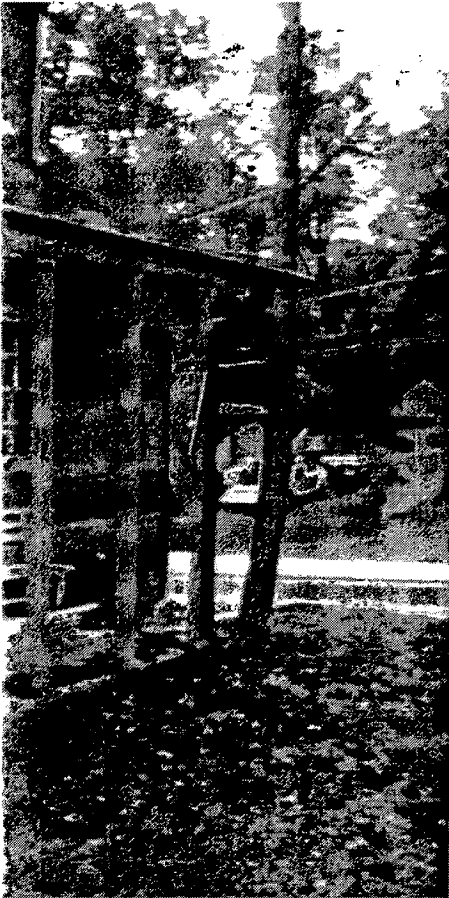
Tree #1

We request to removal 4 hemlock trees that have Hemlock Woolly Adelgid (Trees 1, 2, 3, 4).  
These trees are approximately 30' in height.

The (3) Canadian Hemlocks by the driveway and the (1) at the northwest corner of the house have an infestation of Hemlock Woolly Adelgid. At this point the Trees are so damaged they cannot be salvaged and should be removed. If you opt to try to save the Trees, the spray is fairly toxic and I would not recommend spraying such large trees so close to the house. In any case, I strongly recommend the removal of all (4) Hemlocks.

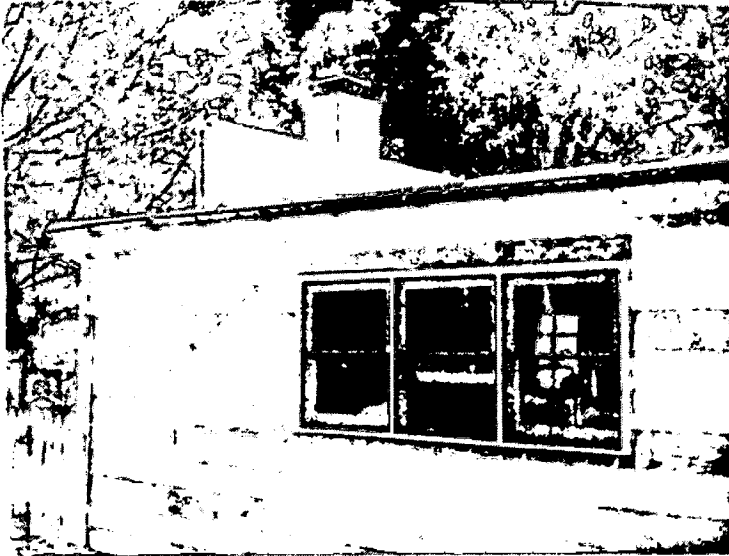
NO RAIL

A railing was removed by the prior owners on top of the great room when they replaced a rubber membrane (the ceiling leaked). We plan to replace the railing with cedar wood inset railing. Dimensions will be 25'x19'x24.9' long and 3' tall.

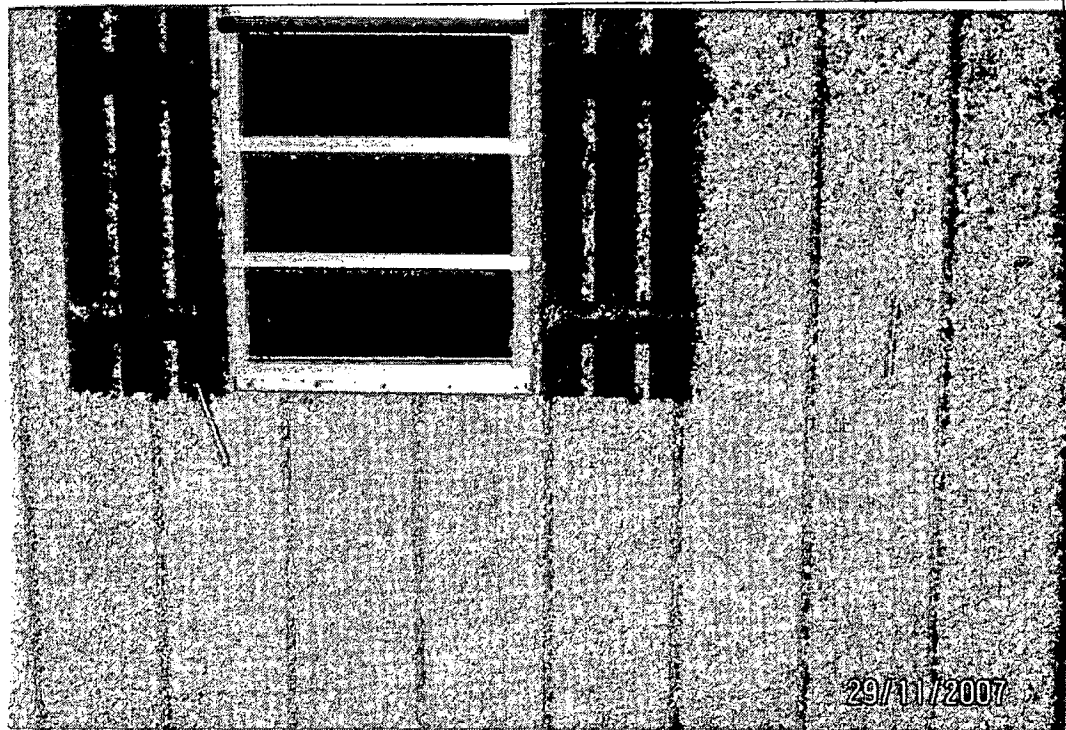
Detail: SHUTTERS (Remove - not original)

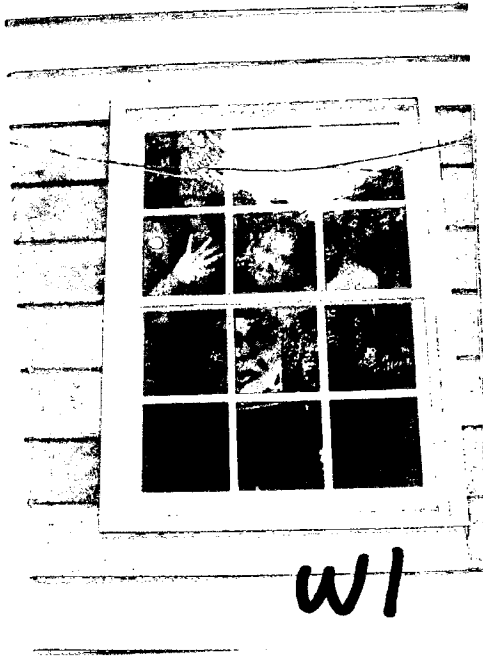
**W1 3' 5 3/8" x 4' 8"**

The window was a metal and glass framed window (not historically or structurally significant) that did not close completely and the glass was cracked. The window was replaced by a 6 over 6 paned wood and glass Jeldwen Energy Star simulated divided light window without screen. The wood will be stained cedar to match the cedar siding.

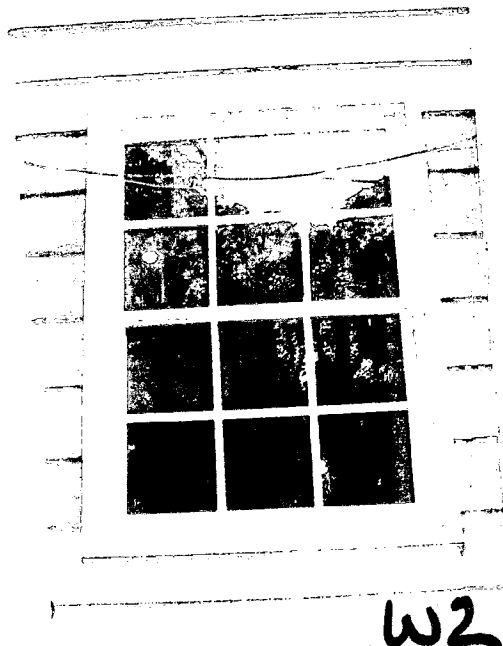
**W2 3' 5 3/8" X 4' 8"**

The wood and glass door (not original to the house or historically significant) had swelled shut and was replaced by a 6 over 6 wood and glass Jeldwen Energy Star simulated divided light window without screen. The wood will be stained cedar to match the cedar siding.

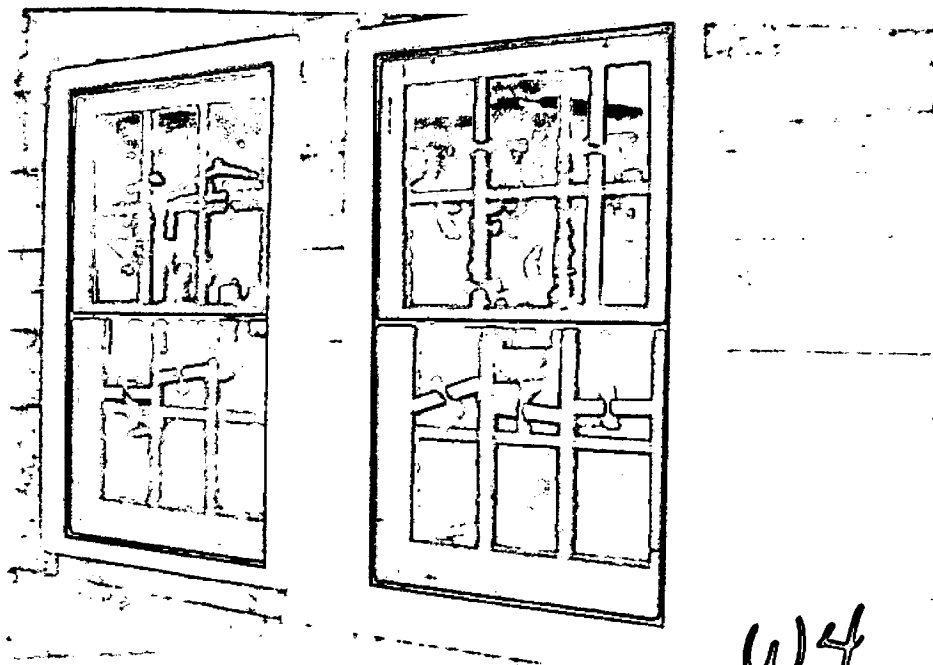
W4

The 6 x 6 true divided light wood and glass framed windows were damaged and one of the windows did not open. The second was held together by duct tape on the inside. There were also large gaps between window and frame that allowed cold air & insects inside. The windows were replaced by a 6 over 6 wood and glass Jeldwen Energy Star simulated divided light windows with screen. The wood will be stained cedar to match the cedar siding.

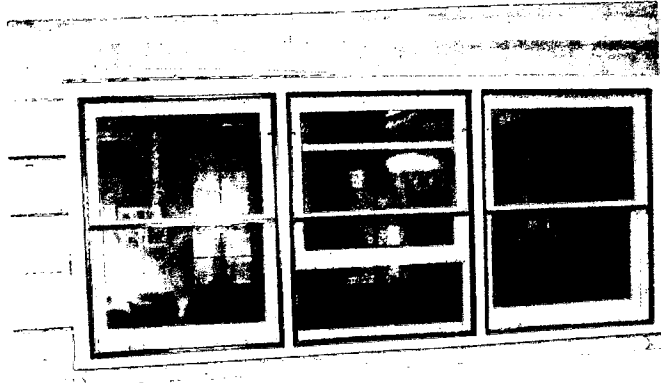
W5

The wood and glass window did not have true divided light. The window was added during an addition that was built in the 1950's. This window had 3 attached windows in one unit and was replaced by 3 attached windows in one unit. Each window has 6 over 6 wood and glass Jeldwen Energy Star simulated divided light windows with screen. The wood will be stained cedar to match the cedar siding.

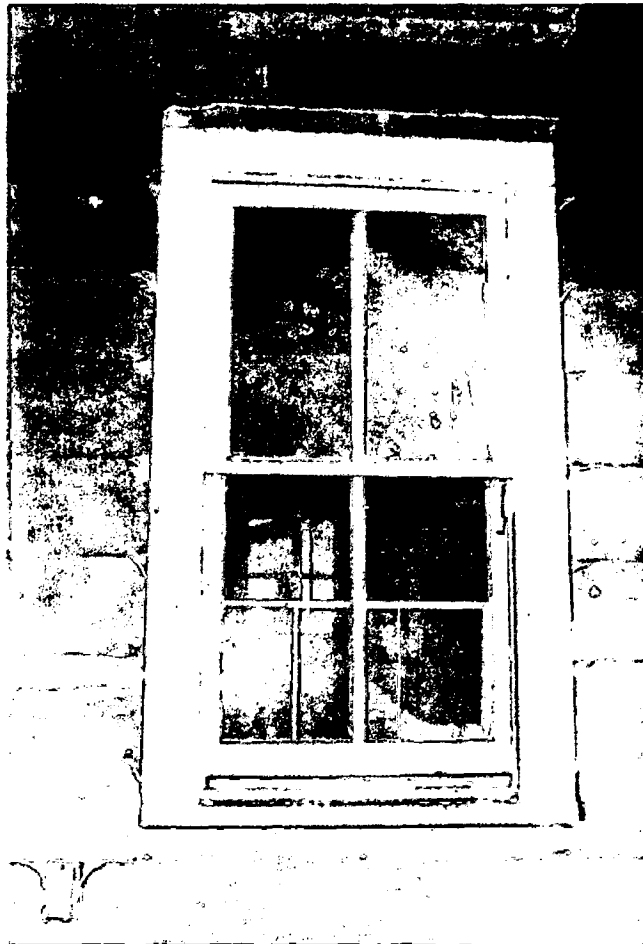
W8 2' 5 3/8" x 4 1/2"

The wood and glass window has true divided light (2 over 2 paned), is damaged and does not close properly or lock. The window will be replaced by a 6 over 6 paned simulated divided light, wood and glass Jeldwen Energy Star with screen. The wood will be stained cedar to match the cedar siding.

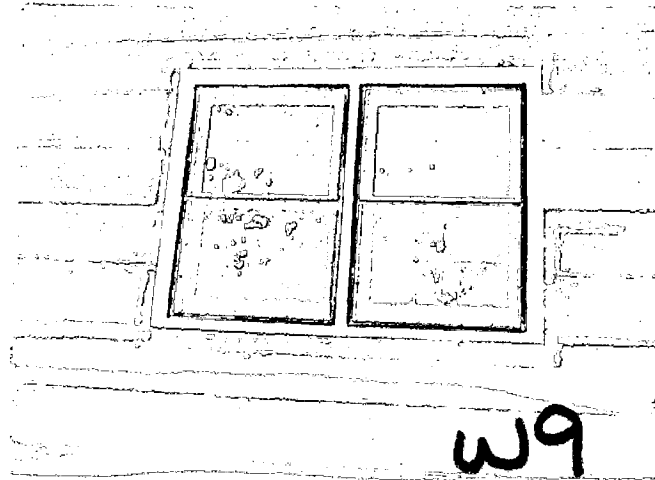
W9 35" x 50"

The metal and glass window (not historically significant) did not close properly and actually cut a guest because the window was cracked. The window was replaced by 4 over 4 paned glass Jeldwen Energy Star simulated divided light windows with screen. The wood will be stained cedar to match the cedar siding.

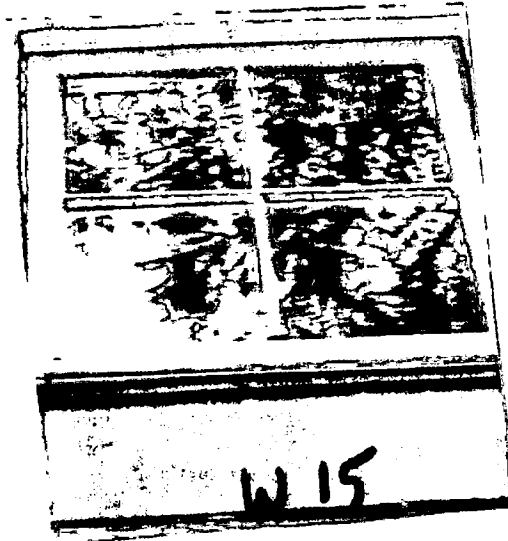
W15 2' x 2'

The 4 paned true divided light wood and glass framed window was broken and did not close. There were also large gaps between window and frame that allowed cold air & insects inside. The windows were replaced by a 4 paned wood and glass Jeldwen Energy Star simulated divided light windows without screen. The wood will be stained cedar to match the cedar siding.

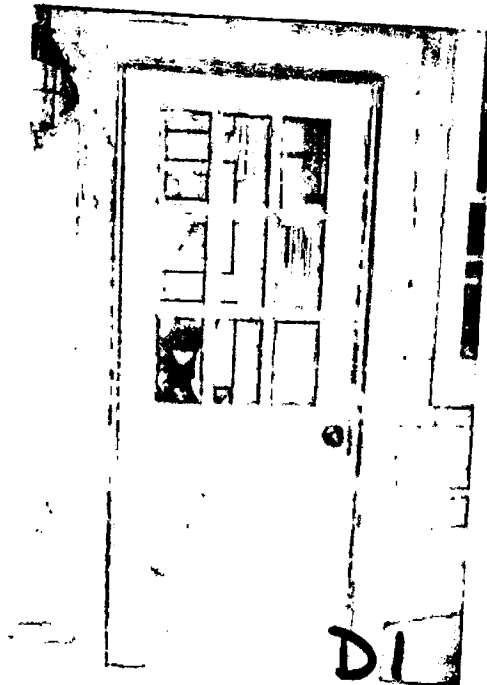
D1 32" x 80"

The 3 paned glass wood and glass door was in poor condition and was replaced by a 9 paned glass true divided light on top of door.

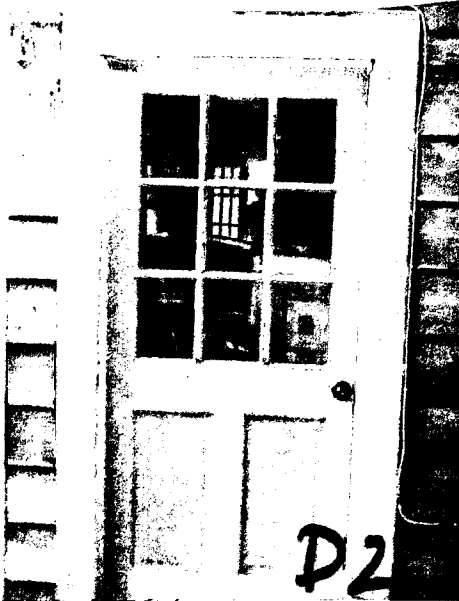
D2 32" x 80"

The 3 paned glass wood and glass door was in poor condition and was replaced by a 9 paned glass true divided light on top of door. The wood will be stained to match the cedar siding.

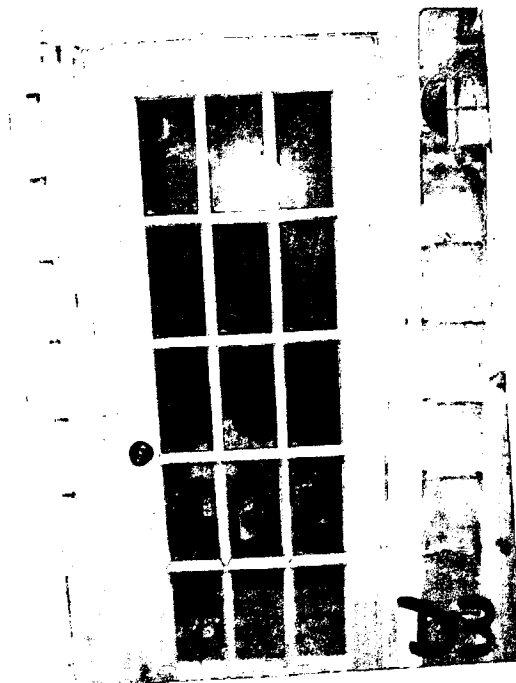
D3 32" x 80"

The 3 paned glass wood and glass door was in poor condition and was replaced by a 9 paned glass true divided light on top of door. The wood will be stained to match the cedar siding.

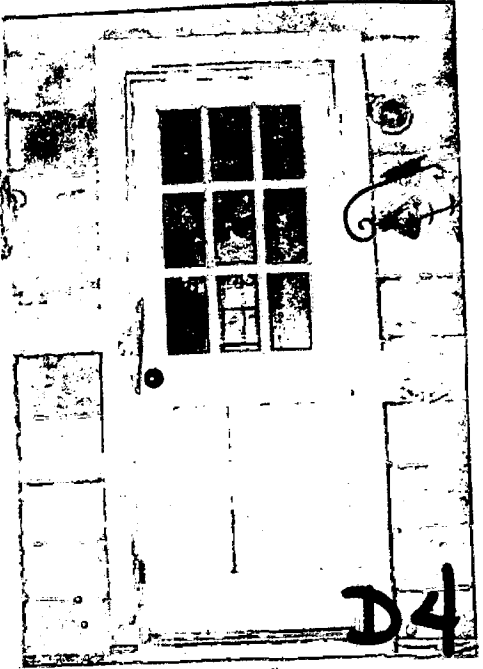
D4 32" x 80"

The 3 paned glass wood and glass door was in poor condition and was replaced by a 9 paned glass true divided light on top of door. The wood will be stained to match the cedar siding.

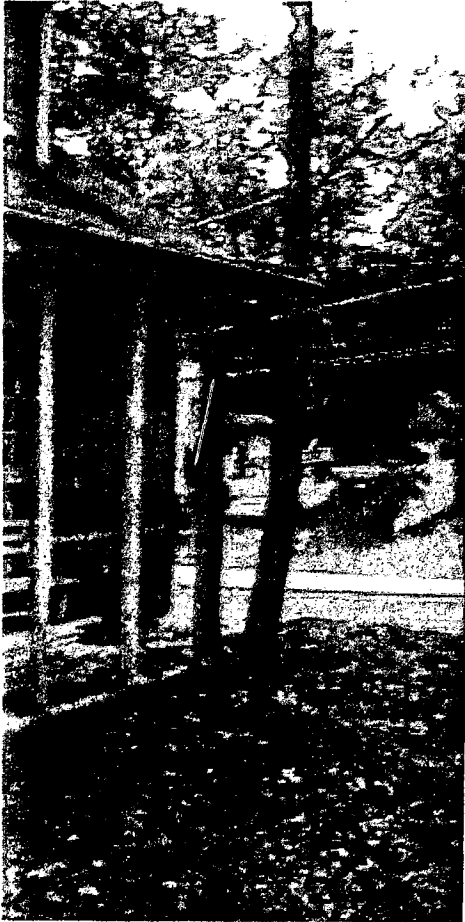
Tree #1

We request to removal 4 hemlock trees that have Hemlock Woolly Adelgid (Trees 1, 2, 3, 4).  
These trees are approximately 30' in height.

The (3) Canadian Hemlocks by the driveway and the (1) at the northwest corner of the house have an infestation of Hemlock Wooly Adelgid. At this point the Trees are so damaged they cannot be salvaged and should be removed. If you opt to try to save the Trees, the spray is fairly toxic and I would not recommend spraying such large trees so close to the house. In any case, I strongly recommend the removal of all (4) Hemlocks.

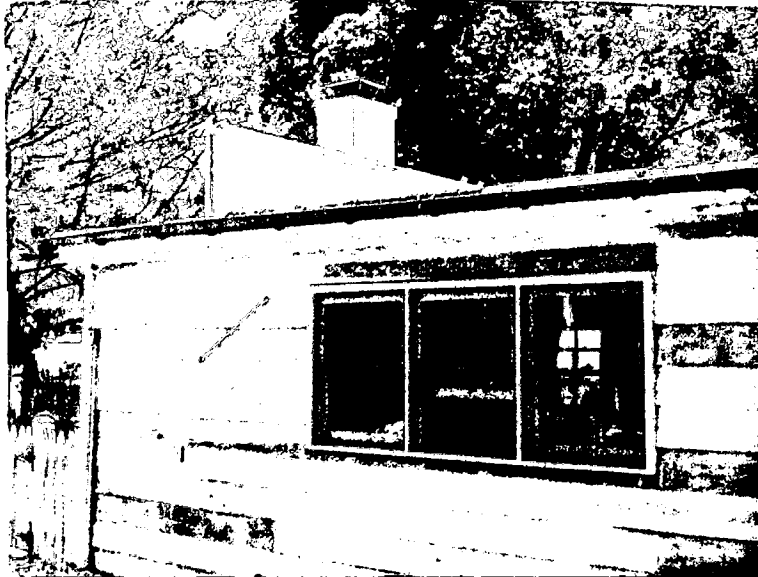
NO RAIL

A railing was removed by the prior owners on top of the great room when they replaced a rubber membrane (the ceiling leaked). We plan to replace the railing with cedar wood inset railing. Dimensions will be 25'x19'x24.9' long and 3' tall.

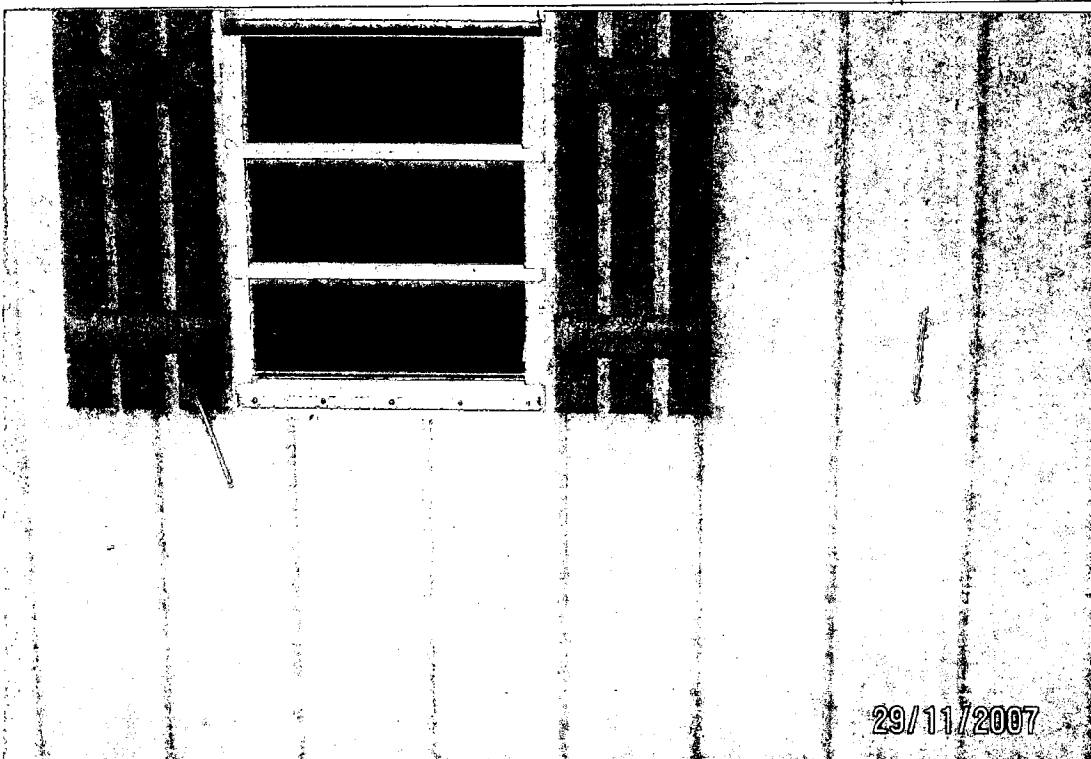
Detail: Shutters (Remove - Not original)

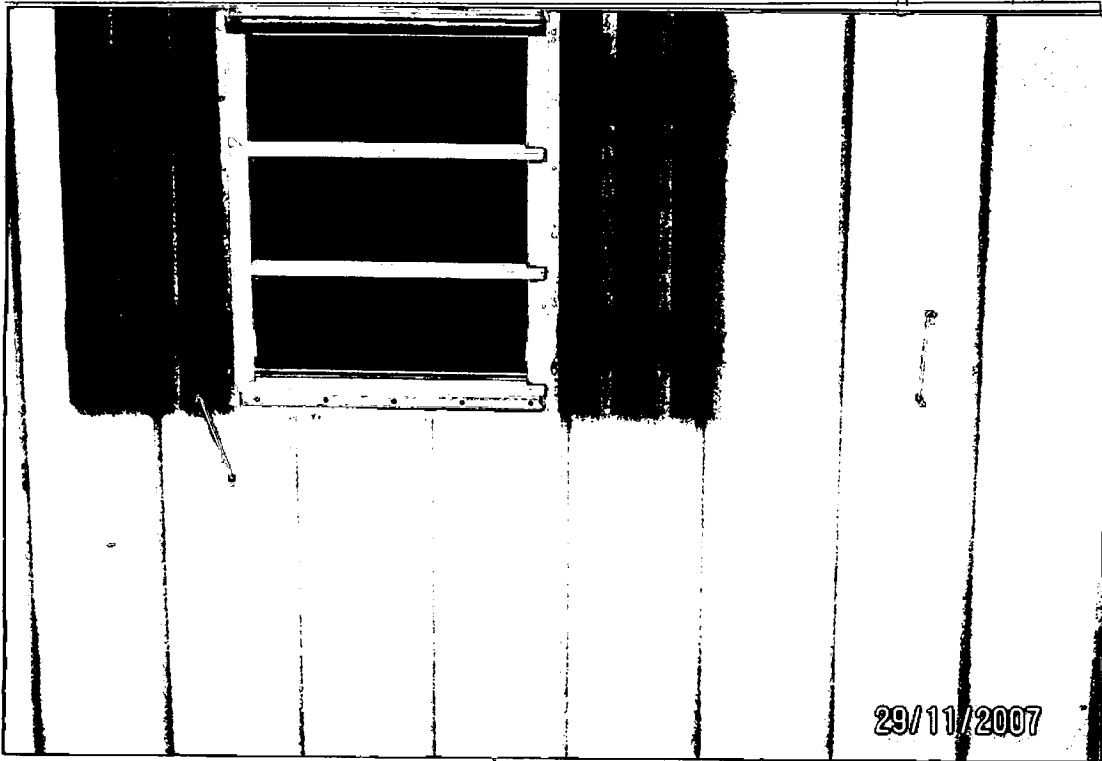
Detail: Shutters (Remove - not original)

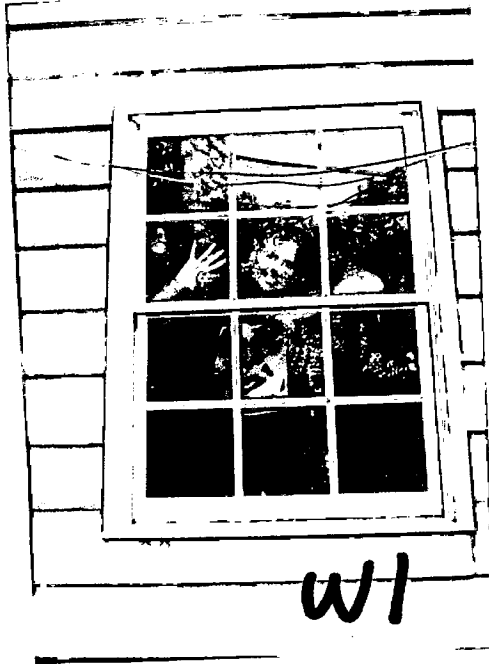
**W1 3' 5 3/8" x 4' 8"**

The window was a metal and glass framed window (not historically or structurally significant) that did not close completely and the glass was cracked. The window was replaced by a 6 over 6 paned wood and glass Jeldwen Energy Star simulated divided light window without screen. The wood will be stained cedar to match the cedar siding.

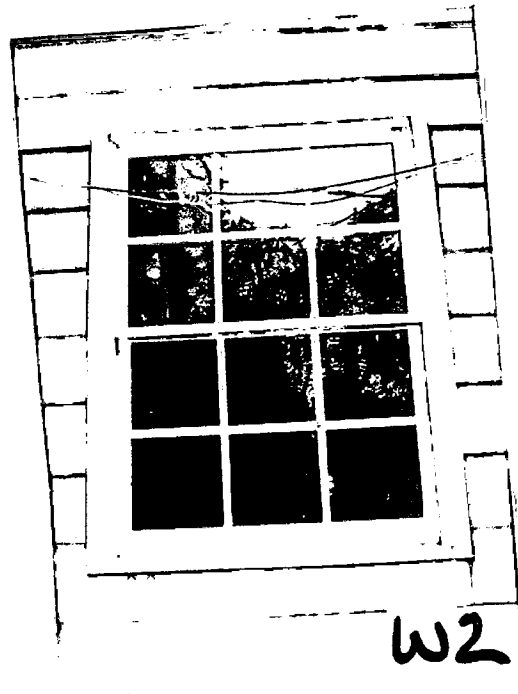
**W2 3' 5 3/8" x 4' 8"**

The wood and glass door (not original to the house or historically significant) had swelled shut and was replaced by a 6 over 6 wood and glass Jeldwen Energy Star simulated divided light window without screen. The wood will be stained cedar to match the cedar siding.

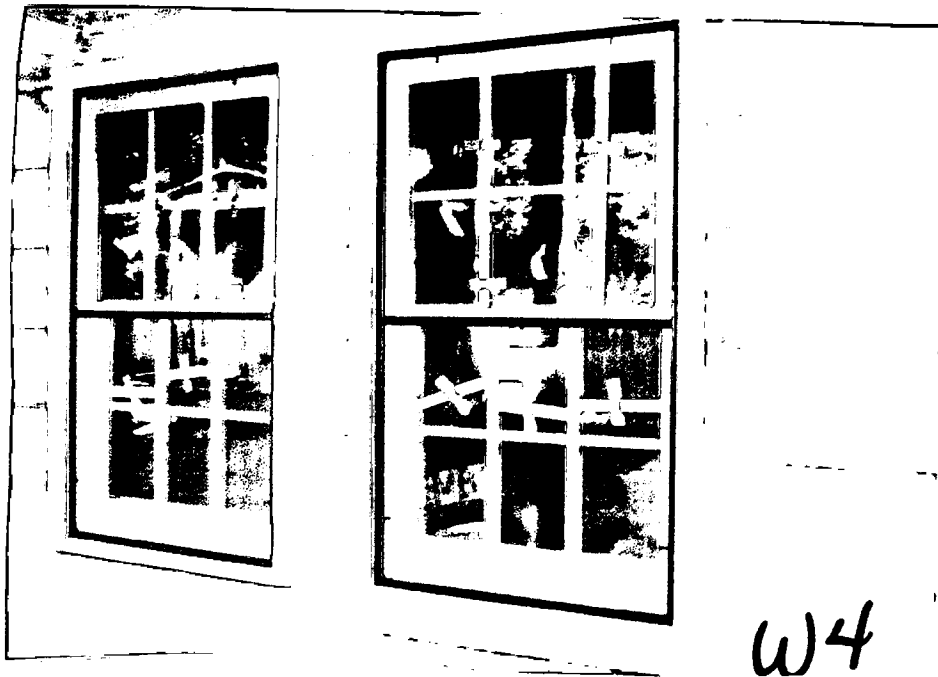
W4 2' 5 3/8" x 4 1/2" (2 each)

The 6 x 6 true divided light wood and glass framed windows were damaged and one of the windows did not open. The second was held together by duct tape on the inside. There were also large gaps between window and frame that allowed cold air & insects inside. The windows were replaced by a 6 over 6 wood and glass Jeldwen Energy Star simulated divided light windows with screen. The wood will be stained cedar to match the cedar siding.

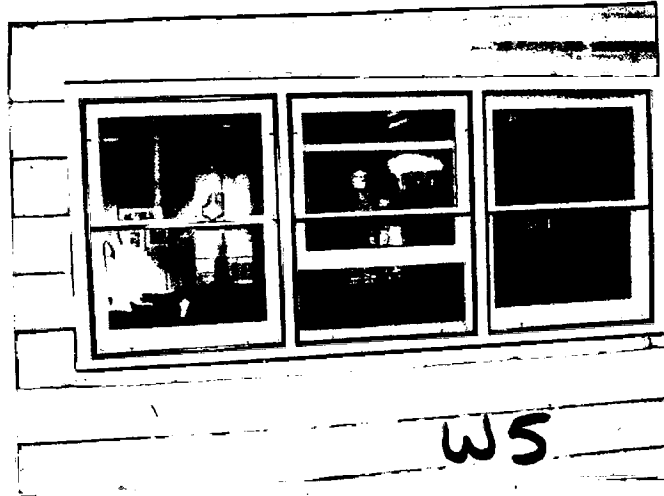
W5 7' 10 1/8" x 3' x 4 1/2"

The wood and glass window did not have true divided light. The window was added during an addition that was built in the 1950's. This window had 3 attached windows in one unit and was replaced by 3 attached windows in one unit. Each window has 6 over 6 wood and glass Jeldwen Energy Star simulated divided light windows with screen. The wood will be stained cedar to match the cedar siding.

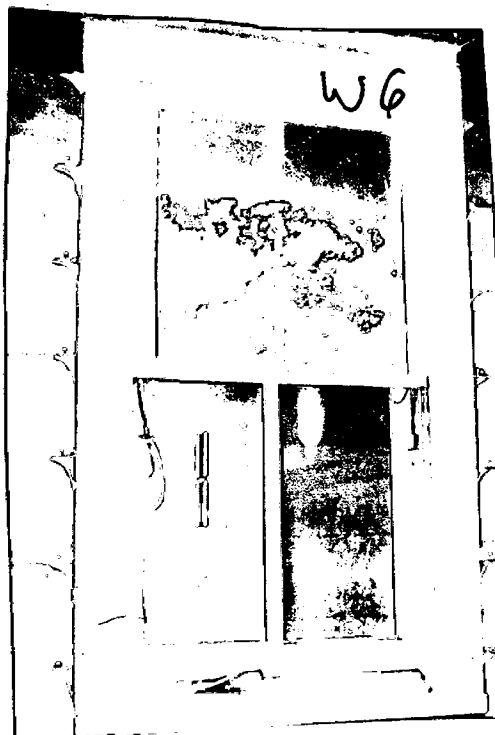
W6 2' 5 3/8" x 4 1/2"

The wood and glass window has true divided light (2 over 2) is damaged and does not close properly or lock. The window will be replaced by a 6 over 6 wood and glass Jeldwen Energy Star simulated divided light windows with screen. The wood will be stained cedar to match the cedar siding.

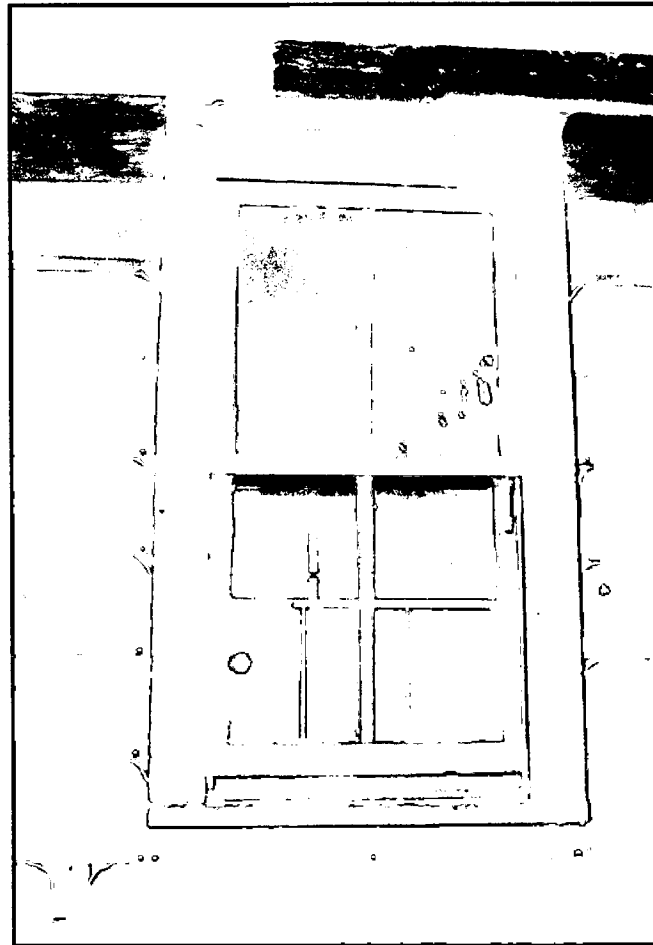
W8 2' 5 3/8" x 4 1/2"

The wood and glass window has true divided light (2 over 2 paned), is damaged and does not close properly or lock. The window will be replaced by a 6 over 6 paned simulated divided light, wood and glass Jeldwen Energy Star with screen. The wood will be stained cedar to match the cedar siding.

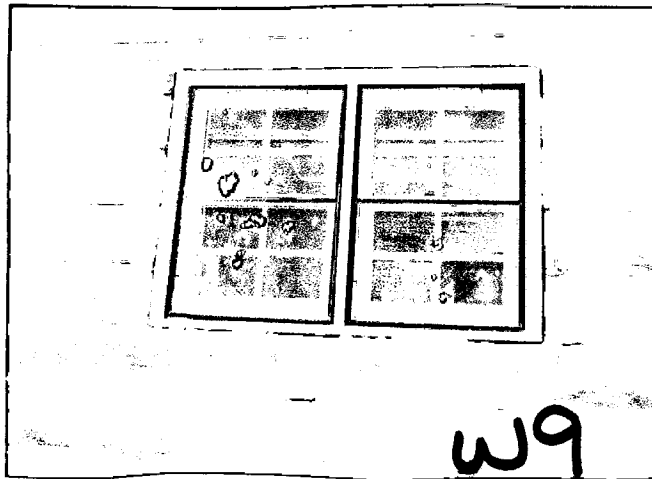
W9 35" x 50"

The metal and glass window (not historically significant) did not close properly and actually cut a guest because the window was cracked. The window was replaced by 4 over 4 paned glass Jeldwen Energy Star simulated divided light windows with screen. The wood will be stained cedar to match the cedar siding.

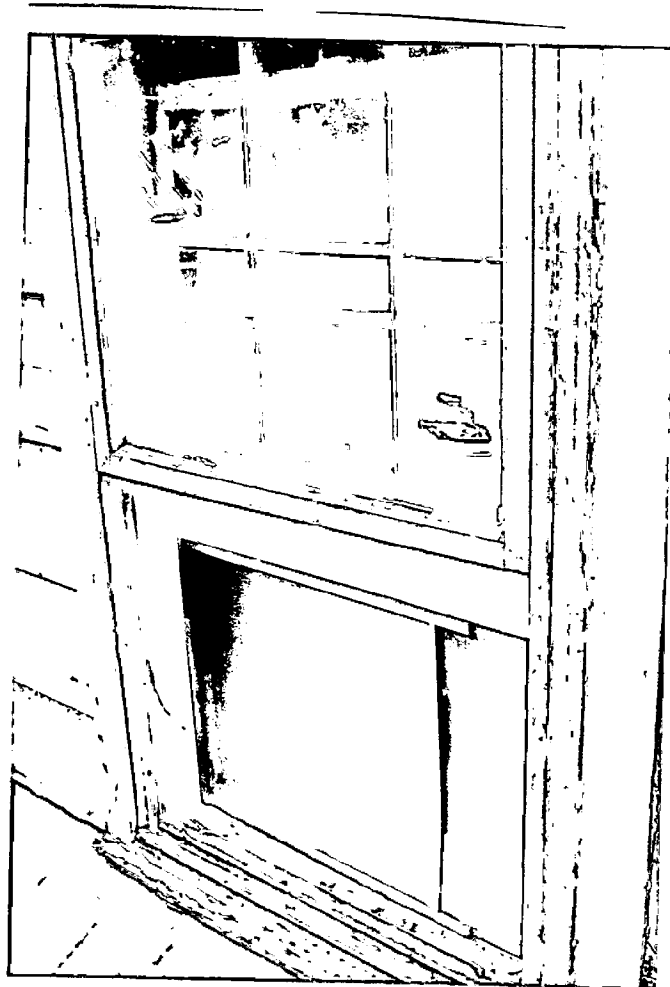
W14 2' 5 3/8" X 4 1/2"

The 6 over 6 true divided light wood and glass window is damaged and does not close properly. There Condition poor. The window will be replaced by a 6 over 6 paned simulated divided light, wood and glass Jeldwen Energy Star with screen. The wood will be stained cedar to match the cedar siding.

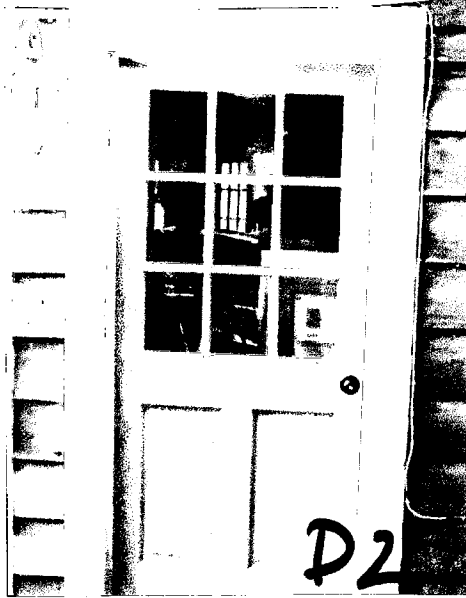
D2 32" x 80"

The 3 paned glass wood and glass door was in poor condition and was replaced by a 9 paned glass true divided light on top of door. The wood will be stained to match the cedar siding.

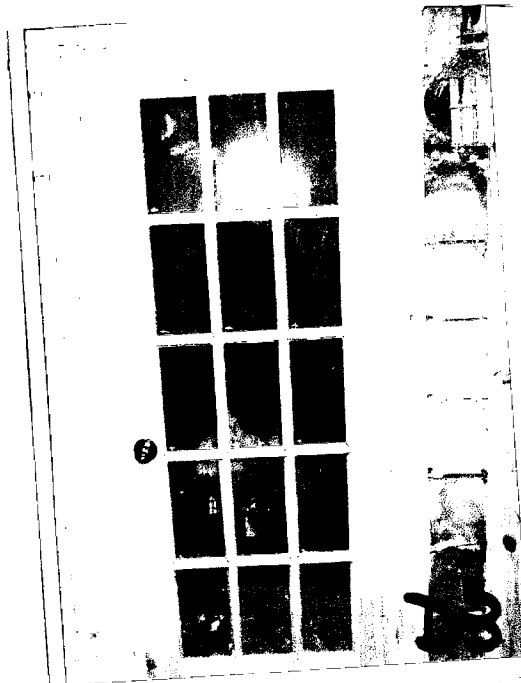
D3 32" x 80"

The 3 paned glass wood and glass door was in poor condition and was replaced by a 9 paned glass true divided light on top of door. The wood will be stained to match the cedar siding.

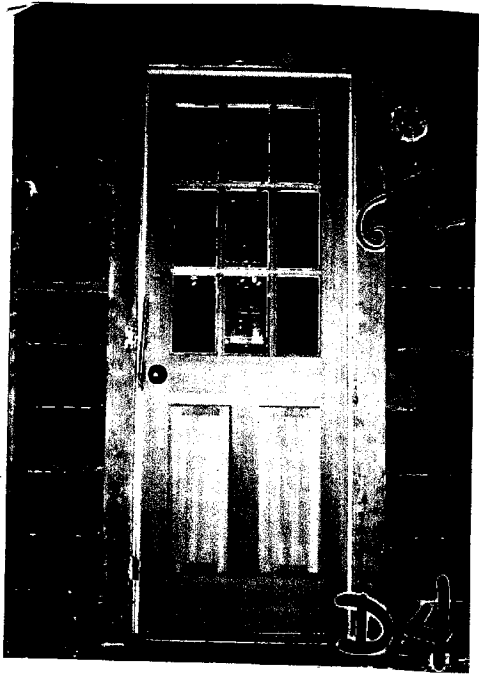
D4 32" x 80"

The 3 paned glass wood and glass door was in poor condition and was replaced by a 9 paned glass true divided light on top of door. The wood will be stained to match the cedar siding.

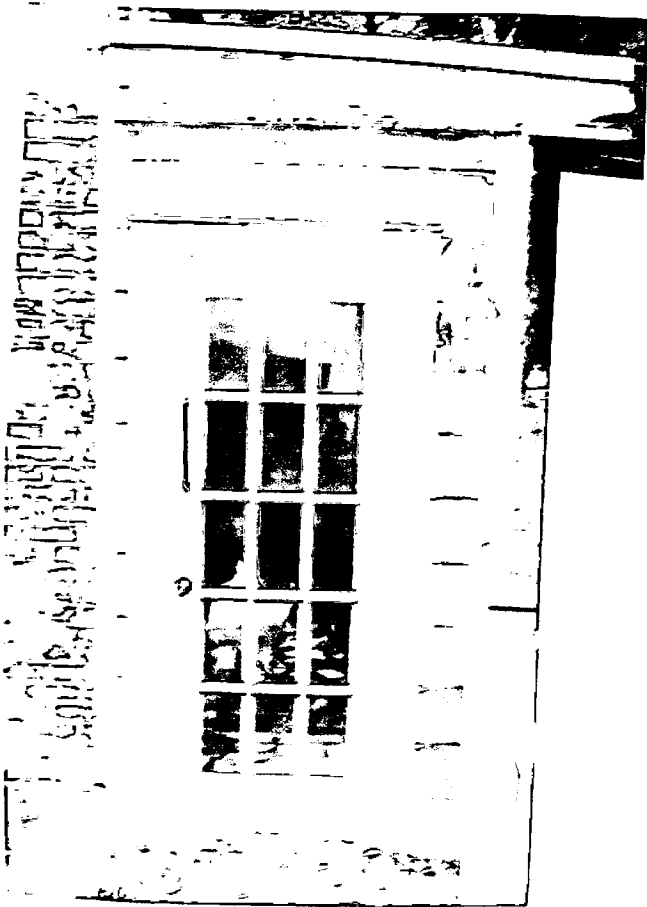
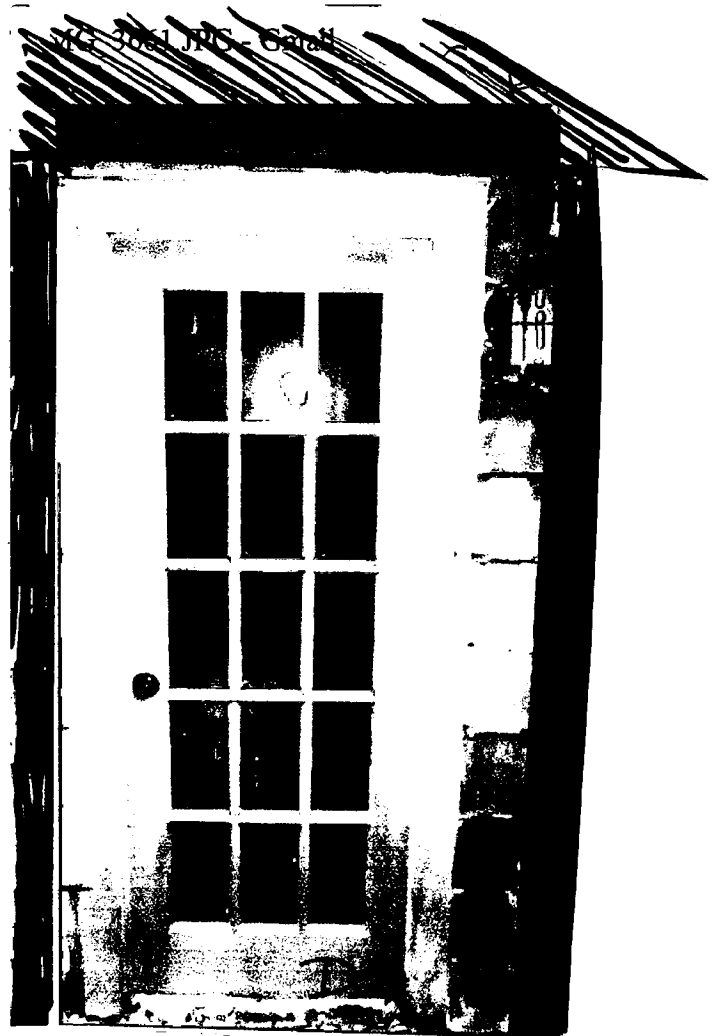
### Awning Over D3

We removed a damaged plastic awning that was attached to the house with no historic significance or value. We plan to attach cedar awning to house over D3. Dimensions are 7' x 3' by 6" cedar in material with two (2) cedar posts that are 4"x4" to support the awning. *wood shingle roof*

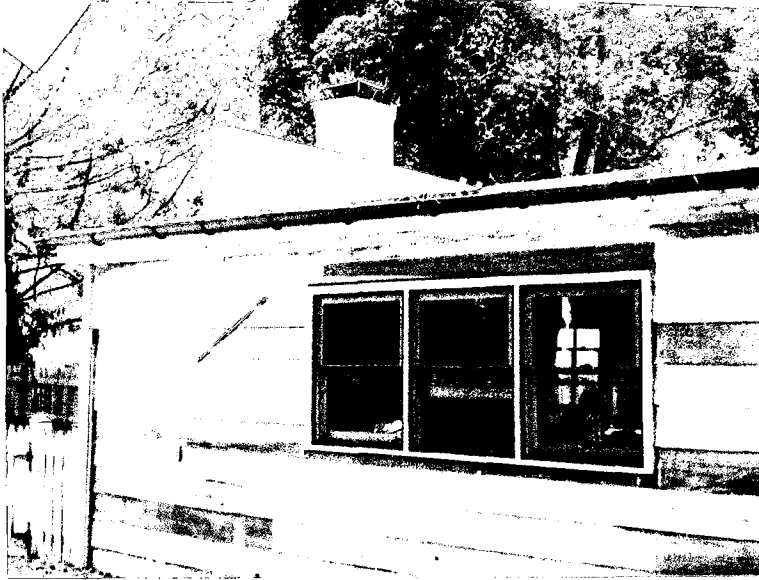
Decorative Railing

A railing was removed by the prior owners on top of the great room when they replaced a rubber membrane (the ceiling leaked). We plan to replace the railing with cedar wood inset railing. Dimensions will be 25'x19'x24.9' long and 3' tall.
