Meadowbrook Stables 2010 RAUP

SUBJECT: Historic Area Work Permit #551089—window replacement and shed removal

Address:	8250 Meadowbrook Lane, Chevy Chase	Meeting Date:	10/27/10
Applicant:	Montgomery County Parks Department (Julie Mueller, Agent)	Report Date:	10/20/10
Resource:	<i>Master Plan</i> Site #36/03 Meadowbrook Stables	Public Notice:	10/13/10
Review:	HAWP	Tax Credit:	Partial
Case Number:	36/03-10A	Staff:	Anne Fothergill
PROPOSAL: Window replacement and shed demolition

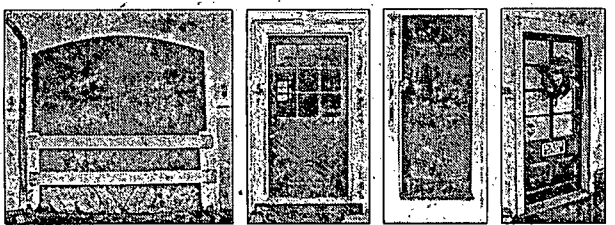
DOOR TYPES CONTINUED FROM DWG A1.0

- D6** 1 1/2" x 120" PAIR
ORIGINAL
- D7** 1 1/2" x 72"
COMPATIBLE REPLACEMENT AT ORIGINAL DOOR LOCATION
- D8** 1 1/2" x 80"
ASSUMED TO BE ORIGINAL (NO DOCUMENTATION AVAILABLE)
- D9** 1 1/2" x 80"
COMPATIBLE REPLACEMENT AT ASSUMED ORIGINAL DOOR LOCATION
