がなる 魔 神でなら 成れ とは 意味の なまがま かまれ ままいけい はまき ちょうせいしょうしょう しゅうせい コンドンストル おぼれる 135/54 8815 Hawkins Lane (Hawkins Lane Historic District)

135/54-97A 8815 Hawkins Lane

This letter serves as my acknowledgment that the drawings of the Hsu Residence Addition and Renovation, 8815 Hawkins Lane, Chevy Chase, MD submitted on this date to Perry Kephart, staff for the Historic Preservation Commission, for approval were inaccurate.

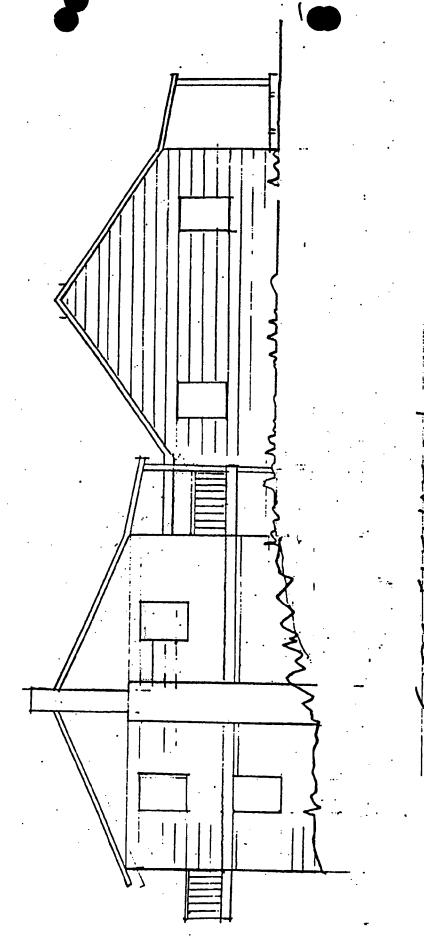
SIDE ELEVATION

5CALE: 18 "=1=0"

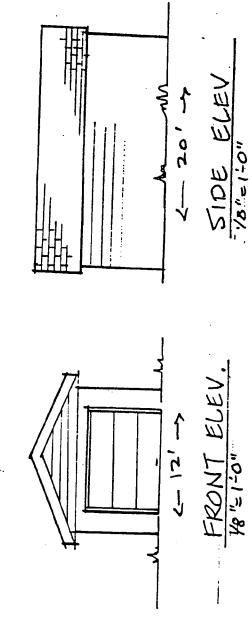
GARAGE

- Wood Framing & siding

- composite shingle roof

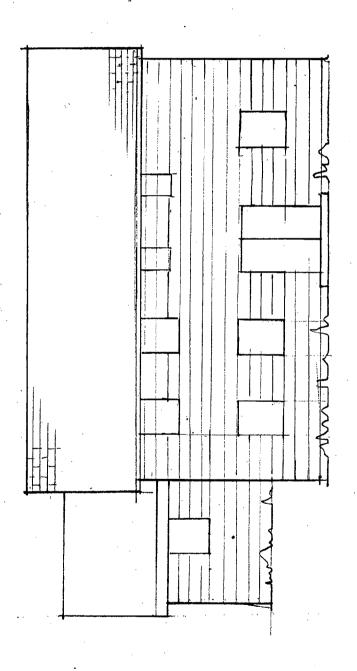
REAR ELEVATION Scave: 18 = 120" 6404 Winnepeg Road Bethesda, MD 20817 April 25, 1996
