35/32-92A 5315 Elliot Drive
Battery Bailey

RE: Battery Bailey Restoration Plans

This report is intended to summarize the recommendations for the preservation, stabilization and interpretation of the Battery Bailey Civil War Earthworks located in the West Moreland Hills Local Park of the Montgomery County Department of Parks, Maryland National Capital Park and Planning Commission.

Andropogon Associates, Ltd.

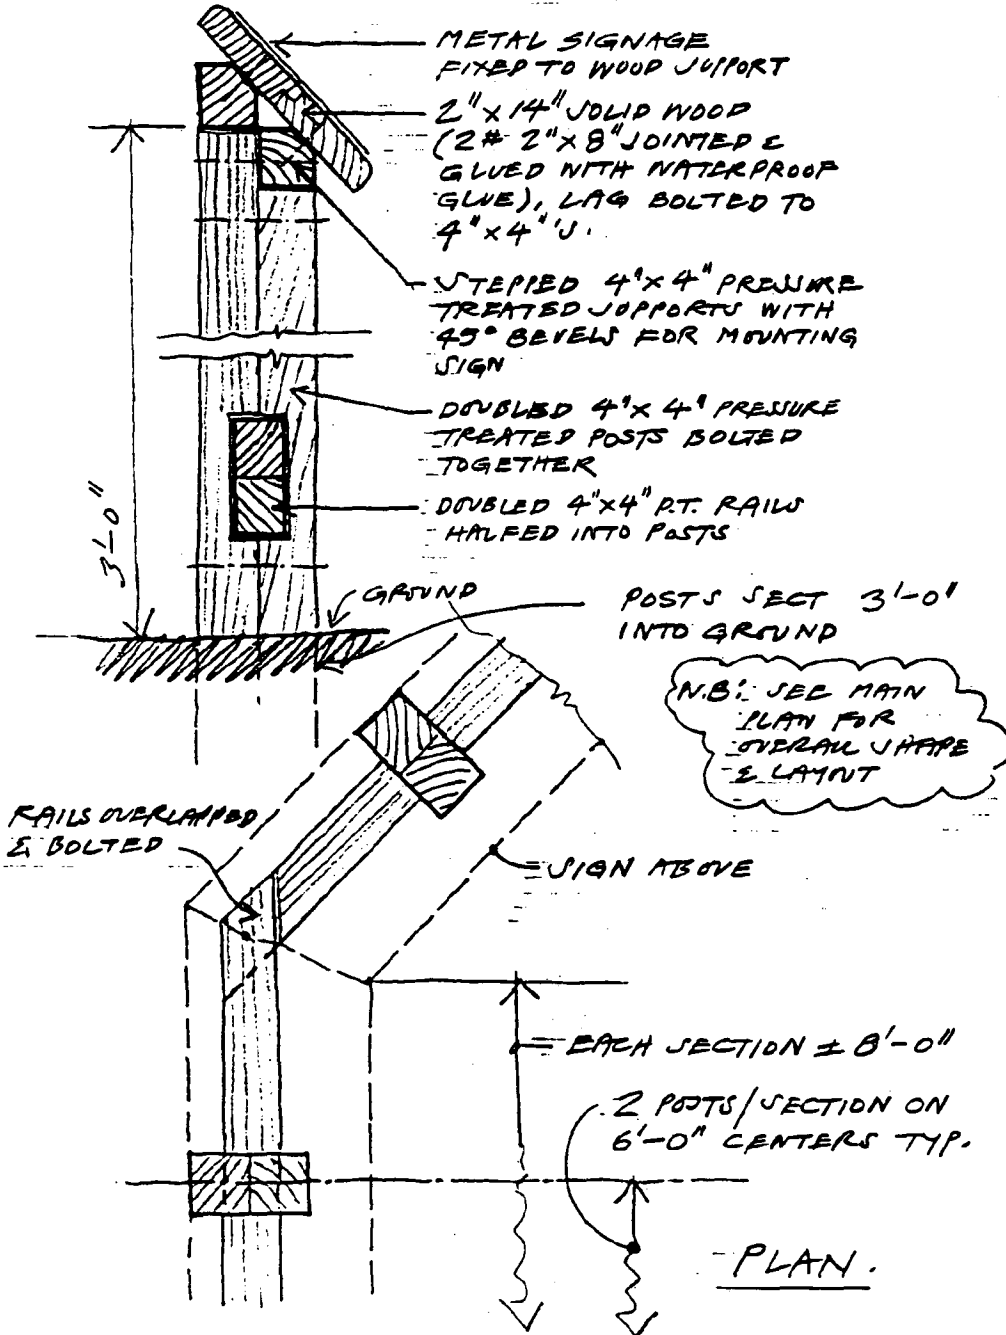
Fig. 5.

SIGNAGE SUPPORTS

SECTION

Interpretative signage partially encircles the viewing area. This is envisioned as a continuous series of boards, inclined at 45 degrees and mounted on wood posts to form a sort of inner fence. This signage could be added at a later date if the present budget does not permit immediate installation. The circle form enables the direction of specific features to be indicated and the graphics to be designed as a storyline rather than as a single sign. [Fig. 5.]
