20/28-99A 11701 Clopper Road
(MP #20/28) St. Rose's Church

SUBJECT: Historic Area Work Permit

Exterior Paint Problems on Historic Woodwork

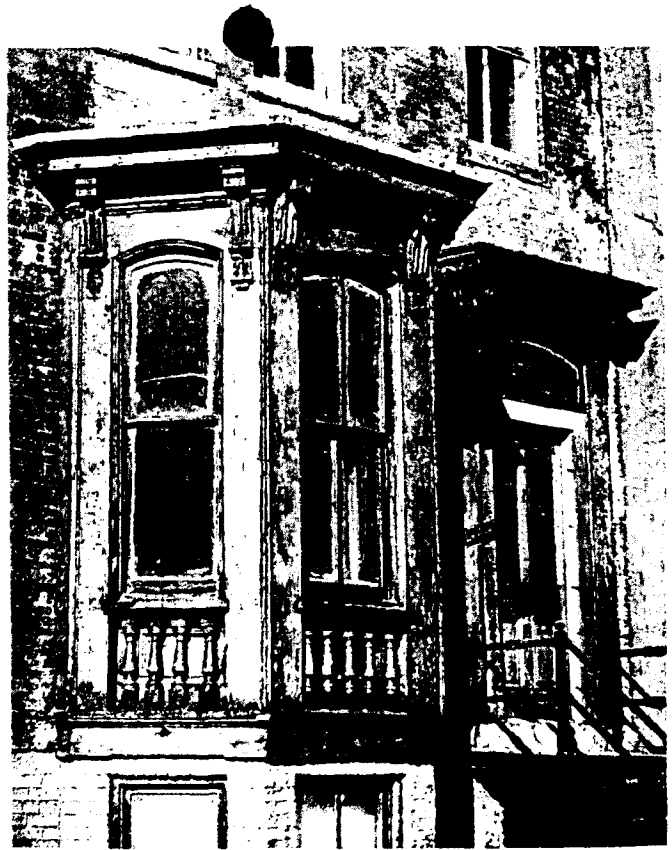
Fig. 2 A traditionally painted bay window has been stripped to bare wood, then varnished. In addition to being historically inaccurate, the varnish will break down faster as a result of the sun's ultraviolet rays than would primer and finish coats of paint. Photo: David W. Look, AIA.

been identified, the general approach should be to remove paint to the next sound layer using the gentlest means possible, then to repaint (see figure 2). Practically speaking as well, paint can adhere just as effectively to existing paint as to bare wood, providing the previous coats of paint are also adhering uniformly and tightly to the wood and the surface is properly prepared for repainting—cleaned of dirt and chalk and dulled by sanding. But, if painted exterior wood surfaces display continuous patterns of deep cracks or if they are extensively blistering and peeling so that bare wood is visible, then the old paint should be completely removed before repainting. The only other justification for removing all previous layers of paint is if doors, shutters, or windows have literally been “painted shut,” or if new wood is being pieced-in adjacent to old painted wood and a smooth transition is desired (see figure 3).

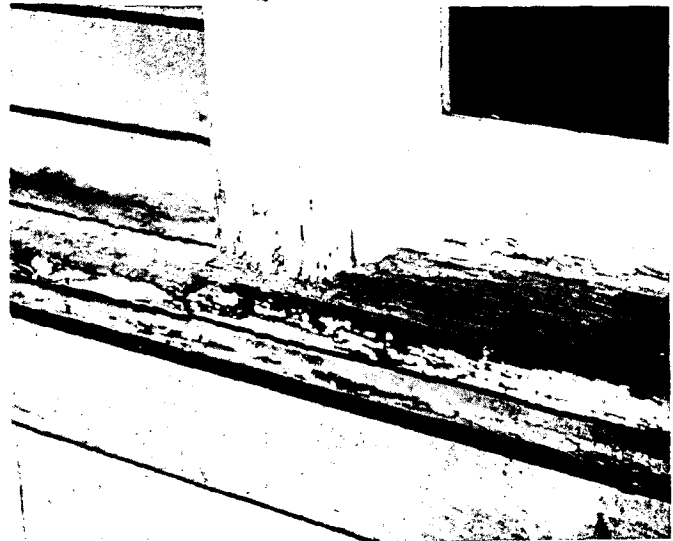
Fig. 4 Paint films wear unevenly depending on exposure and location. Exterior locations which are susceptible to accelerated deterioration are horizontal surfaces such as window sills. These and similar areas will require repainting more often than less vulnerable surfaces. In the case of this window sill where paint has peeled off and adjacent areas have cracked and alligatoring, the paint should be totally removed. Prior to repainting, any weathered wood should be rejuvenated using a solution of 3 cups exterior varnish, 1 oz. paraffin wax, and mineral spirits/paint thinner/or turpentine to make 1 gallon. Liberal brush application should be made. This formula was tested over a 20-year period by the U. S. Department of Agriculture's Forest Products Laboratory and proved to be just as effective as water-repellent preservatives containing pentachlorophenol. After the surface has thoroughly dried (2-3 days of warm weather), the treated surface can be painted. A high quality oil-base primer followed by two top coats of a semi-gloss oil-enamel or latex-enamel paint is recommended. Photo: Baird M. Smith, AIA.

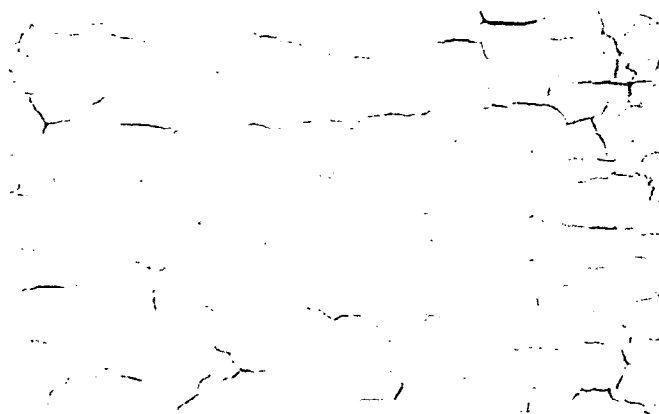
Fig. 5 Crazing—or surface cracking—is an exterior surface condition which can be successfully treated by sanding and painting. Photo: Courtesy, National Decorating Products Association.

Crazing—fine, jagged interconnected breaks in the top layer of paint—results when paint that is several layers thick becomes excessively hard and brittle with age and is consequently no longer able to expand and contract with the wood in response to changes in temperature and humidity (see figure 5). As the wood swells, the bond between paint layers is broken and hairline cracks appear. Although somewhat more difficult to detect as opposed to other more obvious paint problems, it is well worth the time to scrutinize all surfaces for crazing. If not corrected, exterior moisture will enter the crazed surface, resulting in further swelling of the wood and, eventually, deep cracking and alligatoring, a Class III condition which requires total paint removal.

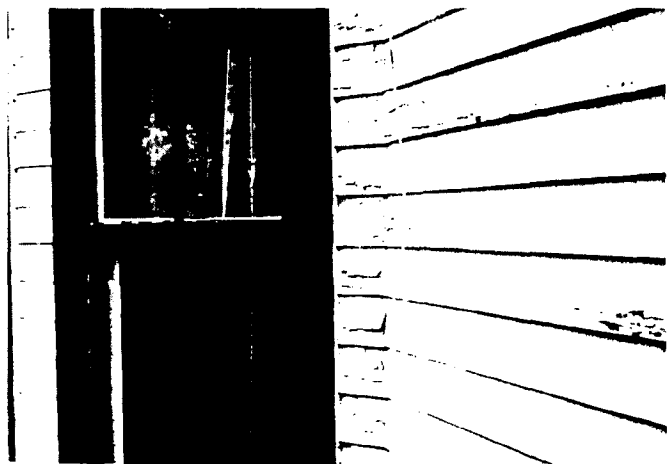
Fig. 8 Peeling to bare wood—one of the most common types of paint failure—is usually caused by an interior or exterior moisture problem. Photo: Anne E. Grimmer.

film, thus impairing adhesion (see figure 8). Generally beginning as blisters, cracking and peeling occur as moisture causes the wood to swell, breaking the adhesion of the bottom layer.

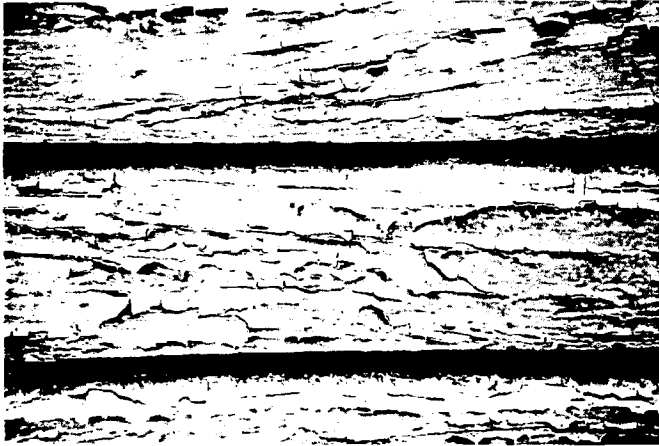
Fig. 9 Cracking, alligatoring, and flaking are evidence of long-term neglect of painted surfaces. The remaining paint on the clapboard shown here can be removed with an electric heat plate and wide-bladed scraper. In addition, unsound wood should be replaced and moisture problems corrected before primer and top coats of paint are applied. Photo: David W. Look, AIA.

Cracking and alligatoring are advanced stages of crazing (see figure 9). Once the bond between layers has been broken due to intercoat paint failure, exterior moisture is able to penetrate the surface cracks, causing the wood to swell and deeper cracking to take place. This process continues until cracking, which forms parallel to grain, extends to bare wood. Ultimately, the cracking becomes an overall pattern of horizontal and vertical breaks in the paint layers that looks like reptile skin; hence, "alligatoring." In advanced stages of cracking and alligatoring, the surfaces will also flake badly.

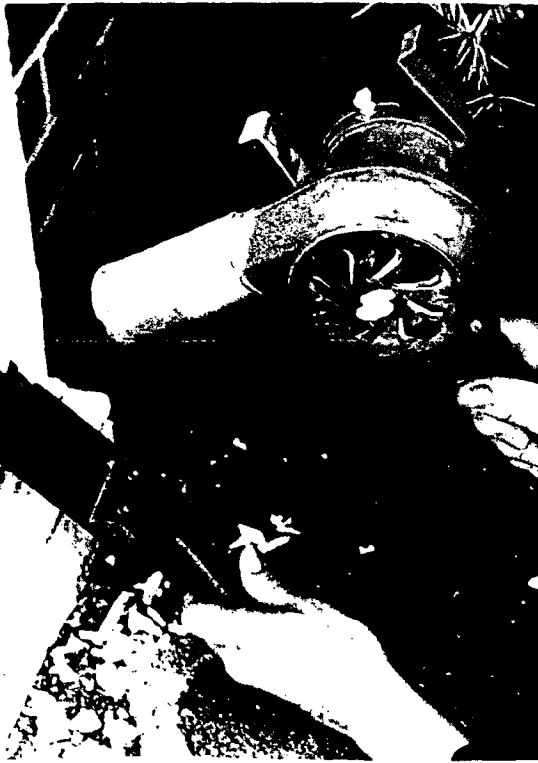
Fig. 14 The nozzle on the electric heat gun permits hot air to be aimed into cavities on solid decorative elements such as this applied column. After the paint has been sufficiently softened, it can be removed with a profiled scraper. Photo: Charles E. Fisher, III.

Electric heat gun: The electric heat gun (electric hot-air gun) looks like a hand-held hairdryer with a heavy-duty metal case (see figure 14). It has an electrical resistance coil that typically heats between 500 and 750 degrees Fahrenheit and, again, uses about 15 amps of power which requires a heavy-duty extension cord. There are some heat guns that operate at higher temperatures but they should not be purchased for removing old paint

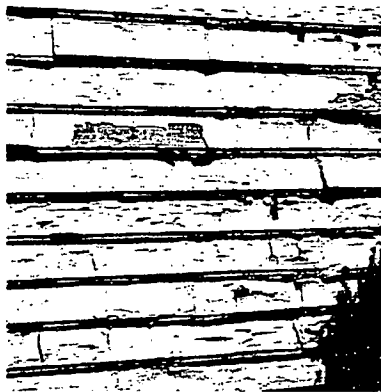
Peeling down to bare wood

bare wood, chances are your problem is moisture-related. These failures typically require more treatment before repainting.
