29/6-1-97A 11231 River View Driv  
Potomac (MP Site #29/6-1)

Application of Dr. Yonus Zegeye

11231 River View Drive, Potomac

**DECISION AND OPINION OF THE COMMISSION**

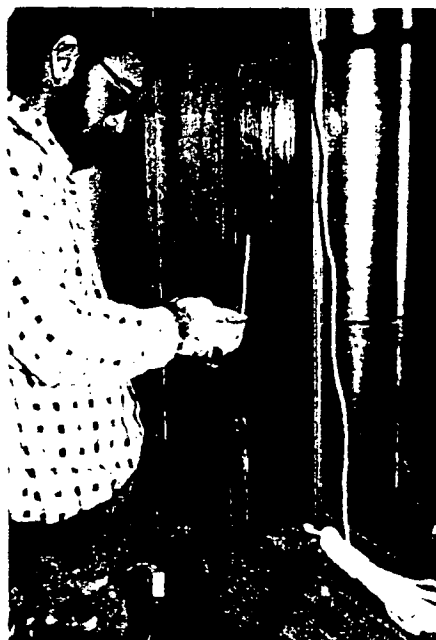
Figure 4e. A common repair is the replacement of broken sash cords with new cords (shown) or with chains. The weight pocket is often accessible through a removable plate in the jamb, or by removing the interior trim. Photo: John H. Myers

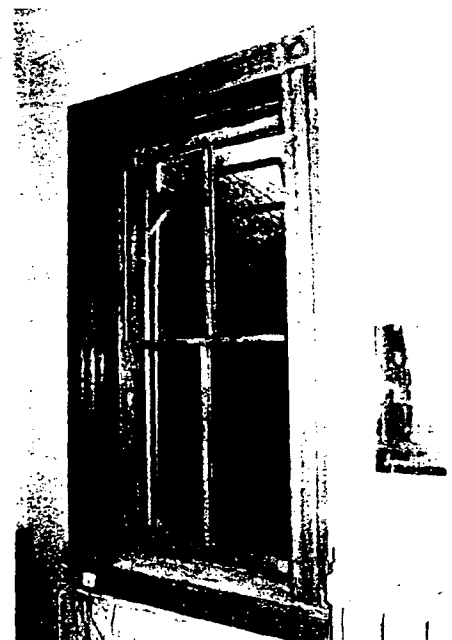
Figure 4f. Following the relatively simple repairs, the window is weathertight, like new in appearance, and serviceable for many years to come. Both the historic material and the detailing and craftsmanship of this original window have been preserved. Photo: John H. Myers

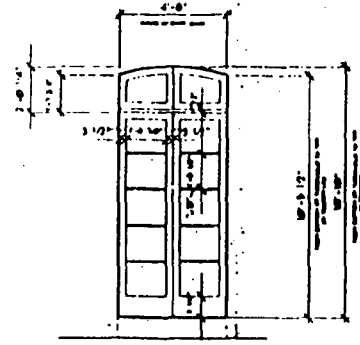
**NEW DOOR TYPE #2**  
FIRST FLOOR - ALL BUT LIVING RM  
NEW DOORS TO MATCH EXIST' WITH TRANSOMS TO MATCH

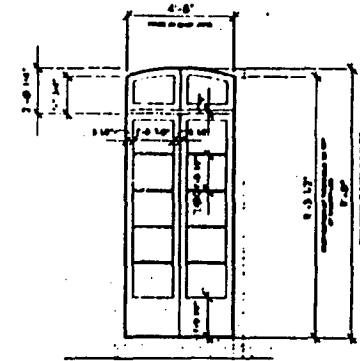
**NEW DOOR TYPE #1**  
FIRST FLOOR LIVING ROOM  
NEW DOORS TO MATCH EXIST' WITH TRANSOMS TO MATCH

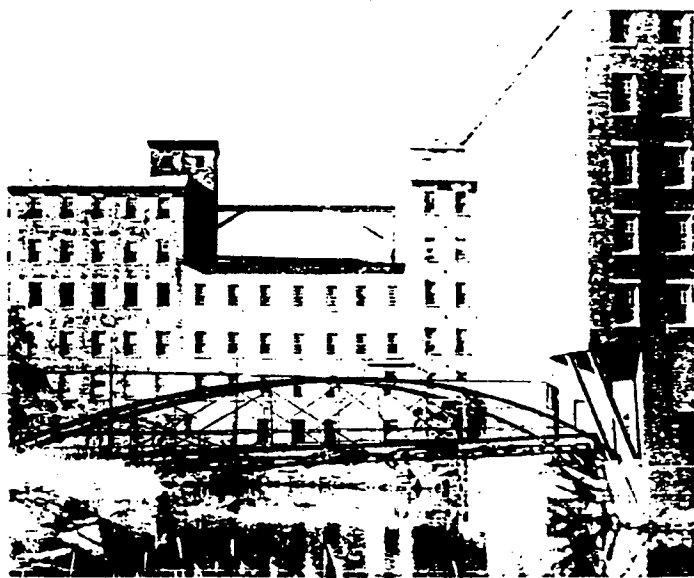
Figure 1. Windows are frequently important visual focal points, especially on simple facades such as this mill building. Replacement of the multi-pane windows here with larger panes could dramatically change the appearance of the building. The areas of missing windows convey the impression of such a change. Photo: John T. Lowe

Figure 1. Windows are frequently important visual focal points, especially on simple facades such as this mill building. Replacement of the multiple windows here with larger panes could dramatically change the appearance of the building. The areas of missing windows convey the impression of such a change. Photo: John T. Lowe

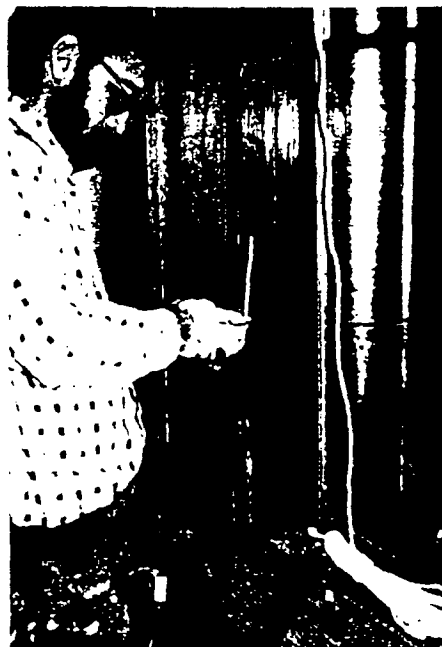
Figure 4e. A common repair is the replacement of broken sash cords with new cords (shown) or with chains. The weight pocket is often accessible through a removable plate in the jamb, or by removing the interior trim. Photo: John H. Myers

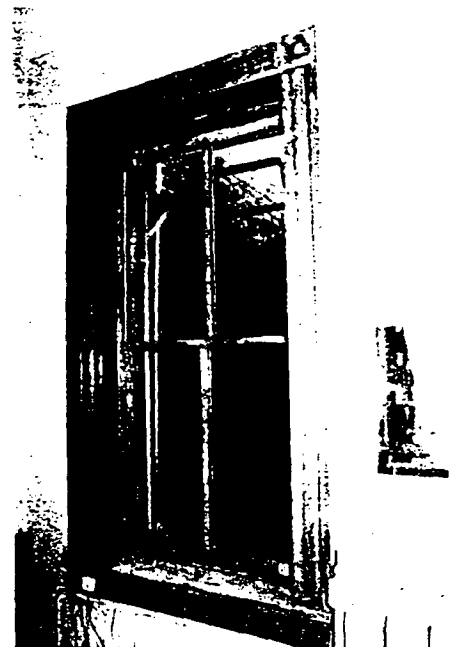
Figure 4f. Following the relatively simple repairs, the window is weathertight, like new in appearance, and serviceable for many years to come. Both the historic material and the detailing and craftsmanship of this original window have been preserved. Photo: John H. Myers
