31/07-03D 10 Post Office Road  
(Capitol View Historic District)

HISTORIC AREA WORK  
PERMIT

HAWP # 31/07-03D  
DPS# 308024

<b>Address:</b>	10 Post Office Road	<b>Meeting Date:</b>	06/25/03
<b>Applicant:</b>	Thompson Family LLC (Rodrigo Azellaneda, Agent)	<b>Report Date:</b>	06/18/03
<b>Resource:</b>	Capitol View Historic District	<b>Public Notice:</b>	06/11/03
<b>Review:</b>	HAWP	<b>Tax Credit:</b>	Yes
<b>Case Number:</b>	31/07-03D	<b>Staff:</b>	Corri Jimenez
<b>PROPOSAL:</b>	Window replacement		
<b>RECOMMEND:</b>	Approve with conditions

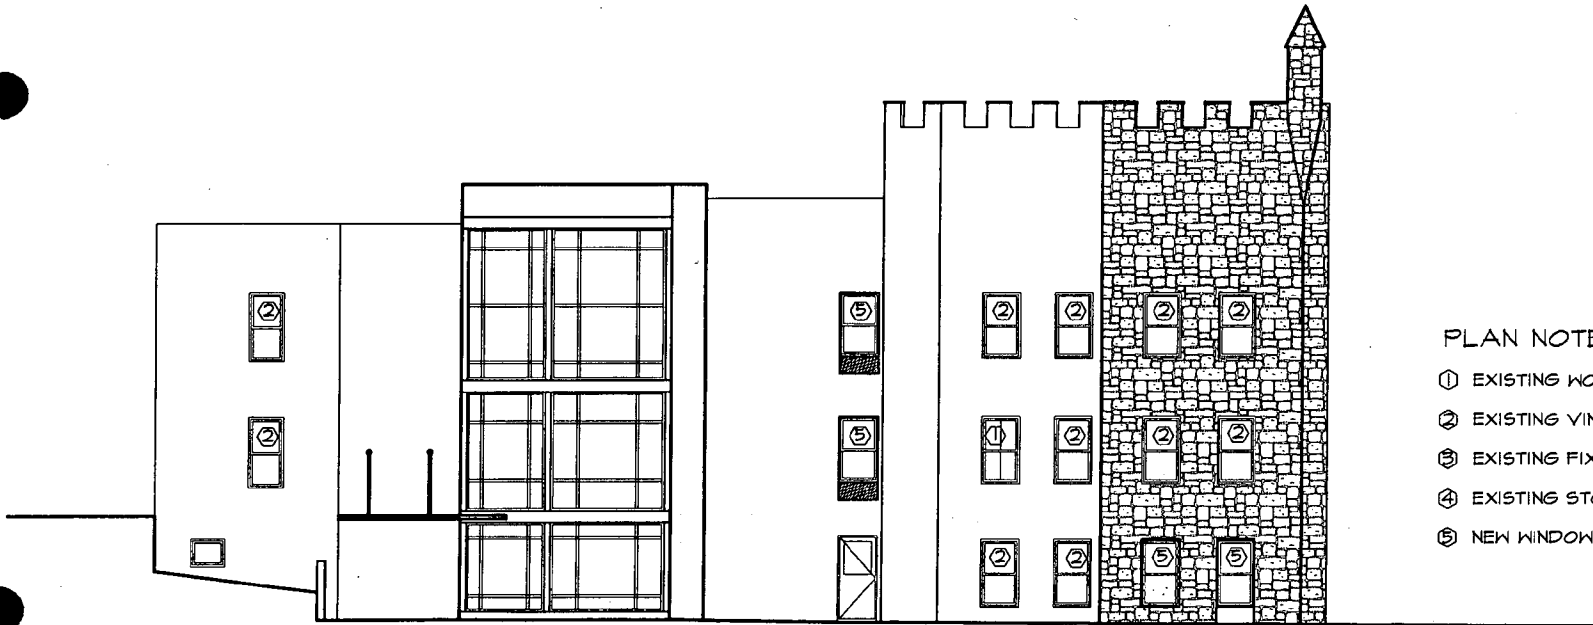
PLAN NOTES

- ① EXISTING WOOD DOUBLE HUNG WINDOW
- ② EXISTING VINYL DOUBLE HUNG WINDOW
- ③ EXISTING FIXED WINDOW
- ④ EXISTING STOREFRONT WINDOW
- ⑤ NEW WINDOW (PREVIOUS PERMIT)

Without a condition assessment of each historic window, staff recommends that the applicant save all of the historic windows (noted as "1" on the window schedule. Staff feels that it is appropriated to replace the windows that are non-historic with new wood 2/2 double-hung windows (non-historic windows are noted as "2" and "3" on the window schedule.)

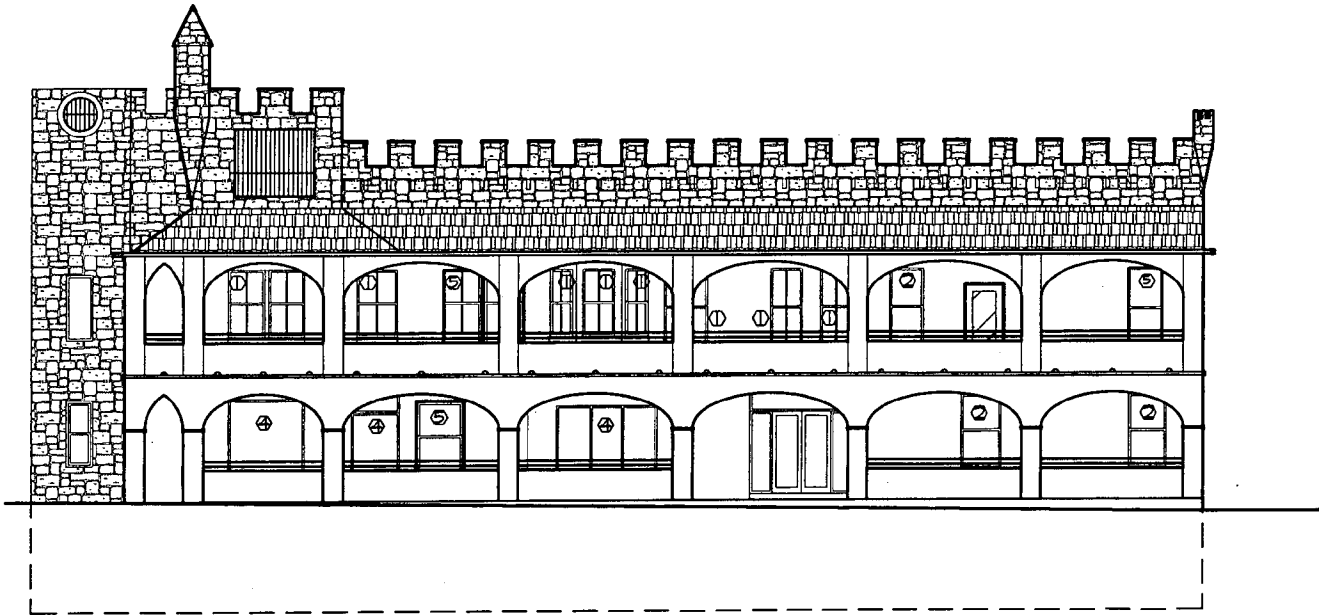
PLAN NOTES

- ① EXISTING WOOD DOUBLE HUNG WINDOW
- ② EXISTING VINYL DOUBLE HUNG WINDOW
- ③ EXISTING FIXED WINDOW
- ④ EXISTING STOREFRONT WINDOW
- ⑤ NEW WINDOW (PREVIOUS PERMIT)

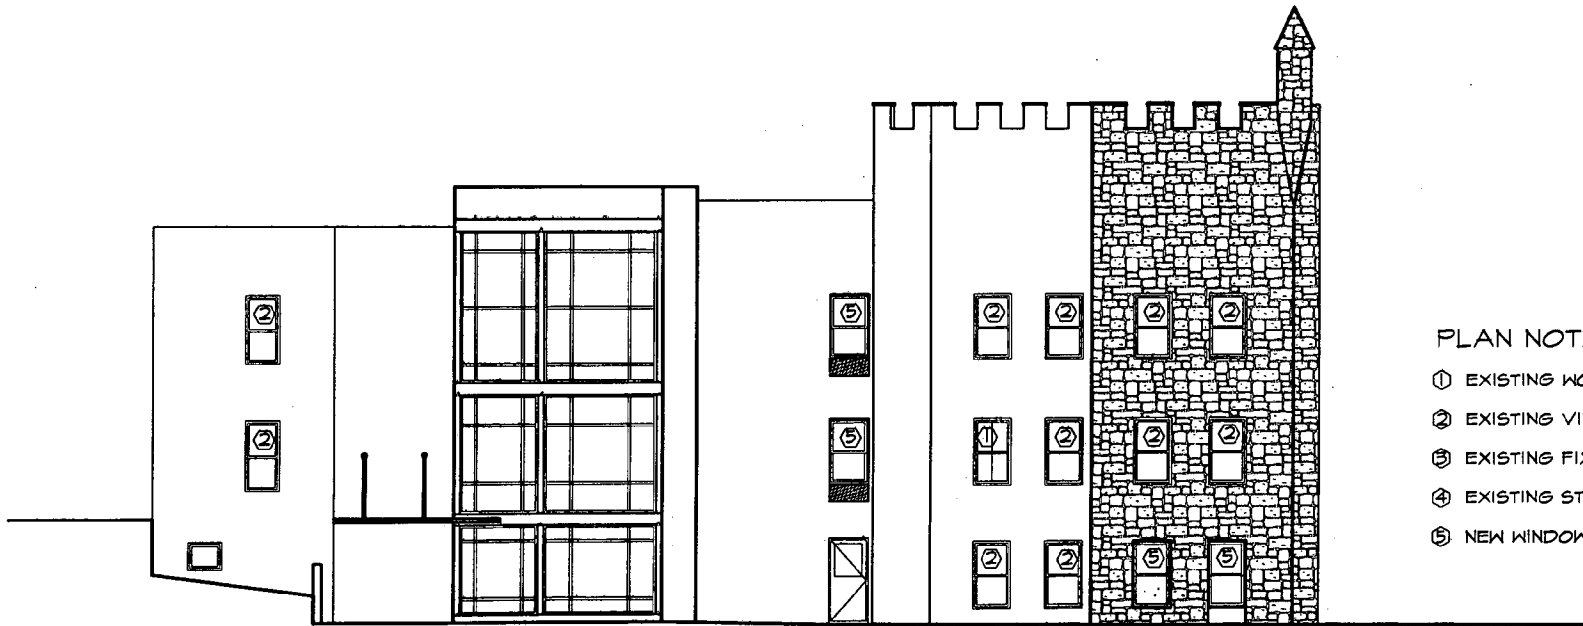
PLAN NOTES

- ① EXISTING WOOD DOUBLE HUNG WINDOW
- ② EXISTING VINYL DOUBLE HUNG WINDOW
- ③ EXISTING FIXED WINDOW
- ④ EXISTING STOREFRONT WINDOW
- ⑤ NEW WINDOW (PREVIOUS PERMIT)

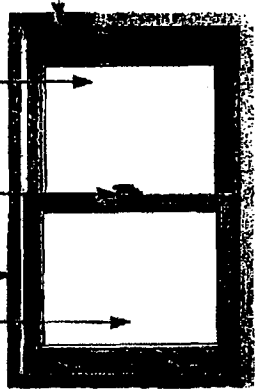
# tilt sash replacement kit

Works with any brand existing window frame.

Available in full lite (shown), TDL, SOL, airspace, removable wood perimeter and Fashion Grilles.

High-quality weather stripping and vinyl jamb liners seal out drafts.

Concealed inside the jamb liners, the spring-loaded block and tackle system allows the window to tilt in for easy cleaning.

The current application proposes to replace all existing windows with wood double hung 2/2 true divided lite windows. The applicant is planning to use a "tilt sash replacement kit" (see Circle 30-32).

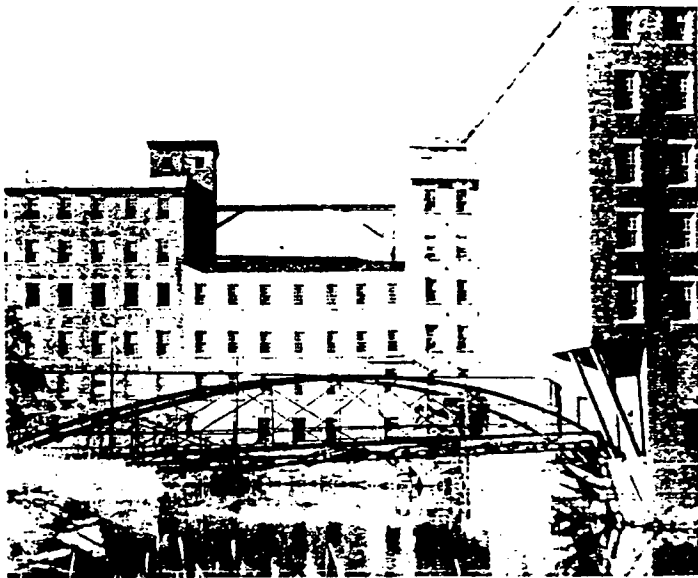
Figure 1. Windows are frequently important visual focal points, especially on simple facades such as this mill building. Replacement of the multiple windows here with larger panes could dramatically change the appearance of the building. The areas of missing windows convey the impression of such a change. Photo: John T. Lowe

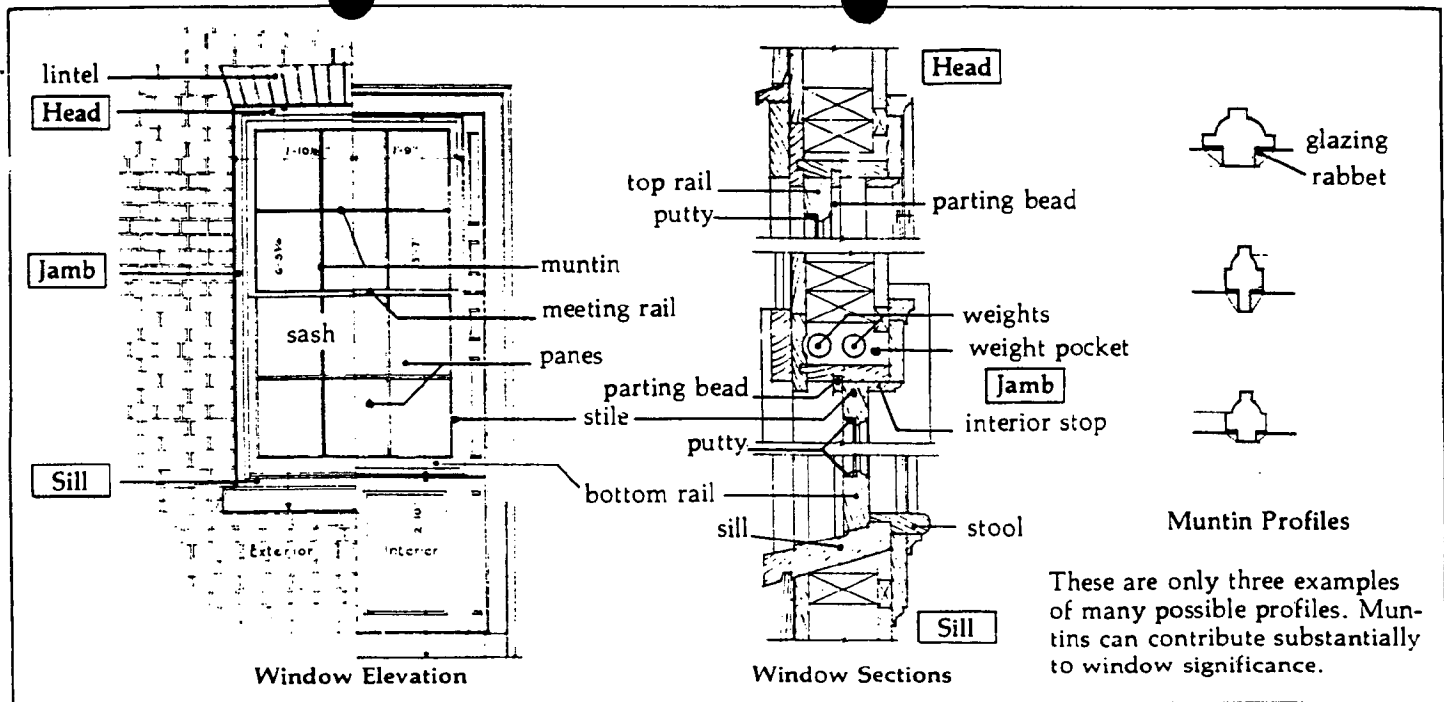
Figure 2. These drawings of window details identify major components, terminology, and installation details for a wooden double-hung window.

Historically, the first windows in early American houses were casement windows; that is, they were hinged at the side and opened outward. In the beginning of the eighteenth century single- and double-hung windows were introduced. Subsequently many styles of these vertical sliding sash windows have come to be associated with specific building periods or architectural styles, and this is an important consideration in determining the significance of windows, especially on a local or regional basis. Site-specific, regionally oriented architectural comparisons should be made to determine the significance of windows in question. Although such comparisons may focus on specific window types and their details, the ultimate determination of significance should be made within the context of the whole building, wherein the windows are one architectural element (see figure 2).

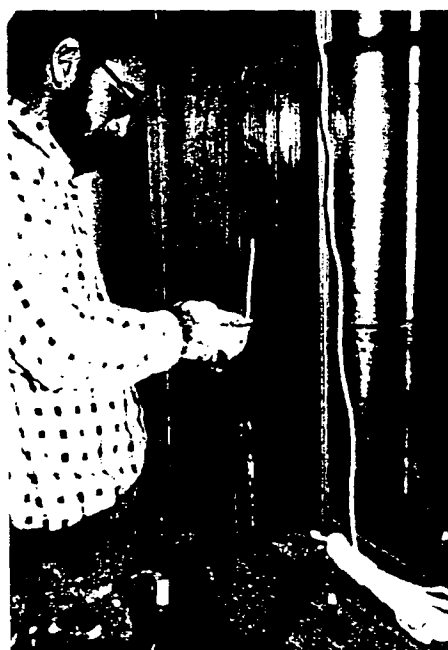
Figure 4e. A common repair is the replacement of broken sash cords with new cords (shown) or with chains. The weight pocket is often accessible through a removable plate in the jamb, or by removing the interior trim. Photo: John H. Myers

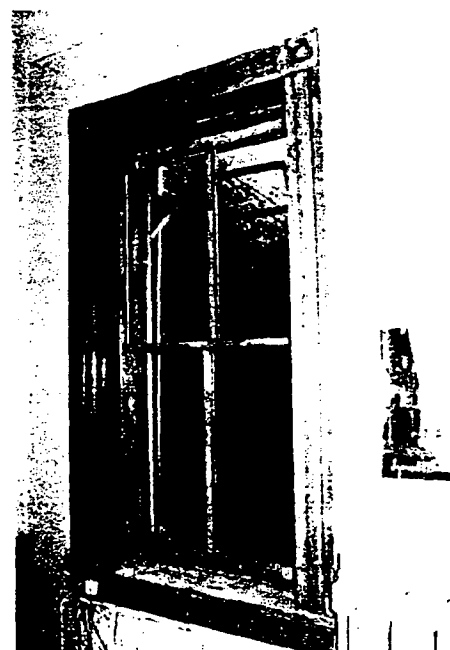
Figure 4f. Following the relatively simple repairs, the window is weathertight, like new in appearance, and serviceable for many years to come. Both the historic material and the detailing and craftsmanship of this original window have been preserved. Photo: John H. Myers

The operations just discussed summarize the efforts necessary to restore a window with minor deterioration to "like new" condition (see figure 4f). The techniques can be applied by an unskilled person with minimal training and experience. To demonstrate the practicality of this approach, and photograph it, a Technical Preservation Services staff member repaired a wooden double-hung, two over two window which had been in service over ninety years. The wood was structurally sound but the window had one broken pane, many layers of paint, broken sash cords and inadequate, worn-out weatherstripping. The staff member found that the frame could be stripped of paint and the sash removed quite easily. Paint, putty and glass removal required about one hour for each sash, and the reglazing of both sash was accomplished in about one hour. Weatherstripping of the sash and frame, replacement of the sash cords and reinstallation of the sash, parting bead, and stop required an hour and a half. These times refer only to individual operations; the entire proc-

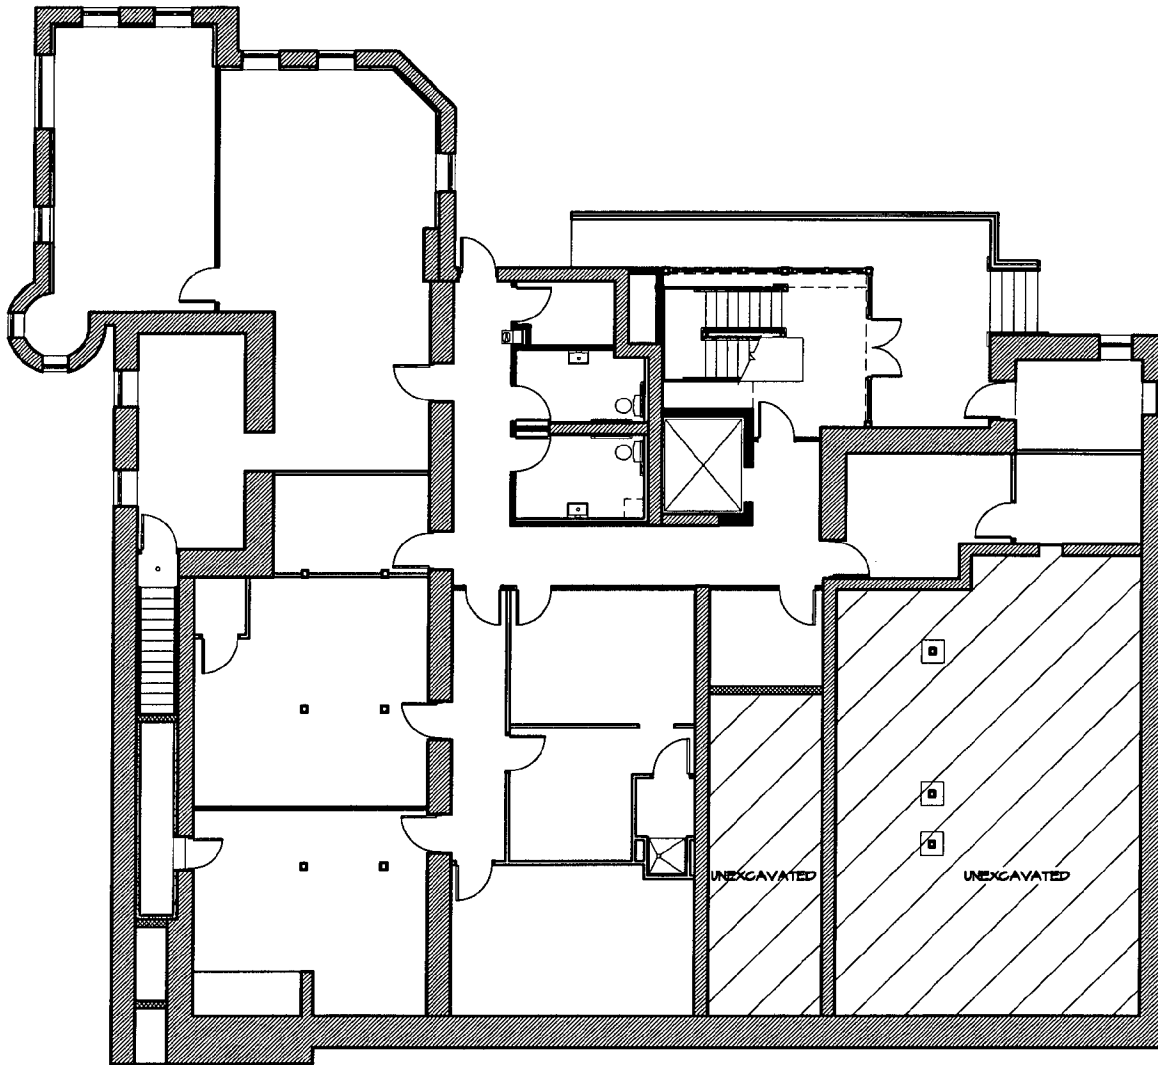
BASEMENT FLOOR

SCALE: 1/16" = 1'-0"

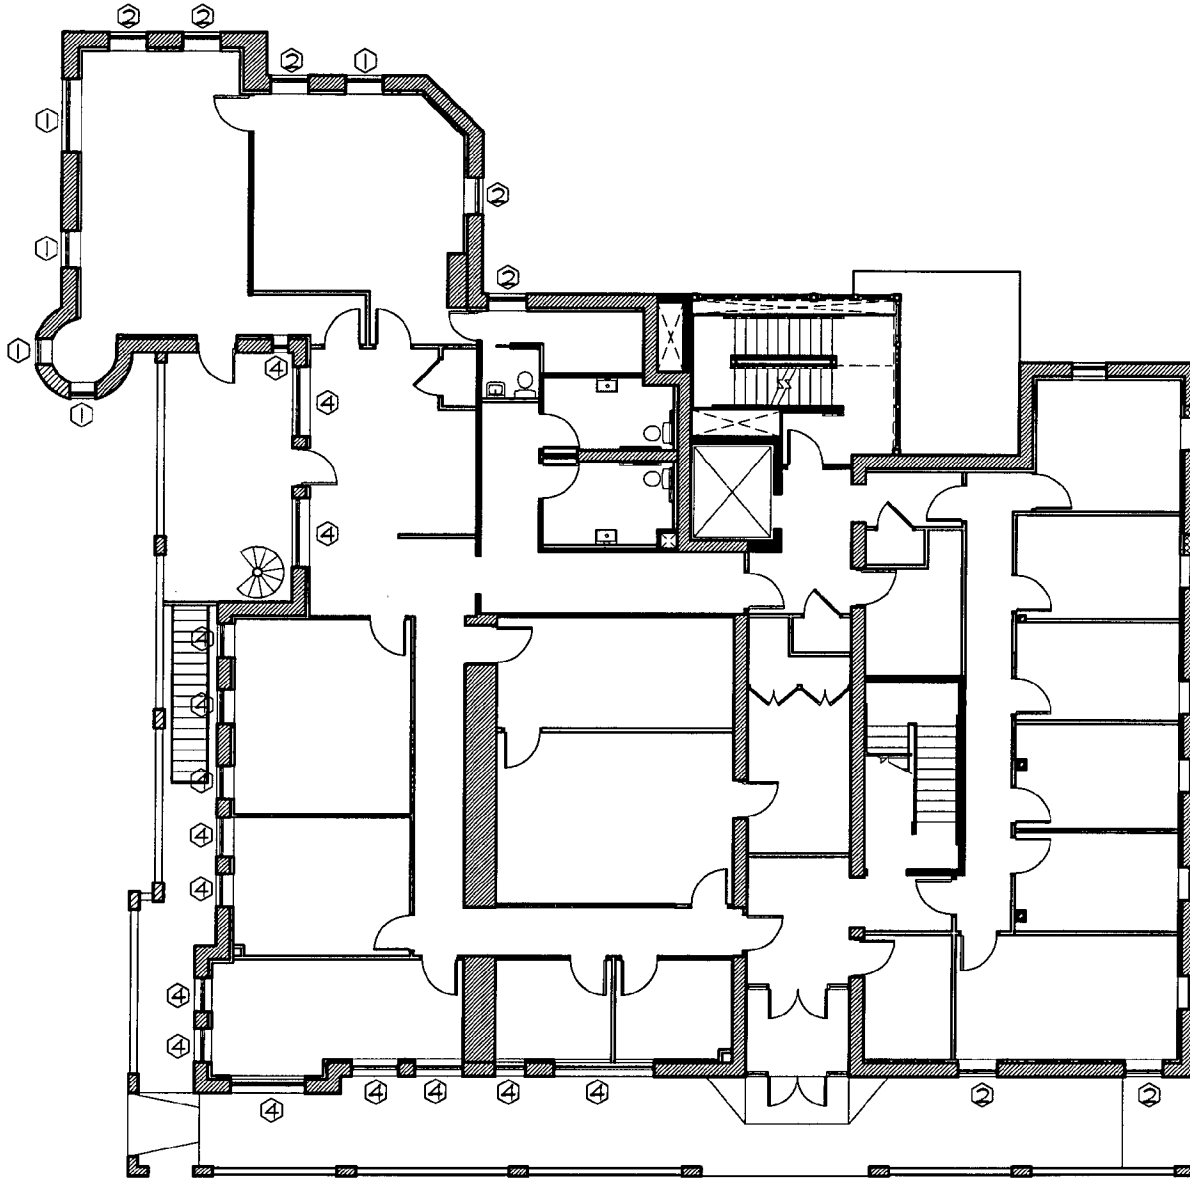
**FIRST FLOOR**

SCALE: 1/16" = 1'-0"

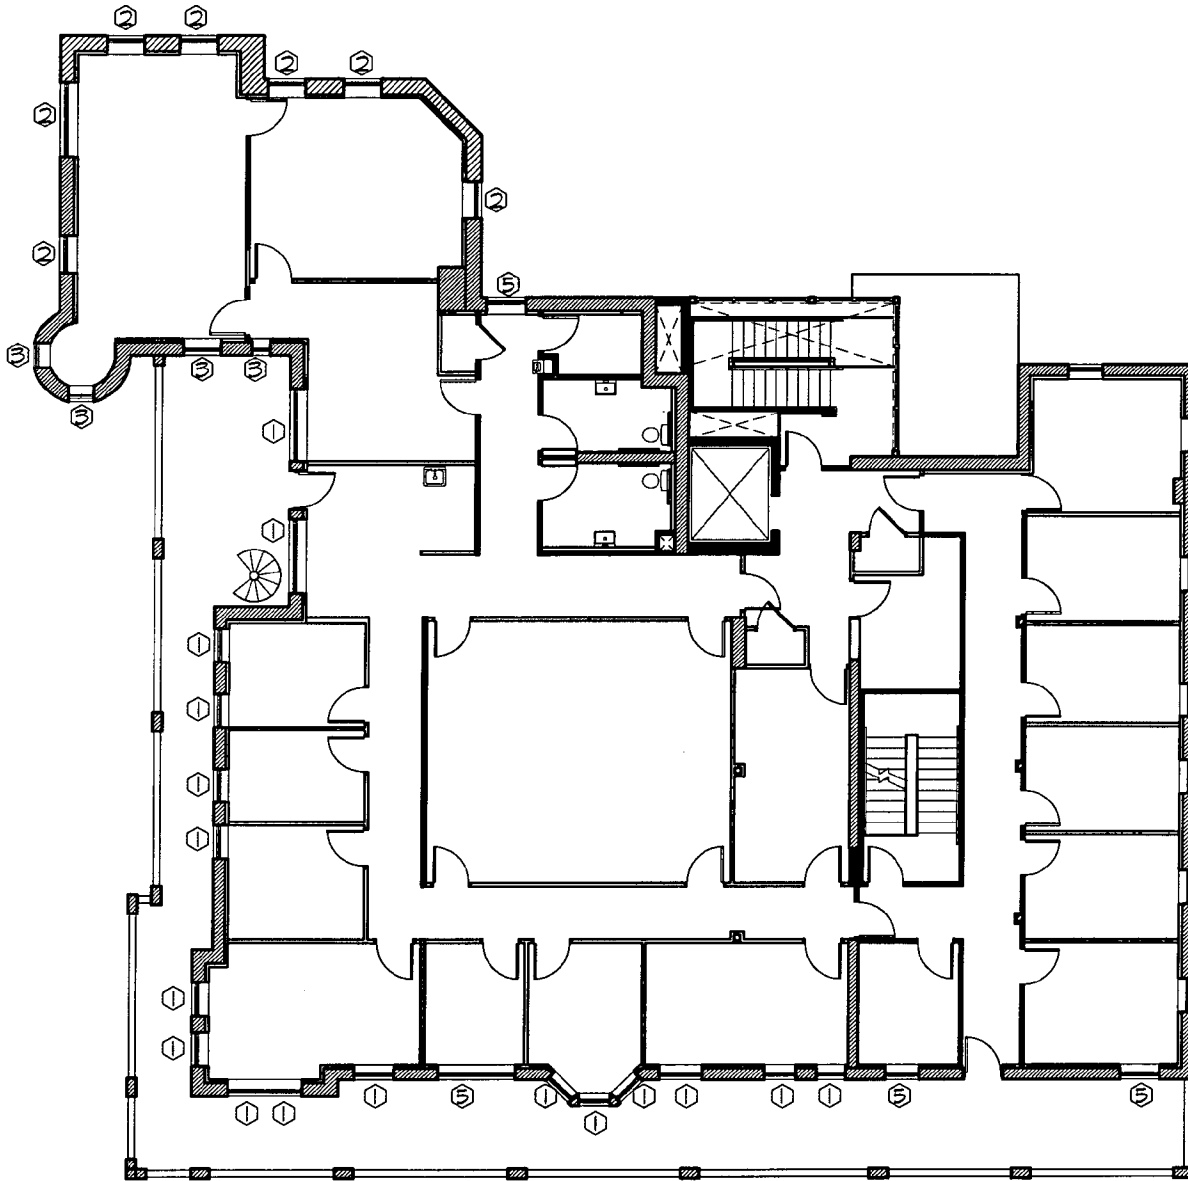
SECOND FLOOR

SCALE: 1/16" = 1'-0"
