National Register of Historic Places
Registration Form

historic name Valley Mill House

street & number 1600 East Randolph Rd. ☐ not for publication

city or town Colesville, ☐ vicinity

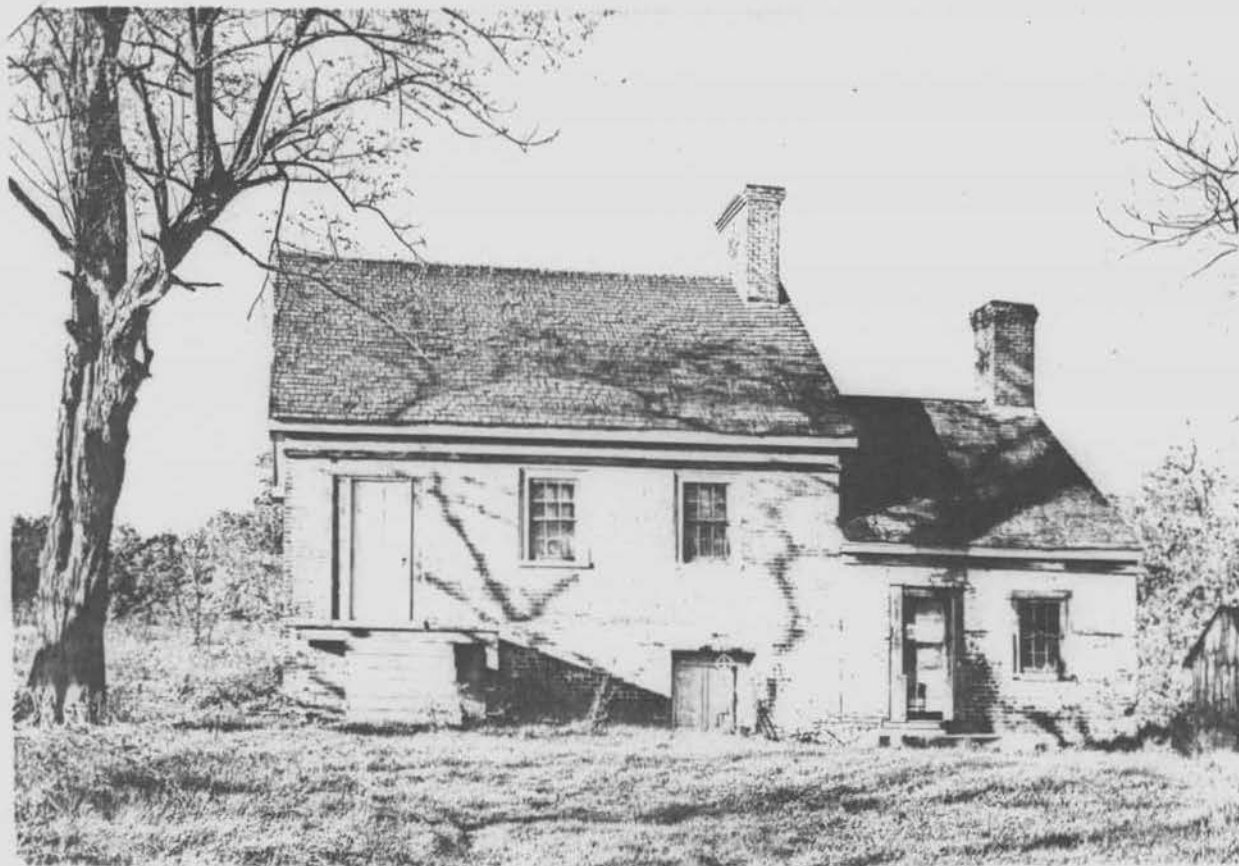
M:33-7
HABS No. 10,507

VIEW OF MILLER'S HOUSE FROM SOUTH (front)

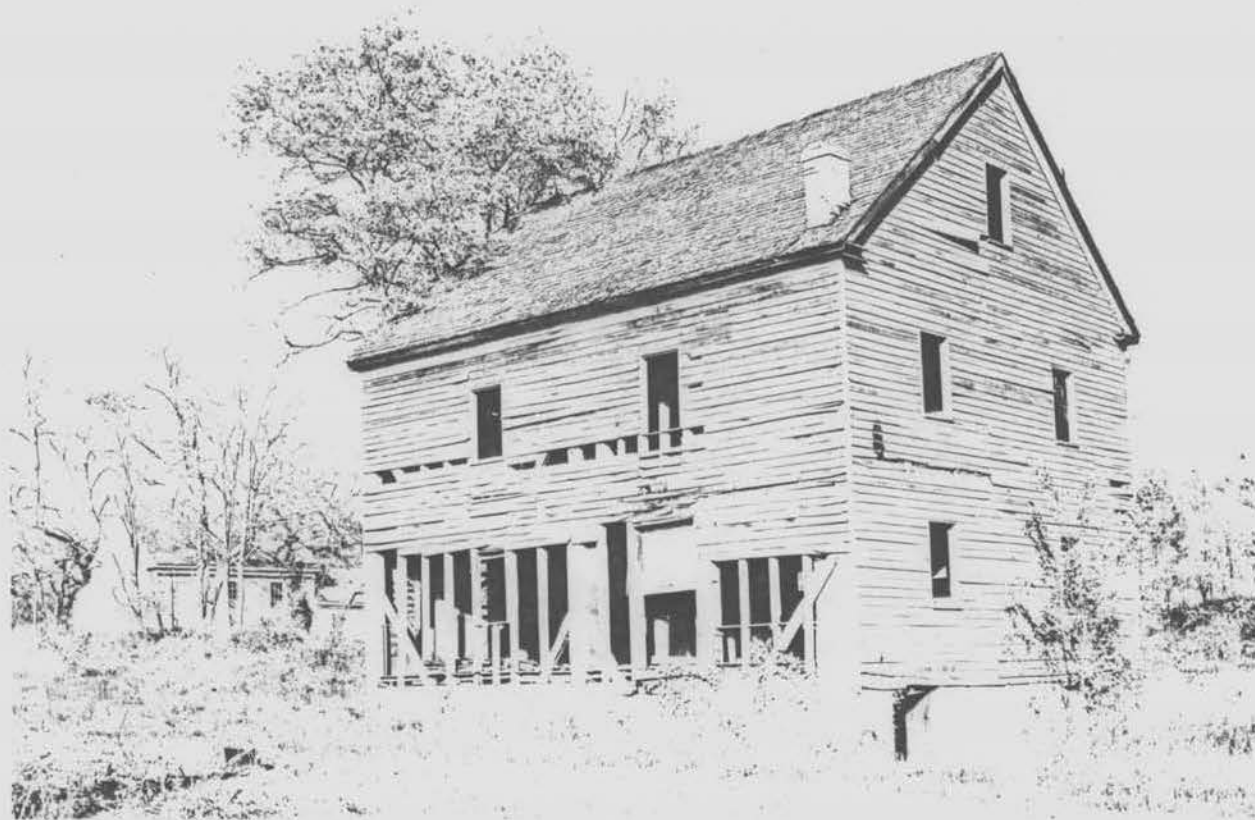
HABS No. 100-568

VIEW FROM SOUTHWEST

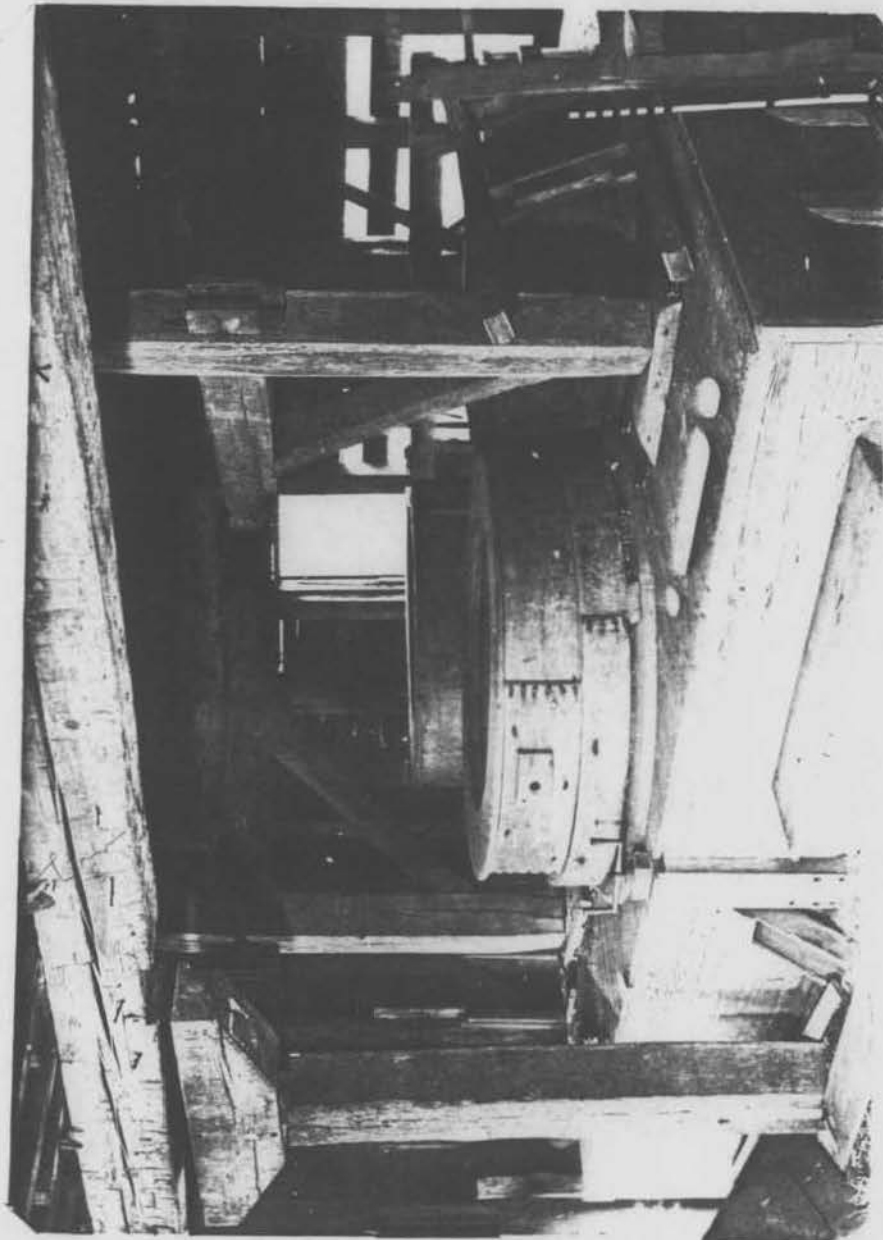
HABS No. MD-568

DETAIL OF MILL STONE TABLE

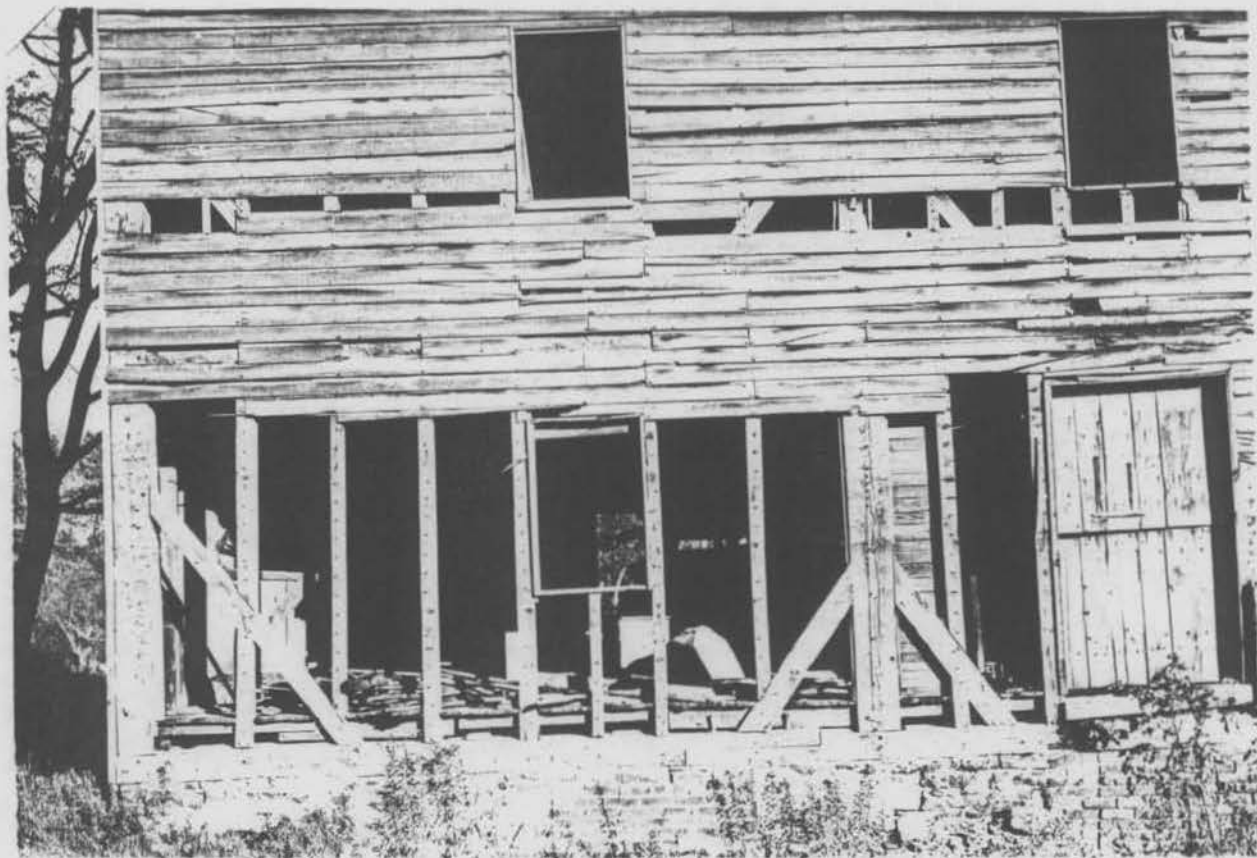
HABS No. Md-566
HABS
MD.
16 COLVIN
1-2

DETAIL OF FRAMING CONSTRUCTION WEST ELEVATION.

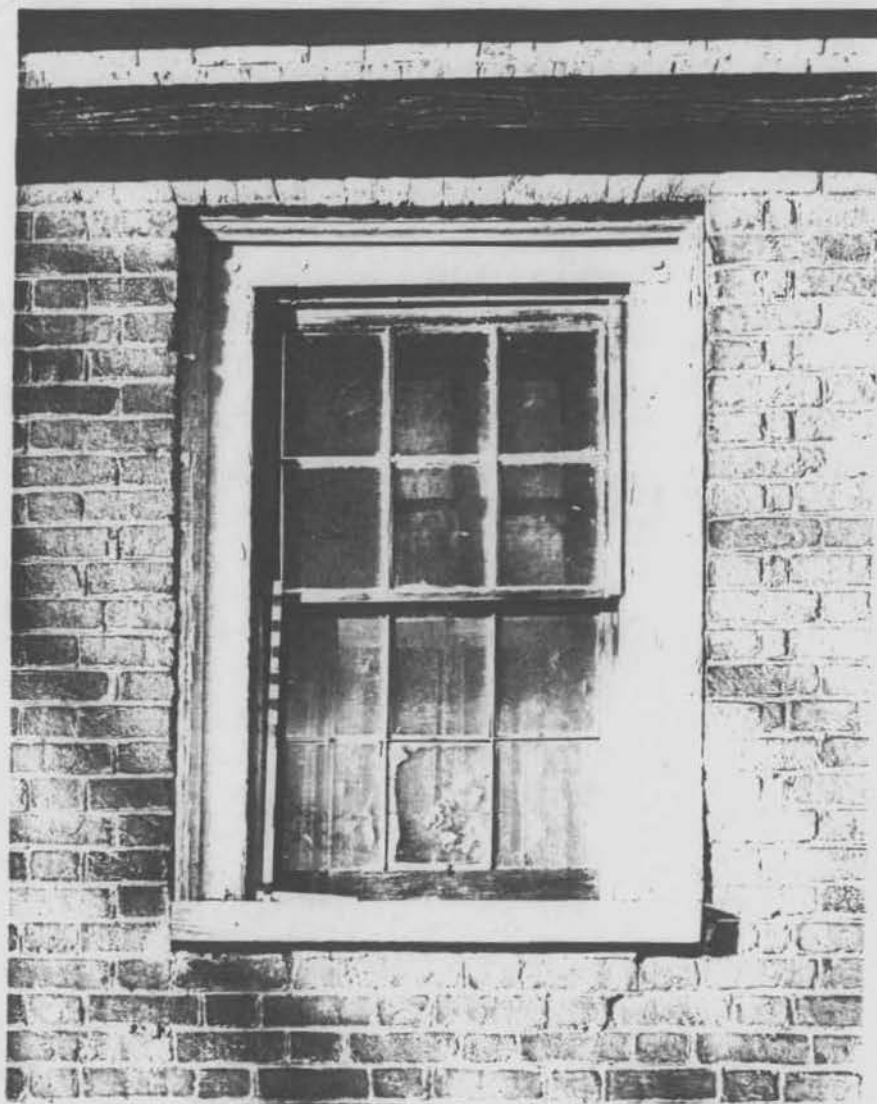
M:33-7
HABS No. MD-567
HABS
MD.
16 Colvi.V
2-2

The brick work on the south facade is Flemish bond, while the sides and the rear are done in common bond. Some decorative features in the brick work include a water table, and random glazed bricks.

DETAIL OF WINDOW AND BRICK WORK

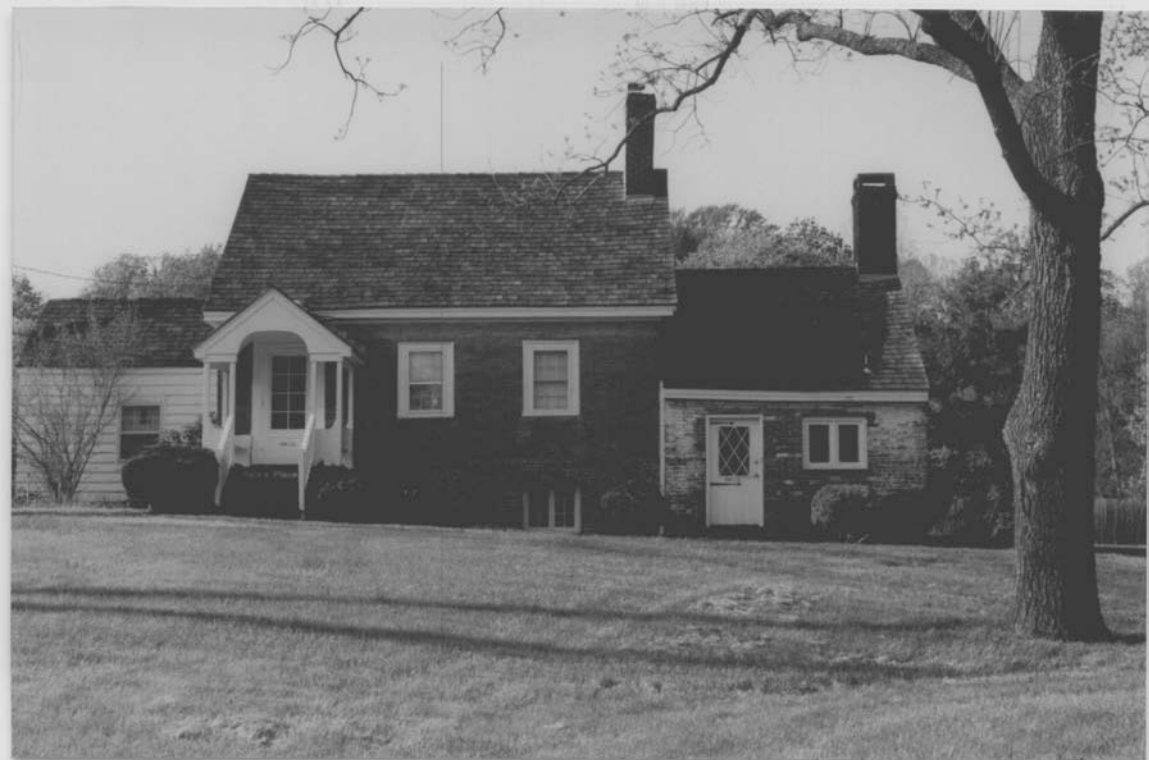
1. Valley Mill House
2. Mont. Co. MD
3. Chris McKneely
4. April 30, 1992
5. 3816 Delano St.
Silver Spring, MD 20902
6. South facade, looking north.

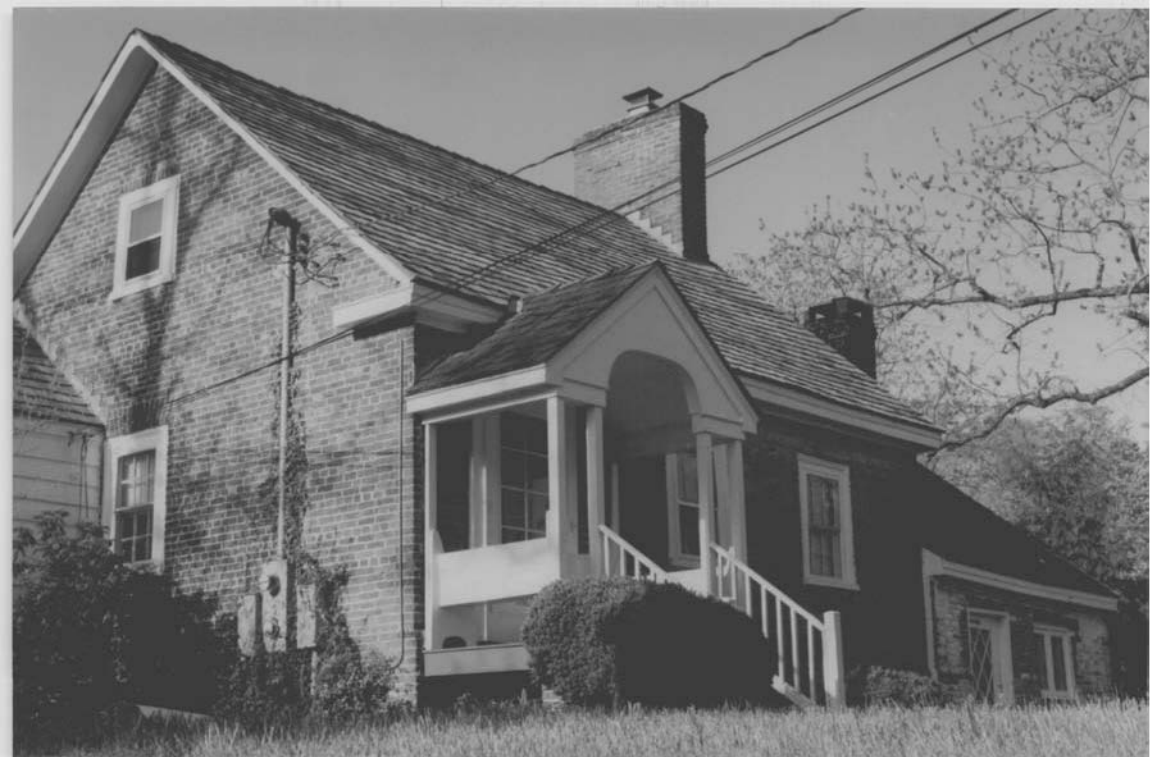
1. Valley Mill House
2. Mont. Co. MD.
3. Chris-McKneely
4. April 30, 1992
5. 3816 Delano St.
Silver Spring, MD 20902
6. South and West facades,
looking northeast

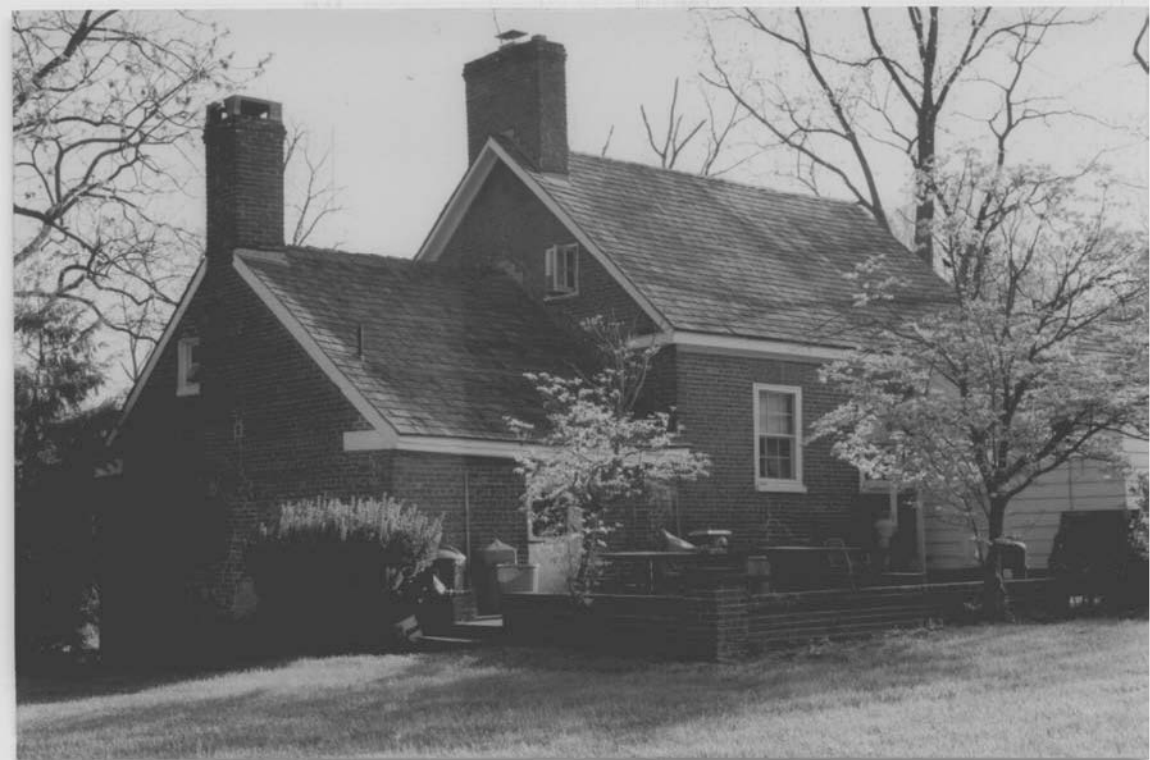
6. North and east facades, looking southwest

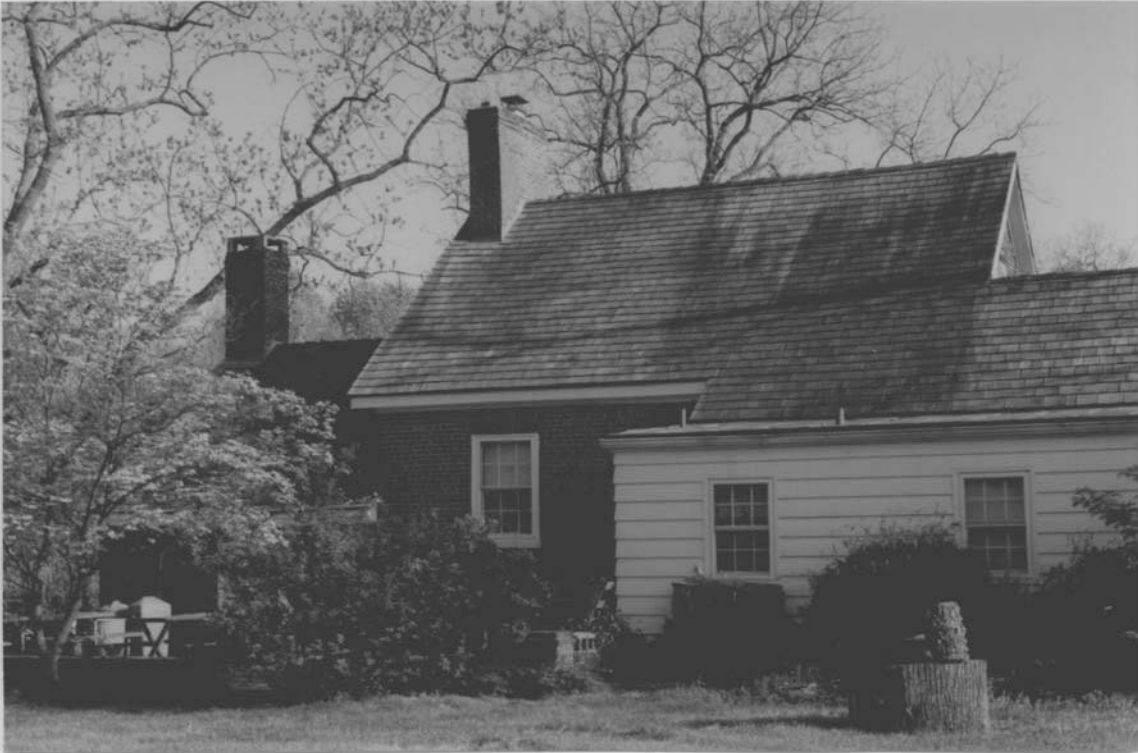
1. Valley Mill House
2. Mont. Co. MD.
3. Chris McKneely
4. April 30, 1992
5. 3016 Delano St
Silver Spring, MD 20902
6. North facade, looking southeast.

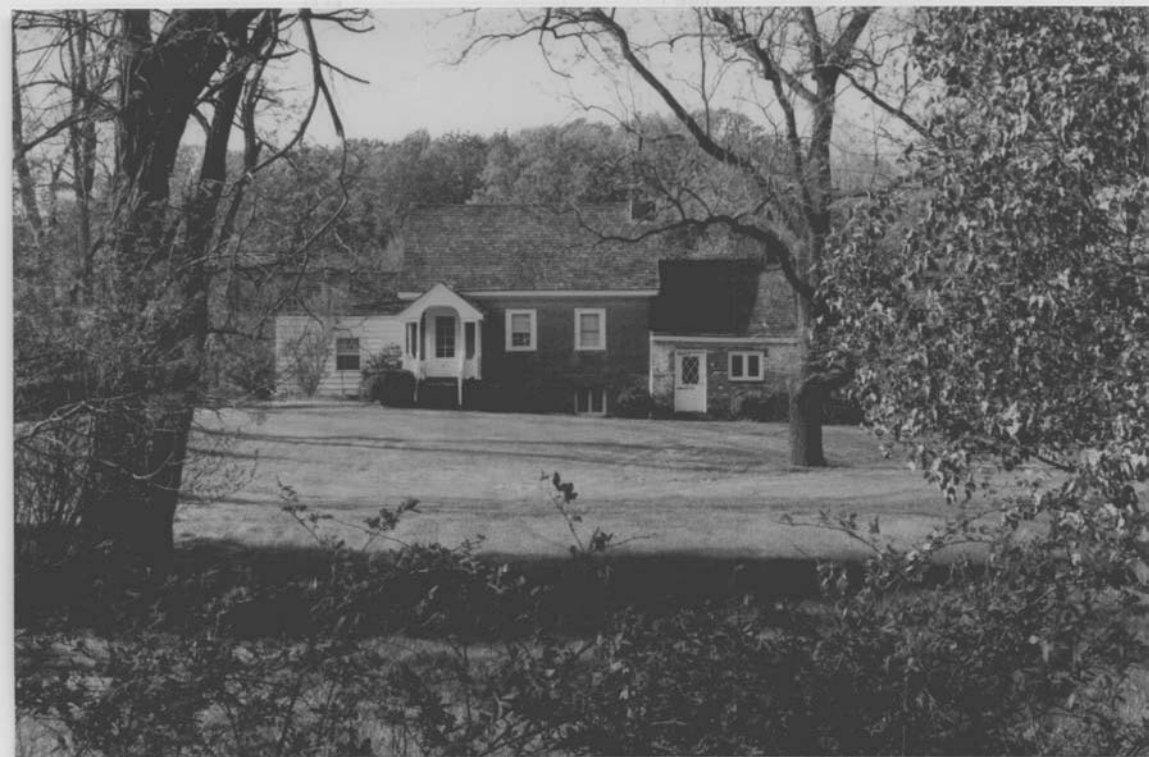
1. Valley Mill House
2. Moht. Co. MD
3. Chris McKneely
4. April 30, 1992
5. 3816 Delano St.
Silver Spring, MD 20902
6. South facade, looking north
from East Randolph Rd.

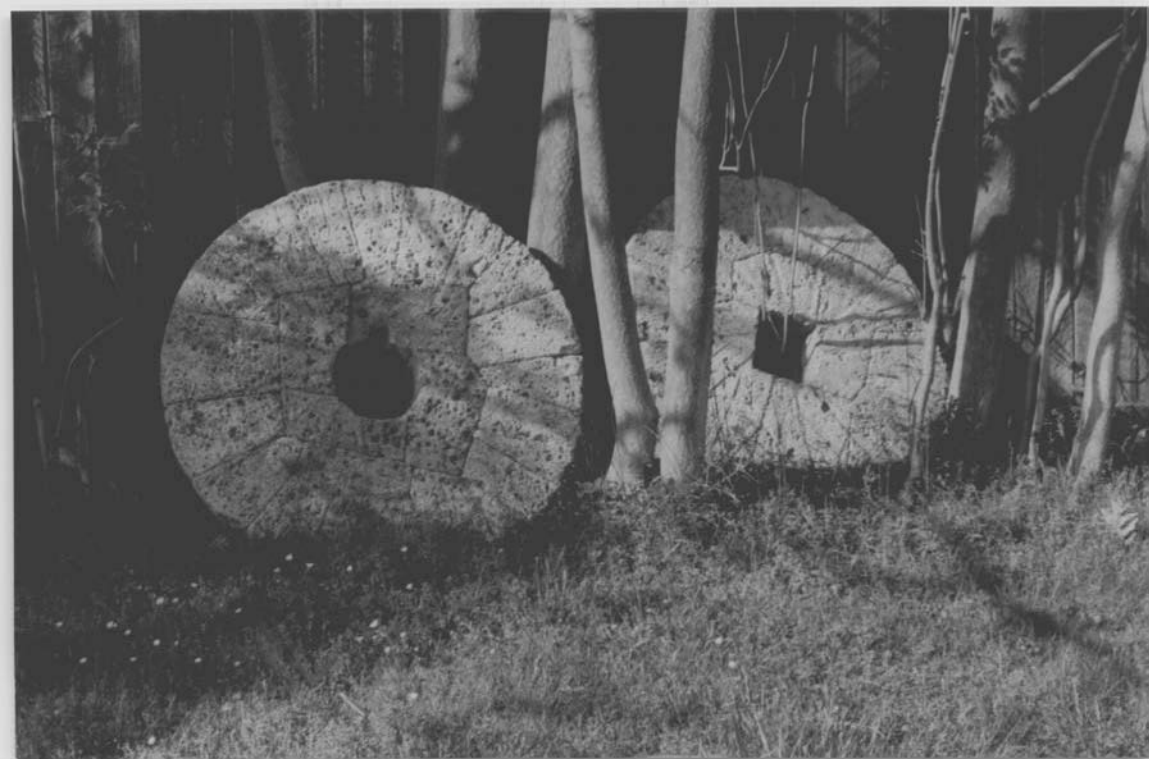
1. Valley Mill millstones
2. Mont. Co. MD
3. Chris McKeehy
4. April 30, 1992
5. 3816 Delano St.
Silver Spring MD 20902
- 6.

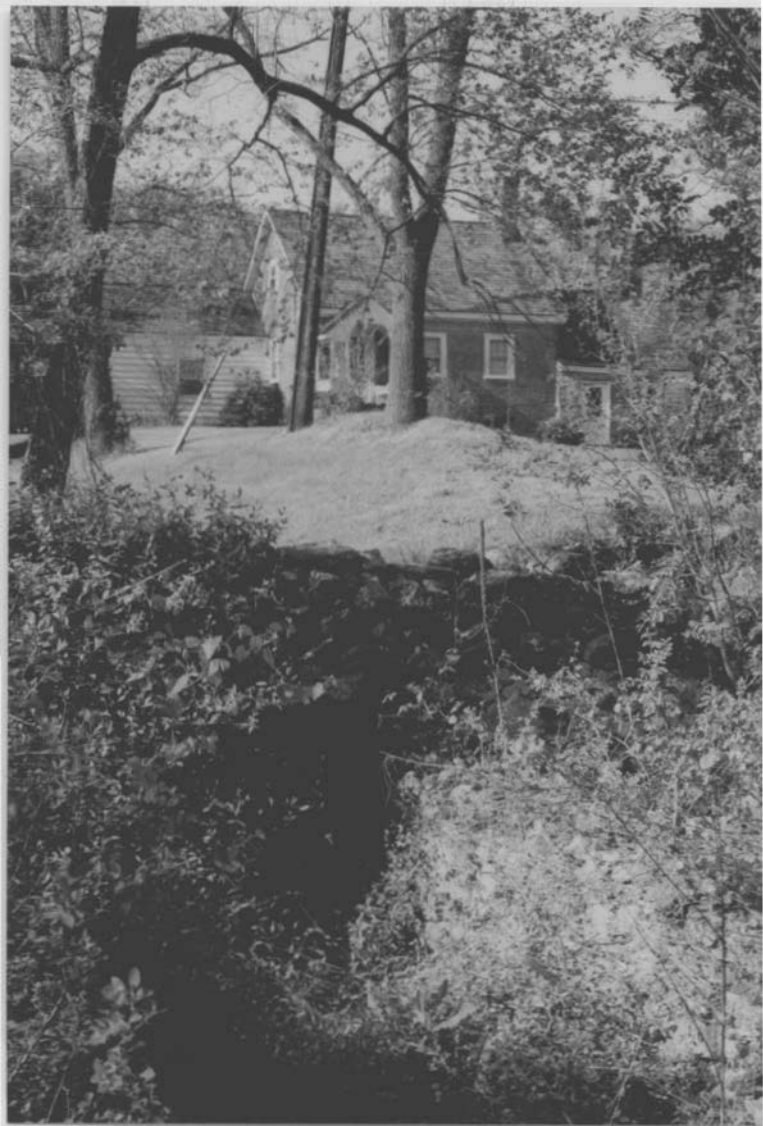
1. Valley Mill site and Valley Mill House.
2. Montgomery County, MD.
3. Christopher McKneely
4. April 30, 1992
5. 3816 Delano St.
Silver Spring, MD 20902
6. South facade from site
of old mill, looking northeast.

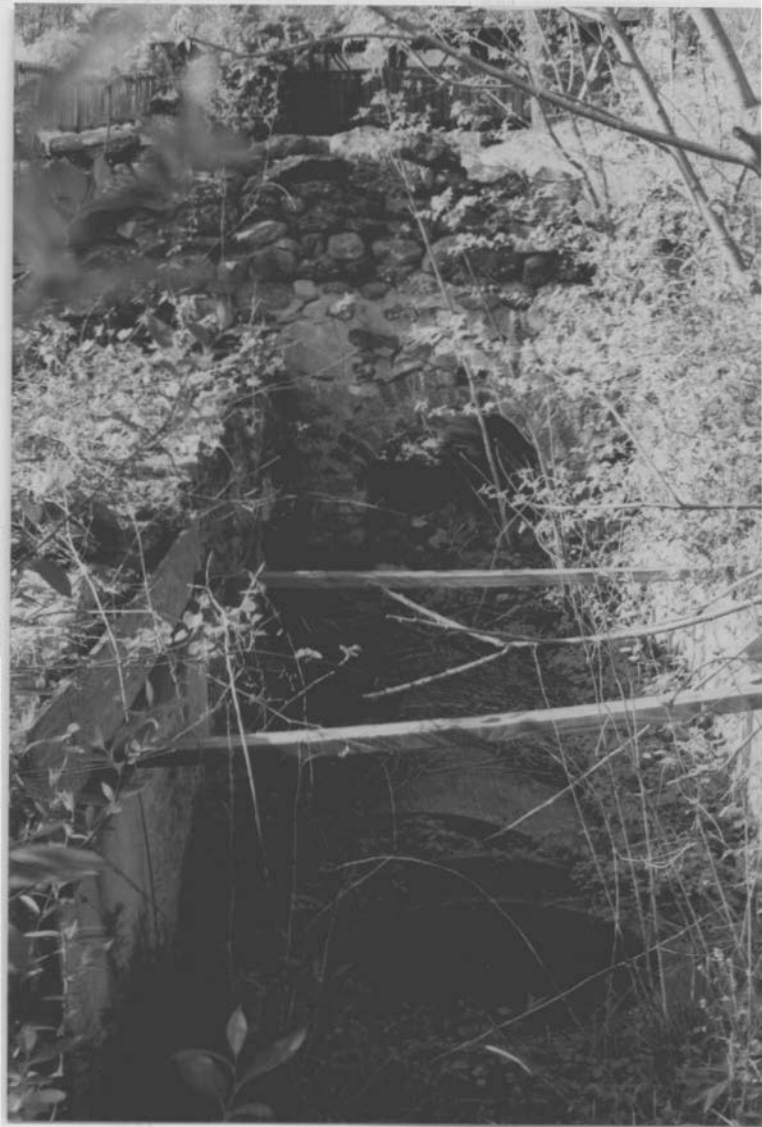
The mill's foundation is of random laid stone construction. The mill measured approximately 30 feet by 30 feet, with a ground floor from three to four feet below ground level. An inner wall or separation is apparent; it is about eight inches wide and divides the ground floor into a one-fourth and three-fourths arrangement. From floor level to top the walls measure eight feet at the highest point. The last mill to operate this site was constructed in 1879 and was a two and a half story frame building covered in horizontal siding with a gable roof covered in wooden shingle. A brick chimney rose from the southwest corner of the mill building.

6. North and interior foundation walls, looking north.
