**MARYLAND HISTORICAL TRUST  
DETERMINATION OF ELIGIBILITY FORM**

Property Name: Howard Marlow Property Inventory Number: M:34-16  
Address: 2610 Fairland Road City: Silver Spring Zip Code: 20904  
County: Montgomery USGS Topographic Map: Beltsville  
Owner: SHA Is the property being evaluated a district? \_\_\_\_\_ yes  
Tax Parcel Number: \_\_\_\_\_ Tax Map Number: \_\_\_\_\_ Tax Account ID Number: \_\_\_\_\_  
Project: MO891B21/US 29 at Fairland and Musgrove Agency: SHA  
Site visit by MHT staff: X no \_\_\_\_\_ yes Name: \_\_\_\_\_ Date: \_\_\_\_\_  
Is the property is located within a historic district \_\_\_\_\_ yes X no

## NR-ELIGIBILITY REVIEW FORM

**Maryland Historical Trust**  
**Maryland Inventory of Historic Properties Form**  
**Intercounty Connector Project**

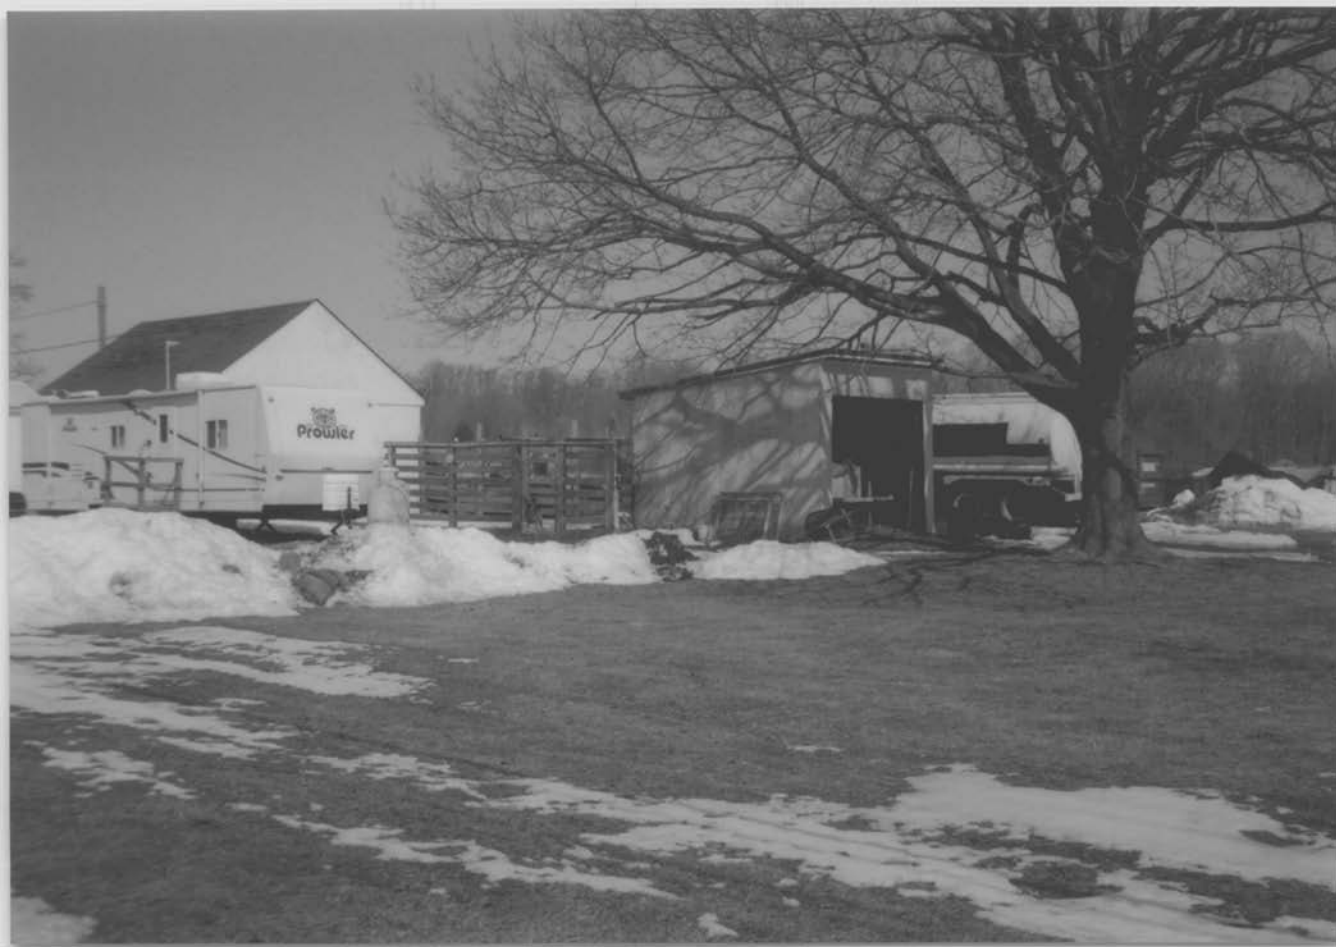
M' 34-16

As previously stated, the corn crib and Shed # 3 are the only remaining outbuildings. Shed #3 was described on the 1996 MIHP form as an 1910 outbuilding built of wood frame construction with a shed roof. However, the shed consists of four wood poles and plywood siding and appears to be a later vintage. SHA concludes that shed #3 does not contribute to the property's illustration of early twentieth century agricultural and architectural themes and is not a contributing building to the significance of the Marlow Property. The one-story shed (Shed #1), possibly used for milking, was located on its northwest end and is now gone. The circumstances relating to its removal are not known. The concrete block garage was previously determined non-contributing.

Shed #3 Corn crib

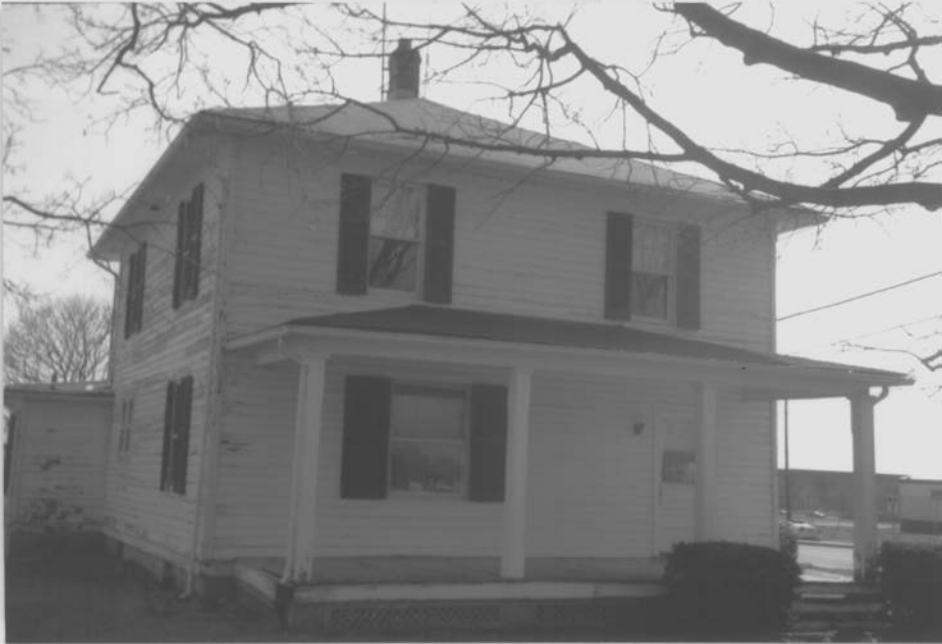
The west, or front facade has a 1-story, hipped-roof porch with wood posts and wood lattice skirting. The fenestration pattern is symmetrical, with a glass and wood panelled door and one 1/1 double-hung window on the first story. The window, which is larger than the other windows in the structure, is a later replacement. The second story has two 6/1 double-hung windows.

7 13425 Old Columbia Pike, west elevation

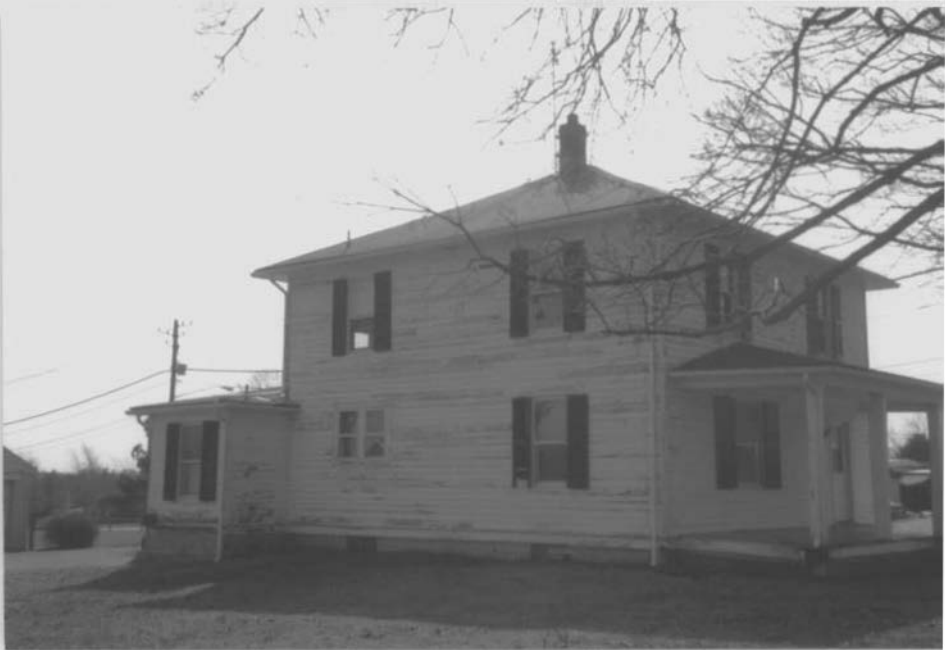
The north elevation has a symmetrical fenestration pattern with two 3-light fixed sash windows on the basement level and two 6/1 double-hung windows on the first story. The second story has two 6/1 double-hung windows.

- 1 M: 34-16
- 2 Howard Marlow Property
- 3 Montgomery County
- 4 Caroline Hall
- 5 February 1996
- 6 PAC Spec and Company, Towson MD 21204
- 7 13425 Old Columbia Pike, north elevation
- 8 2 of 9

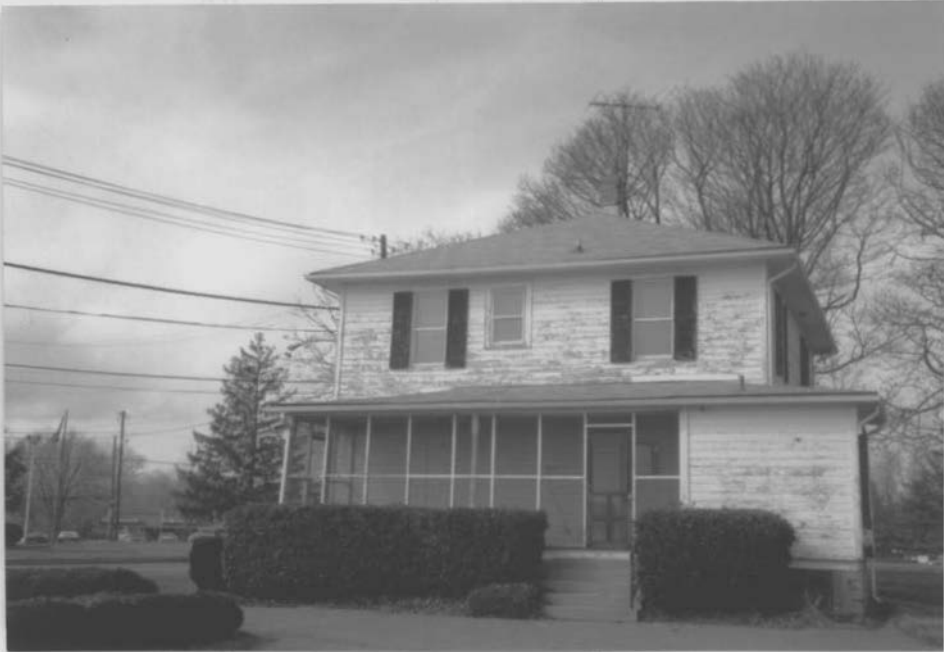
The east, or rear elevation has a full-width screened porch. Attached to the porch is a 1-story addition which projects north of the northeast corner of the building. The fenestration pattern is symmetrical with two wood doors on the first story. The second story has two 6/1 double-hung windows.

- 1 m. 34-16
- 2 Howard Marlow Property
- 3 Montgomery County
- 4 Caroline Hall
- 5 February 1996
- 6 PAC Speco and Company, Tauson MD 21204
- 7 13425 Old Columbia Pike, east elevation
- 8 3 of 9

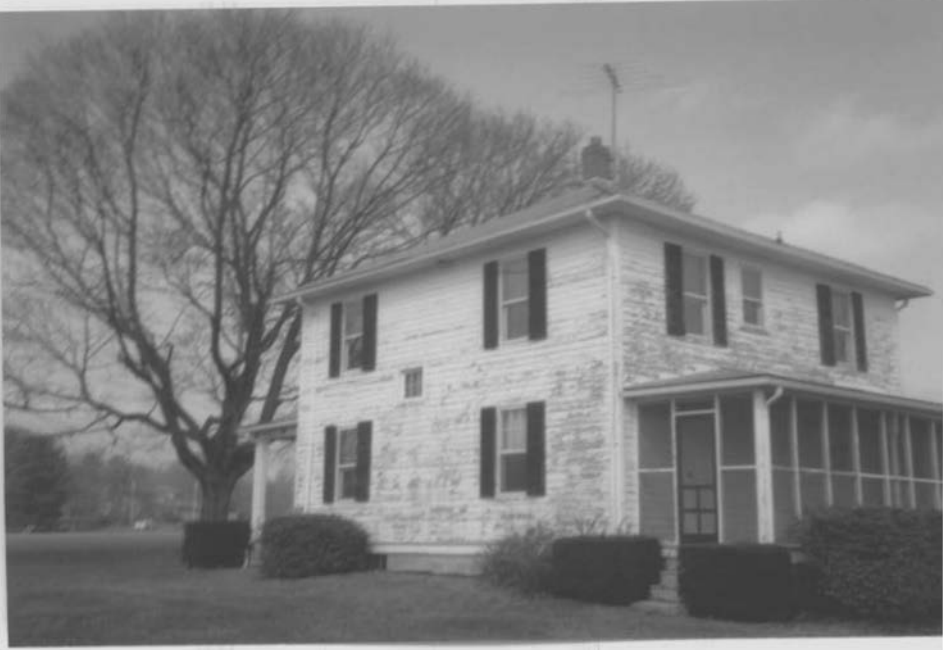
The south elevation has a symmetrical fenestration pattern with two 3-light fixed sash windows on the basement level and two 6/1 windows on the first story. The second story has two 6/1 double-hung windows and there is a small, square 6-light, fixed sash window between the first and second stories, placed slightly off center.

- 1 M: 34-16
- 2 Howard Marlow's Property
- 3 Montgomery County
- 4 Caroline Hall
- 5 February 1996
- 6 PAC Spew and Company, Tawson MD 21204
- 7 13425 Old Columbia Pike, south elevation
- 8 4 of 9

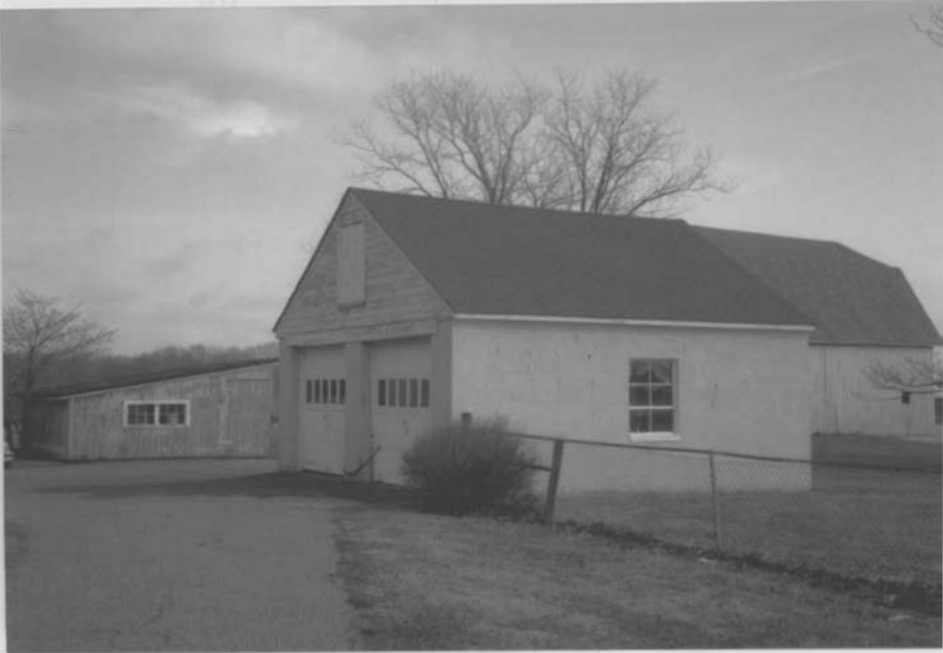
There are six outbuildings associated with this property. The first outbuilding is a two-car garage with a front-gable roof covered with asphalt shingles. Constructed circa 1940, it is of concrete block construction with wood siding in the gable end, and is located east of the main house.

- 1 M: 34-16
- 2 Howard Marlow Property
- 3 Montgomery County
- 4 Caroline Hall
- 5 February 1996
- 6 PAC Speio and Company, Towson MD 21204
- 7 13425 Old Columbia Pike. garage
- 8 5 of 9

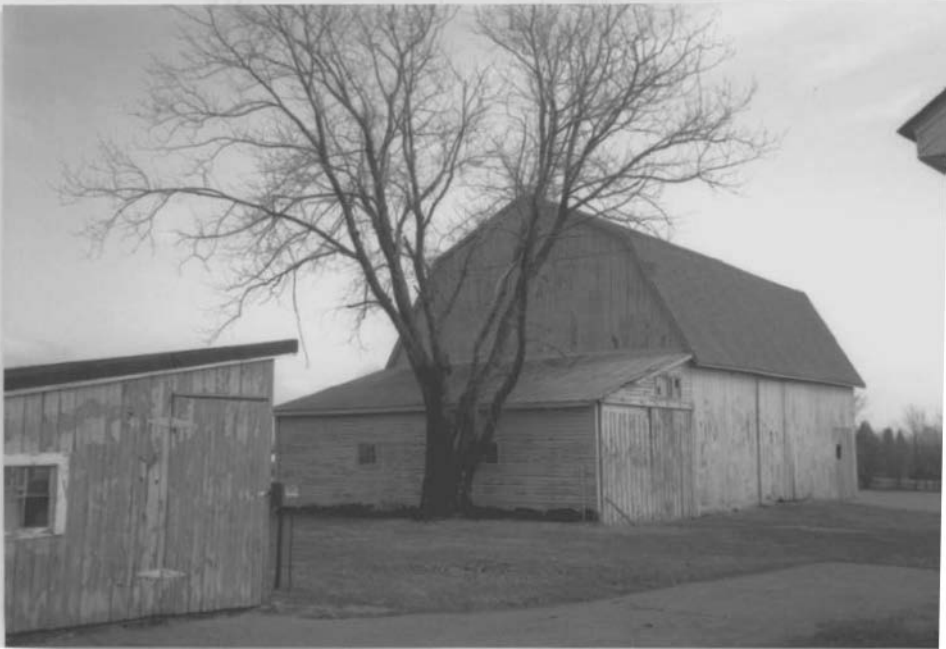
1 M. 34-16

The fourth outbuilding is a barn with a gambrel roof and vertical wood siding. Constructed circa 1910, it is located northeast of the house and garage.

7 13425 Old Columbia Pike, bairn

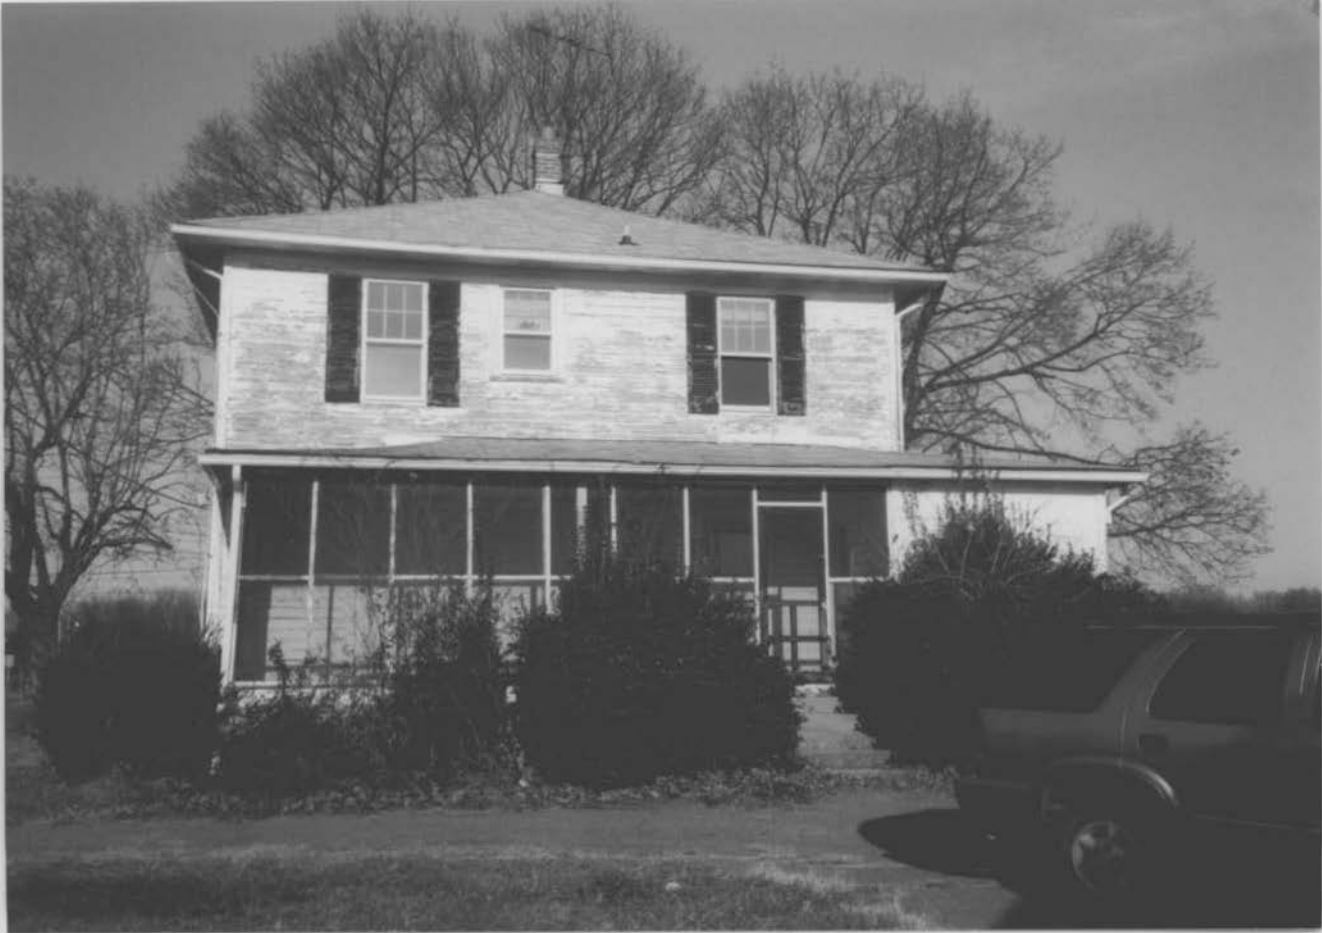
M: 34-16

The Marlow house has suffered substantial deterioration in the last two years. In the 2000 report, Marlow Property Condition Assessment and Recommendations prepared by John Milner, the front porch is described in "relatively poor condition...the northwest corner is especially damaged and is resting on temporary shoring consisting of several bricks".

SE Elevation of House Facing NW

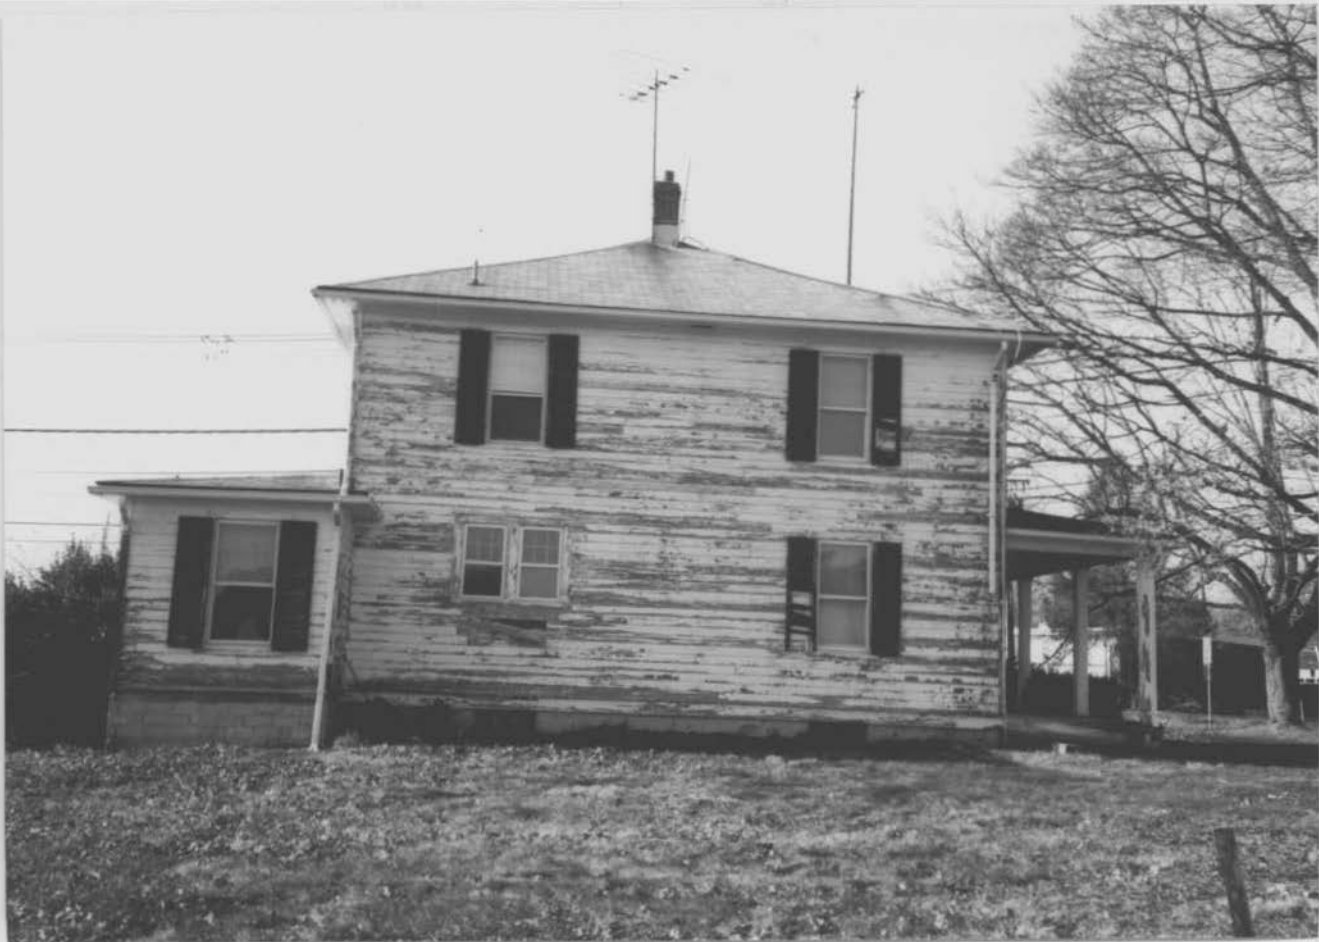
M: 34-16

NE Elevation of House Facing SW

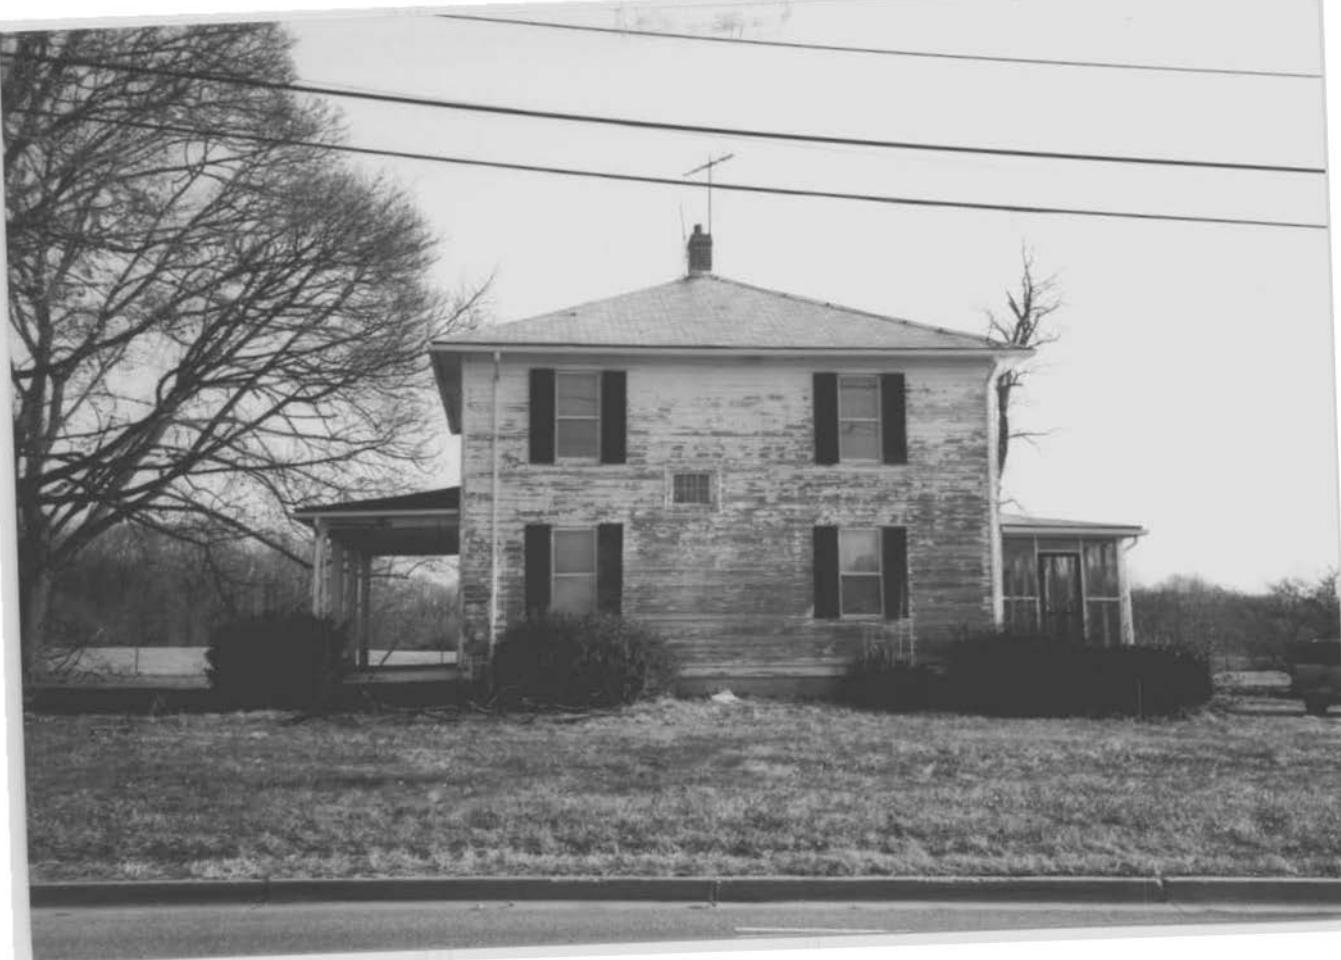
M: 34 - 16

SW Elevation of House Facing NE

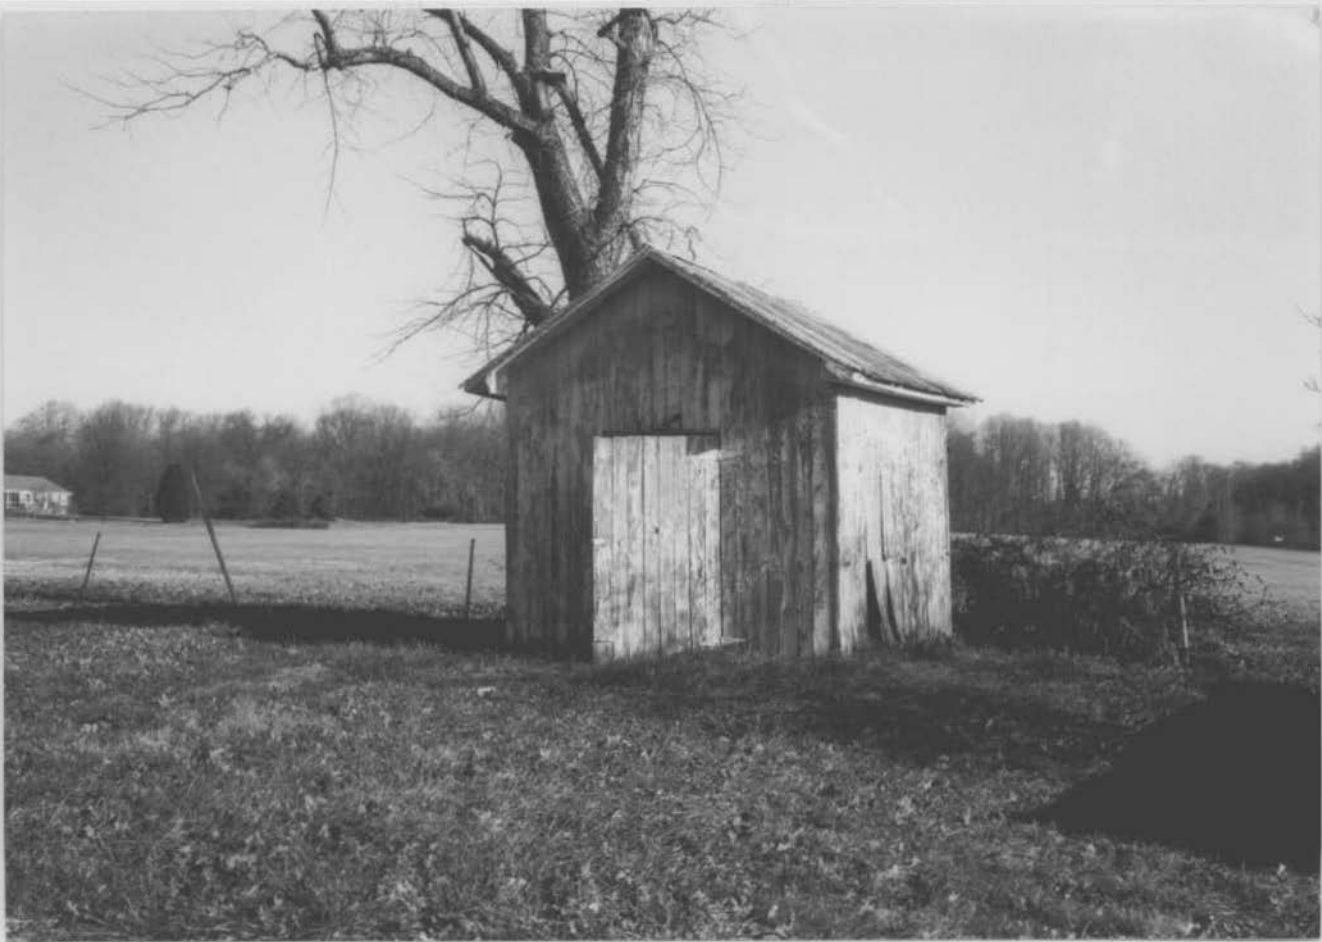
M: 34-16

S and SE Elevations of Shed #3 Facing N  
5/31

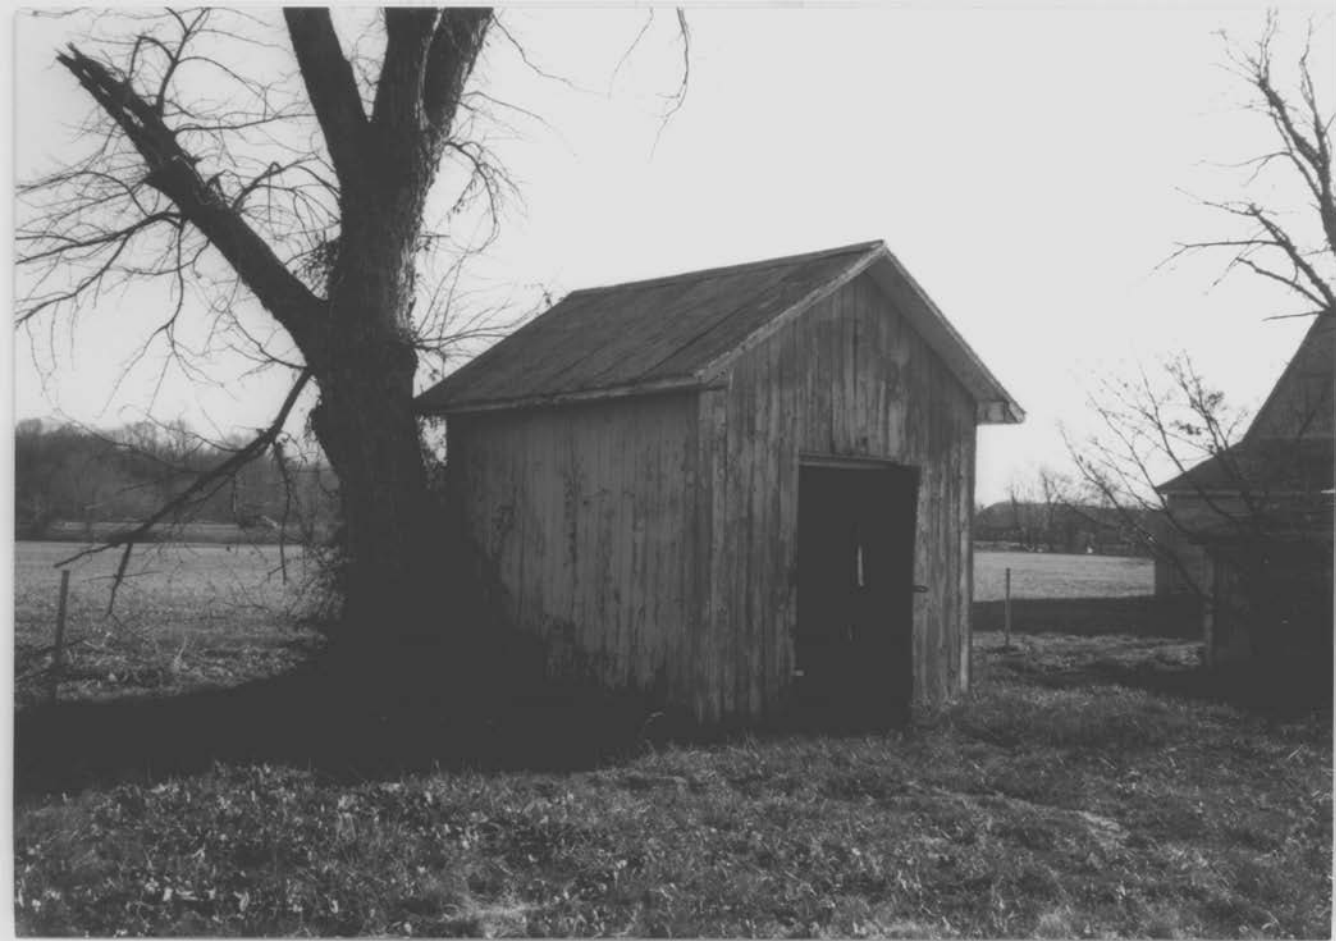
W: 34-16

NW and SW Elevations of Shed #3 Facing NE.

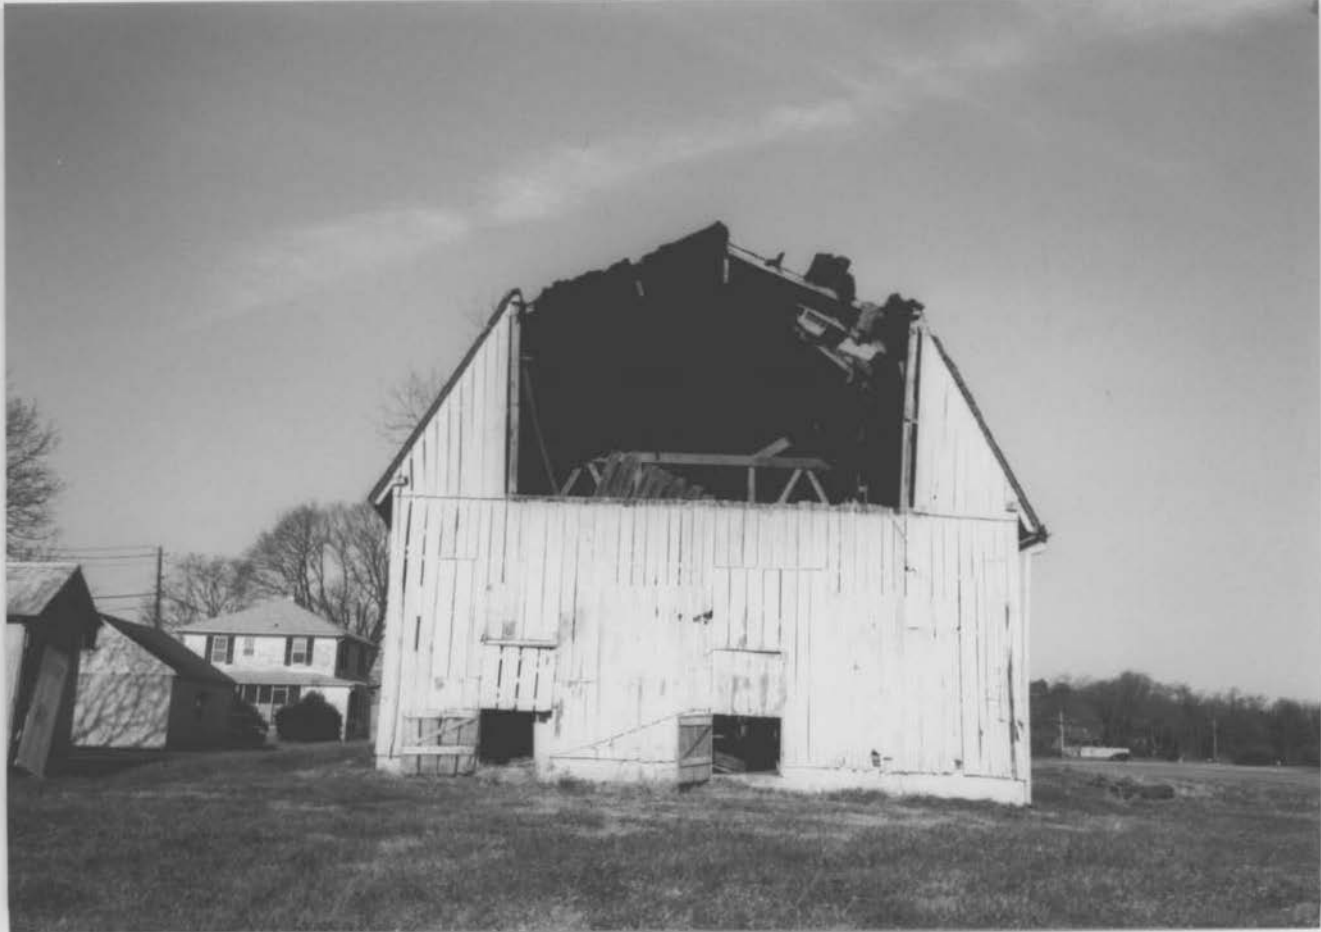
M: 34-16

The barn is a one and one-half story frame gambrel-roof barn. It has large double wagon doors on its southwest and northeast sides. It has Dutch doors on its southeast end. It may have also had a hay hood on its southeast end, but deterioration has obscured its original form. A one-story shed, possibly used for milking is located on its northwest end.

SE Elevation of Barn Facing NW

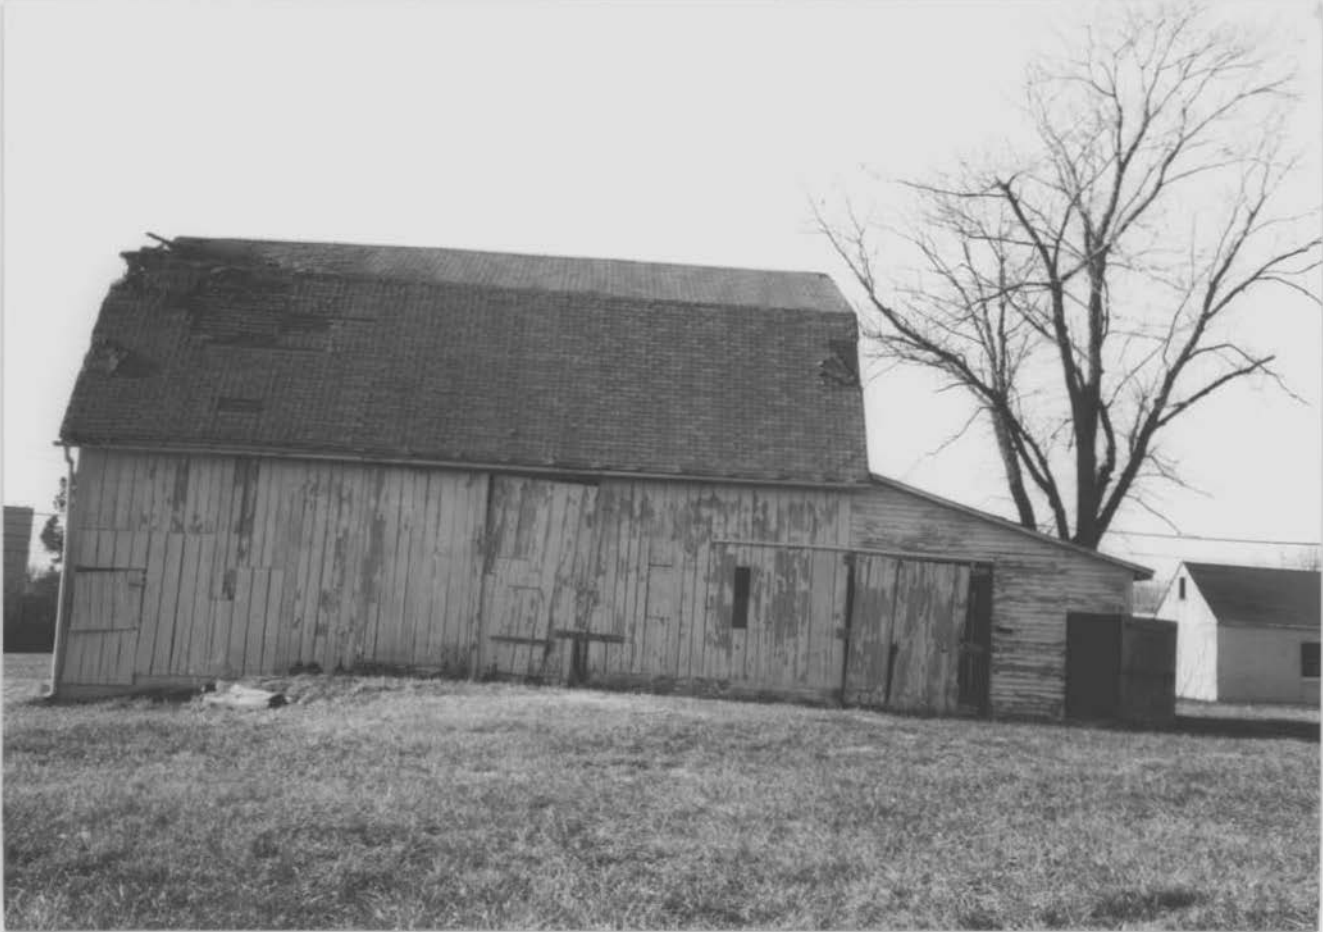
M: 34-16

NE Elevation of Barn Facing SW

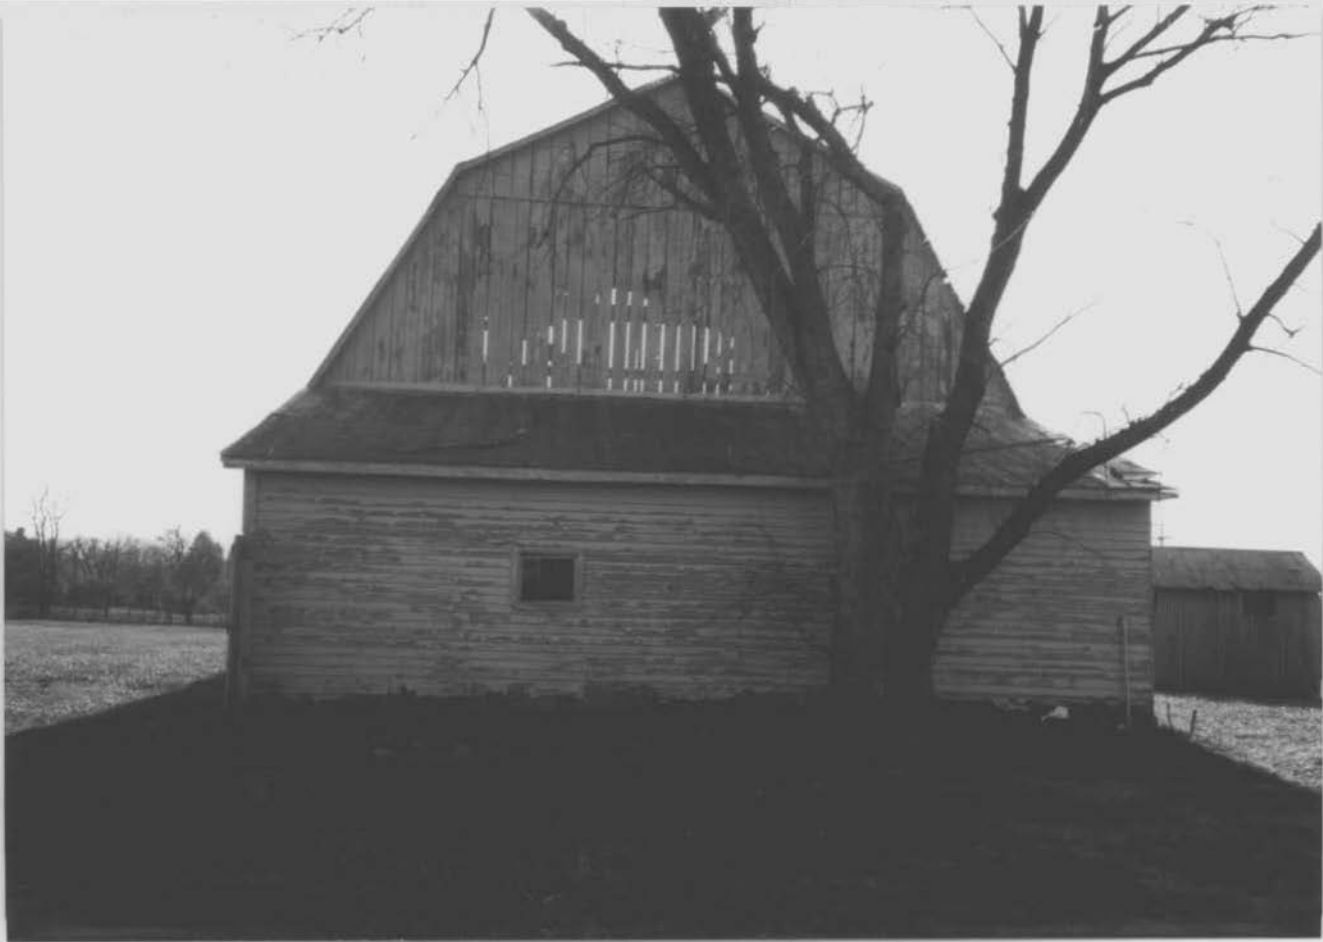
11234-16

NW Elevation of Barn Facing SE
