ACHS SUMMARY FORM

1. Name Neelsville Presbyterian Church
2. Planning Area/Site Number 19/5
3. MNCPPC Atlas Reference Map 7
F-12
4. Address 20701 Frederick Road, Germantown

INVENTORY FORM FOR STATE HISTORIC SITES SURVEY

HISTORIC **Neelsville Presbyterian Church**

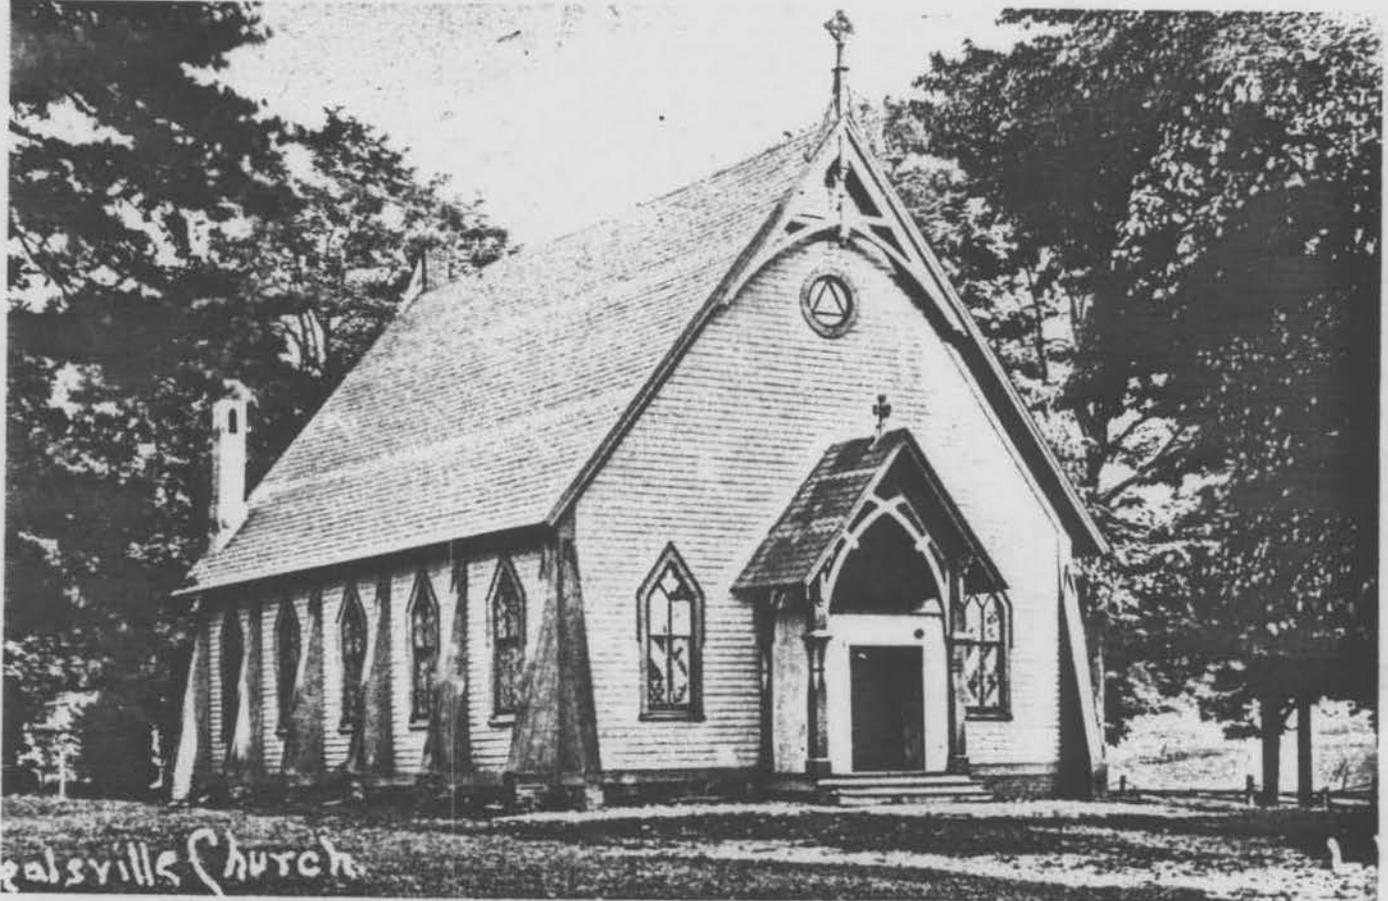
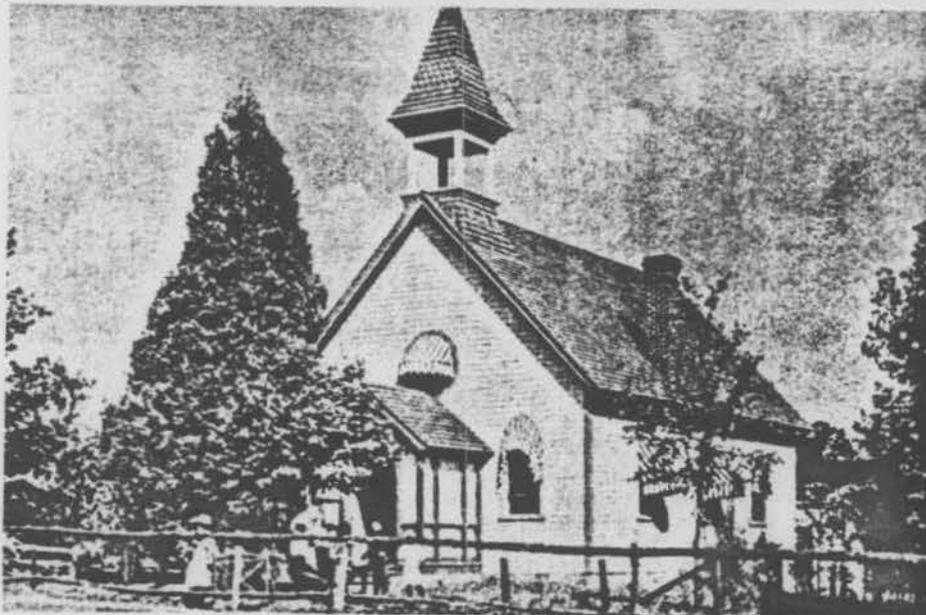
In 1849 a road was constructed in Montgomery County connecting two Presbyterian congregations, one at Nealsville (later Neelsville) and one at Darnestown. Later, the stained-glass windows and expensive archi-

tectural details were added to the Neelsville Presbyterian Church, reflecting the prosperity of the railroad era. Courtesy of Idella Leaman
