TO: Mitra Pedoeem
Department of Permitting Services
FROM: Michael Kyne
Historic Preservation Section
Maryland-National Capital Park & Planning Commission
SUBJECT: Historic Area Work Permit #962667: Removal of six (6) trees

Applicant: Town of Garrett Park
Address: 10814 Kenilworth Avenue, Garrett Park

Remove six diseased trees and replace a deteriorating fence with a like quality cedar fence. 6' tall along north side. 3' tall with gate along west side.

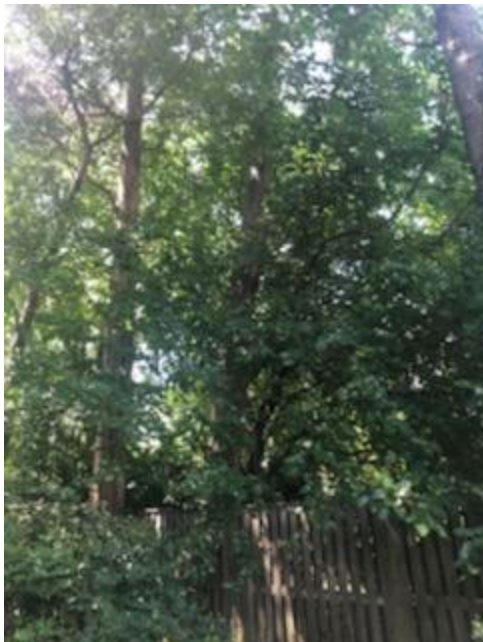
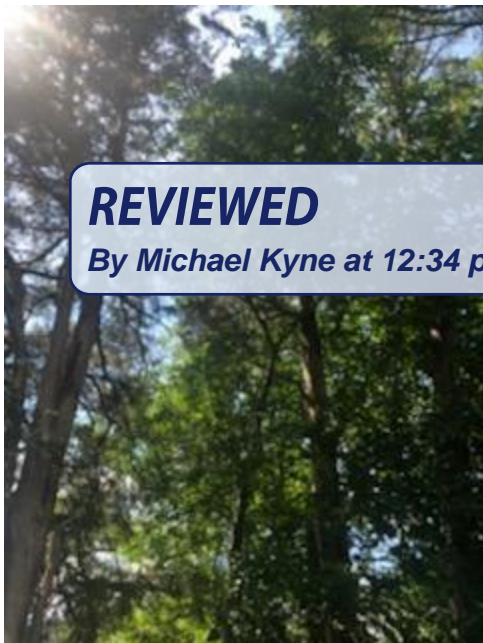
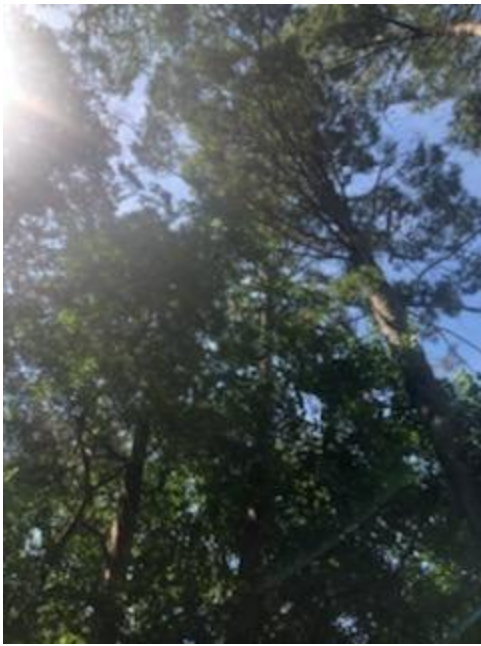
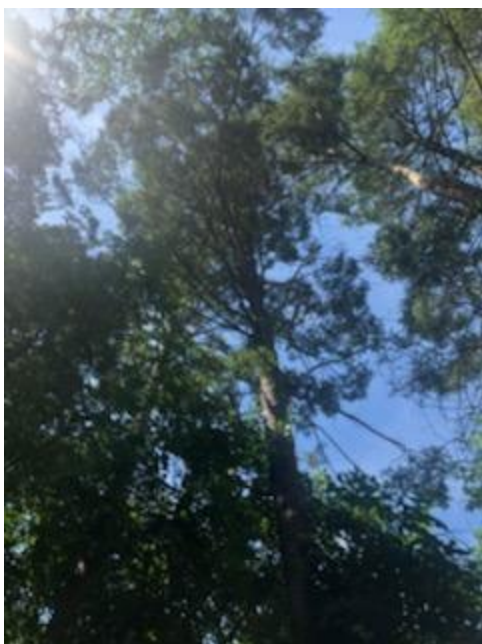
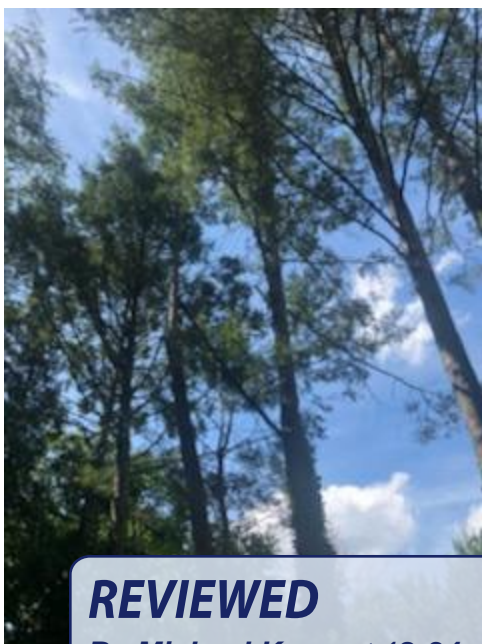
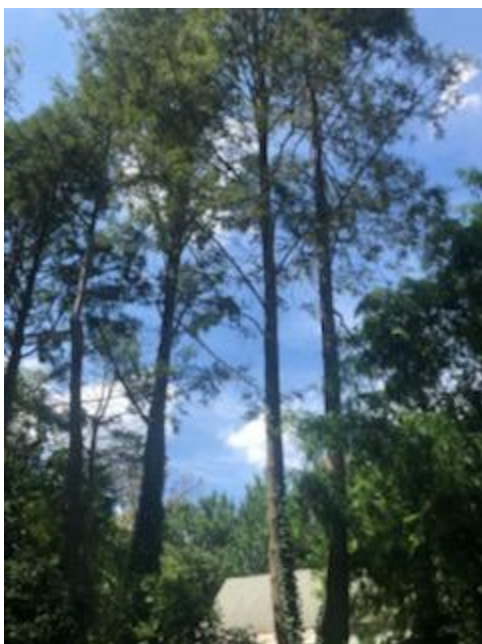
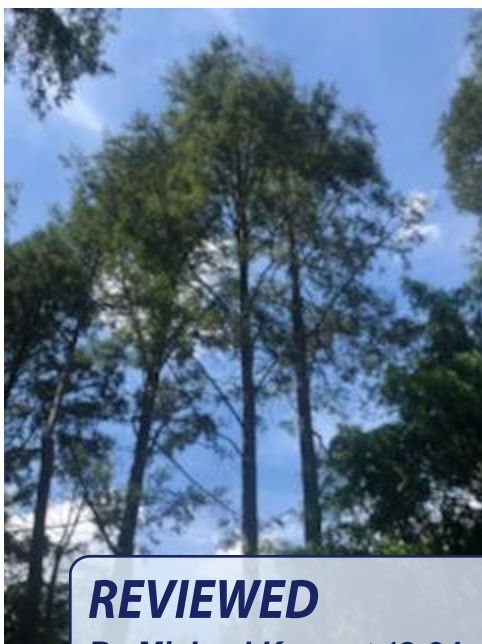
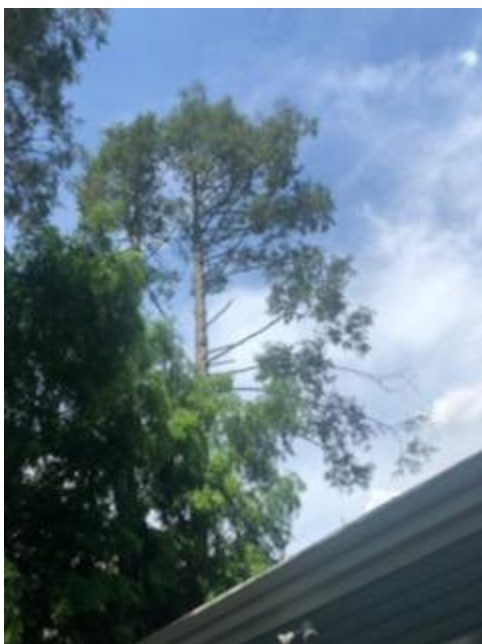
TREE PICTURES

The fence is in poor condition and needs to be replaced.

In regards to the historic property at 10814 Kenilworth. There is a line of five (5) hemlocks and a cherry along the side of the property that were assess on June 21,2021

22" DBH Hemlock, Canadian (Eastern) (*Tsuga canadensis*), decline from scale, lean over fence and property, significant deadwood, decay in main lead(s), aging supplemental support system

19" DBH Hemlock, Canadian (Eastern) (*Tsuga canadensis*), decline from scale, lean over fence and property, significant deadwood, decay in main lead(s),

36" DBH Twin Stem Hemlock, Canadian (Eastern) (*Tsuga canadensis*), decline from scale, lean over fence and property, significant deadwood, decay in main lead(s), aging supplemental support system

38" DBH Twin Stem Hemlock, Canadian (Eastern) (*Tsuga canadensis*), decline from scale, lean over fence and property, significant deadwood, decay in main lead(s), aging supplemental support system

39" DBH Twin Stem Hemlock, Canadian (Eastern) (*Tsuga canadensis*), decline from scale, lean over fence and property, significant deadwood, decay in main lead(s), aging supplemental support system

6" DBH Cherry, Japanese Flowering (*Prunus serrulata*), significant lean over property

The deteriorating fence will be replaced with a like quality cedar fence. 6' tall along north side. 3' tall with gate along west side (see attached photos).

It is our recommendation that these trees be removed. Please feel free to contact me with any questions. Thank you.
