MEMORANDUM

TO:	Mitra Pedoeem
	Department of Permitting Services
FROM:	Michael Kyne
	Historic Preservation Section
	Maryland-National Capital Park & Planning Commission
SUBJECT:	Historic Area Work Permit #961927: New vent pipe

work will occur on the exterior at the back of the house where it's not visible from the street. 10" radon fan about 2-3 ft off the ground and 3" white pipe going up the back of the house to above the roof. Slab penetration made laterally from rear exterior.

HISTORIC AREA WORK PERMIT APPLICATION

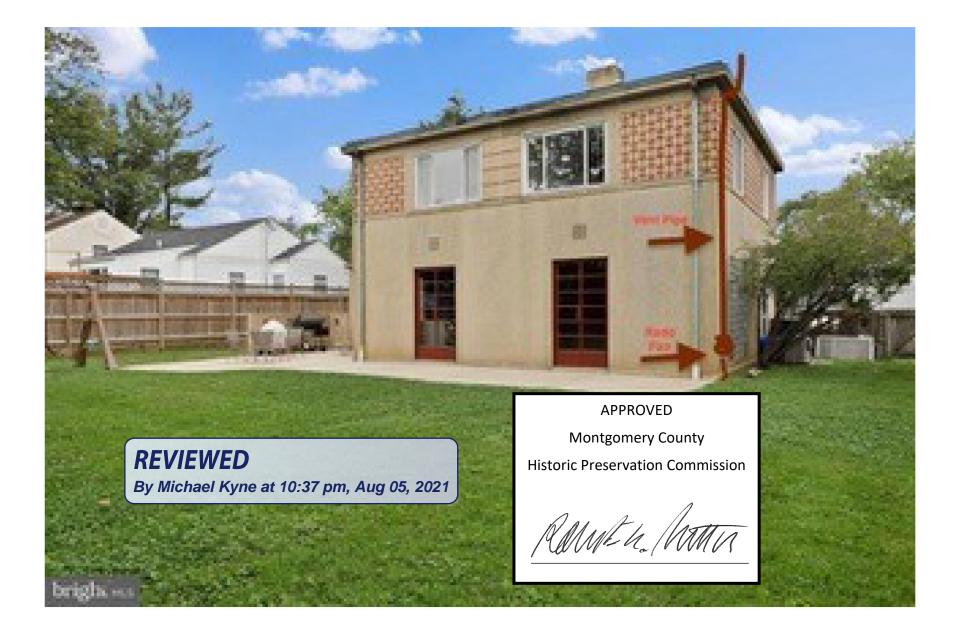
I'm not great at this kind of thing, but I hope the attached photo is sufficient for the Historical Society. Please note that the vent pipe will be straight...not slightly bent like my inexpert mark-up shows.

The radon pipe will not "pierce the exterior wall per se, rather it will go laterally under the foundation/ slab from outside, at the base of the wall, right at ground level. The pipe penetration is drilled laterally at an oblique angle to get under the slab from ground level.
