30/13-5-97A 11018 Kenilworth Ave.  
(Garrett Park Historic District)

# APPLICATION FOR HISTORIC AREA WORK PERMIT

## HISTORIC PRESERVATION COMMISSION STAFF REPORT

**PROPOSAL:** Alteration/Addition/  
Fire Damage Restoration

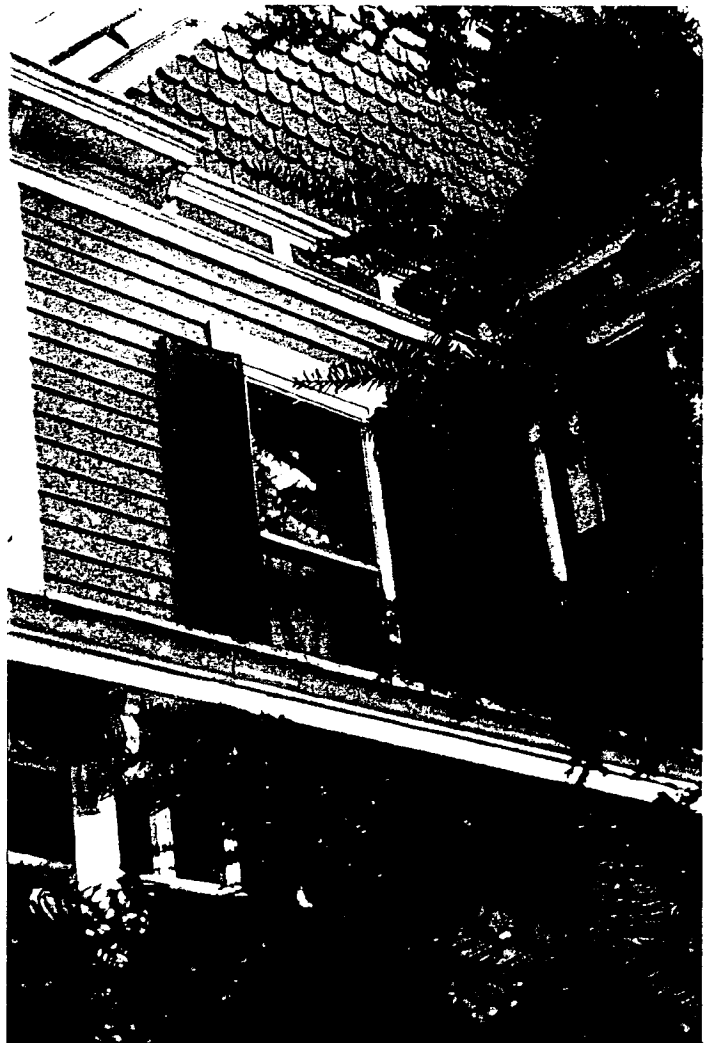
#13

Glass - All broken

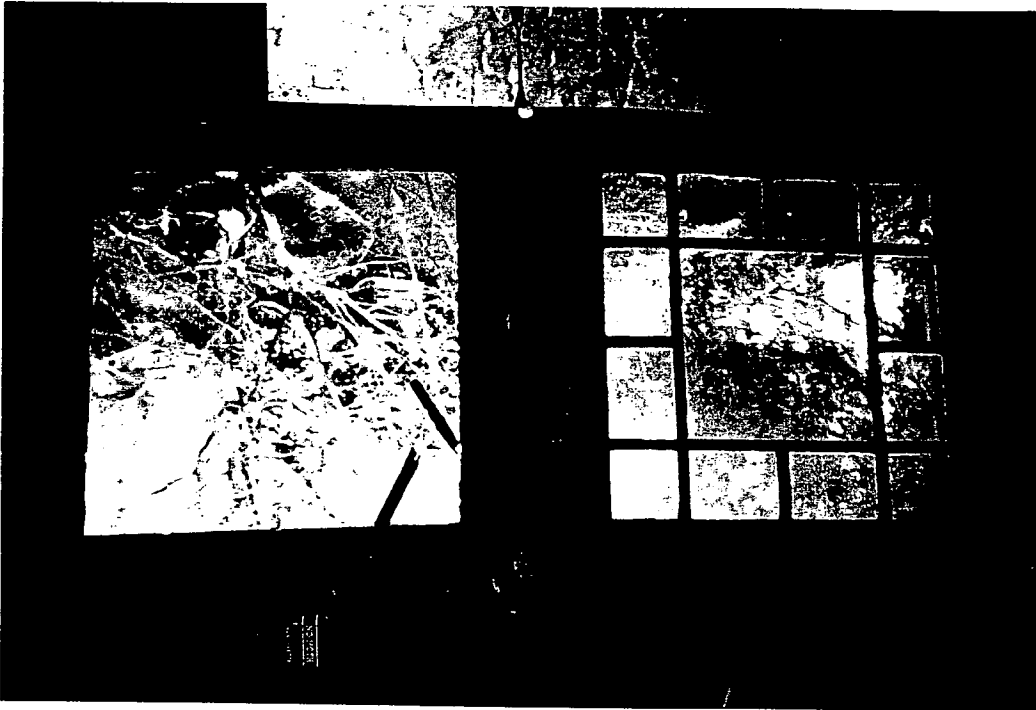
Front Gable

# 31 Action : repair, if possible

# 32 Good condition

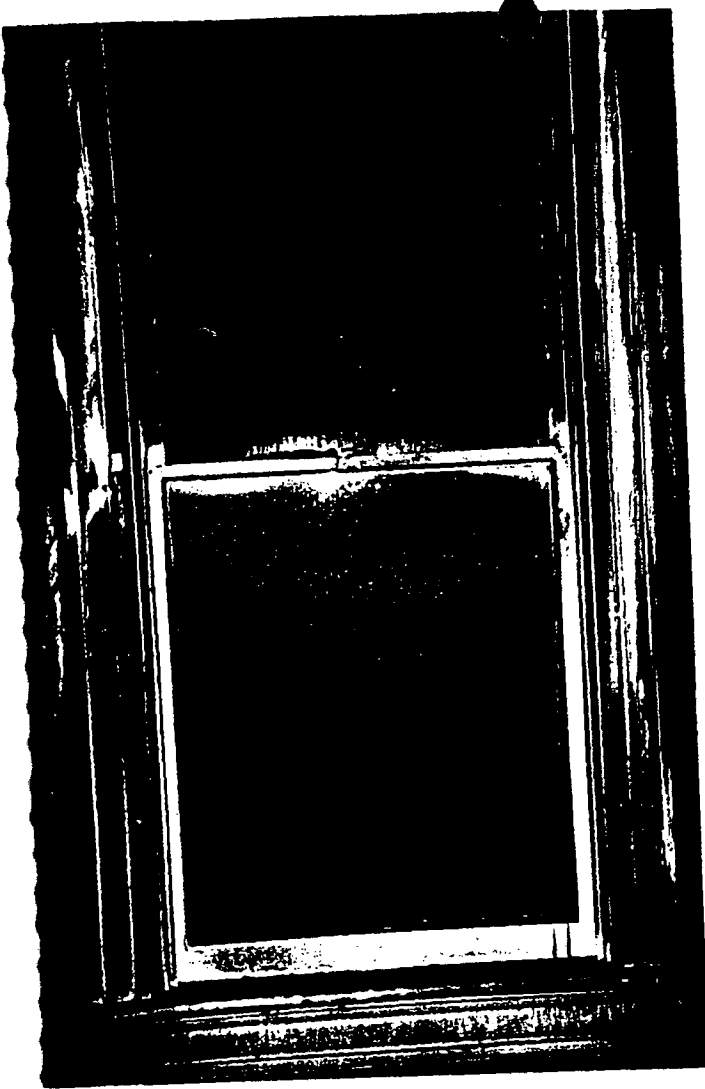
Stairwell

#13  
Glass - All broken  
Non-Operational  
Sash - heat damage  
Action - repair if possible

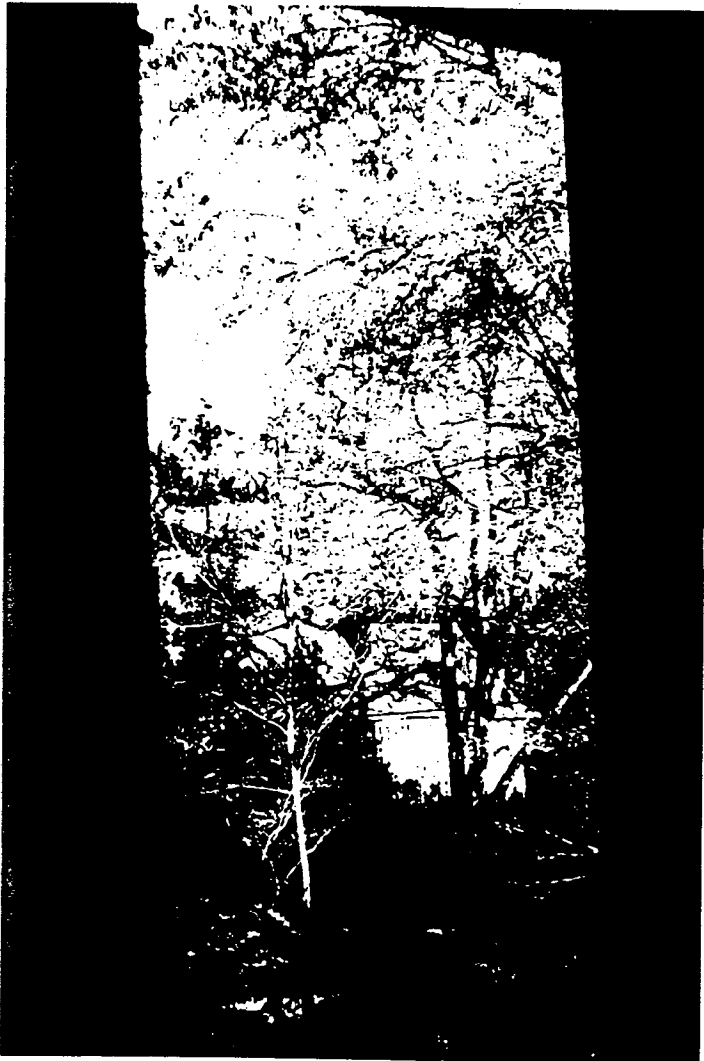
#15

Glass. All broken

Sashes: heavily damaged  
(nothing left)

Action: replace

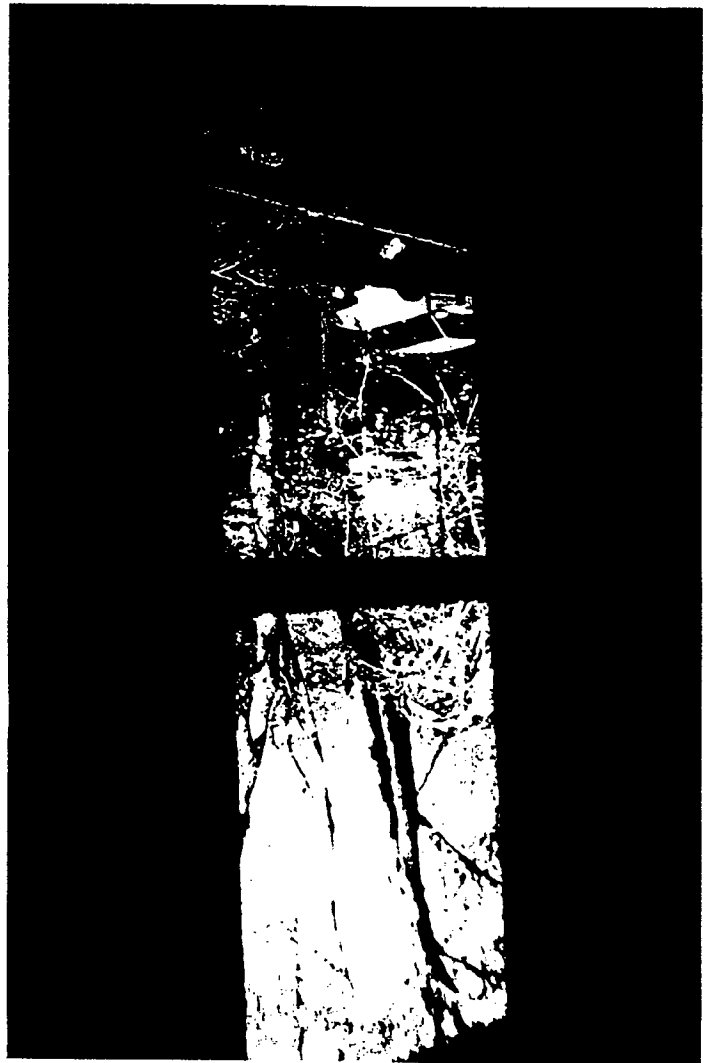
by fireman, also ref

Sashes: heavily damaged

Glass: All broken

Acron: replace

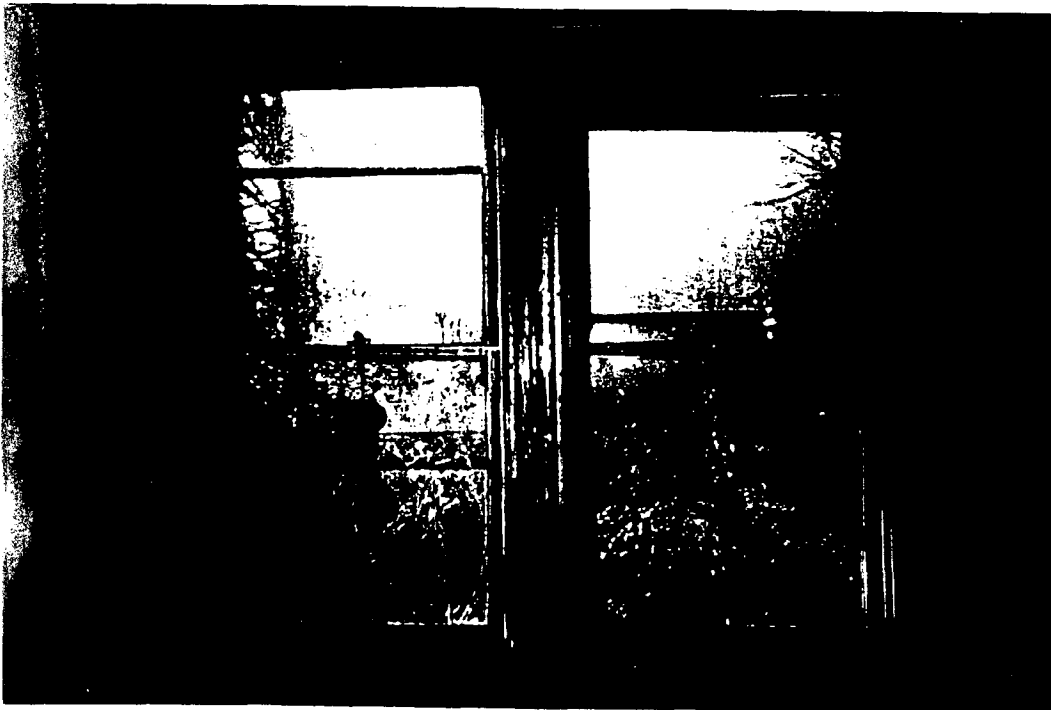
Bedroom  
#3

#24

Action:  
repair

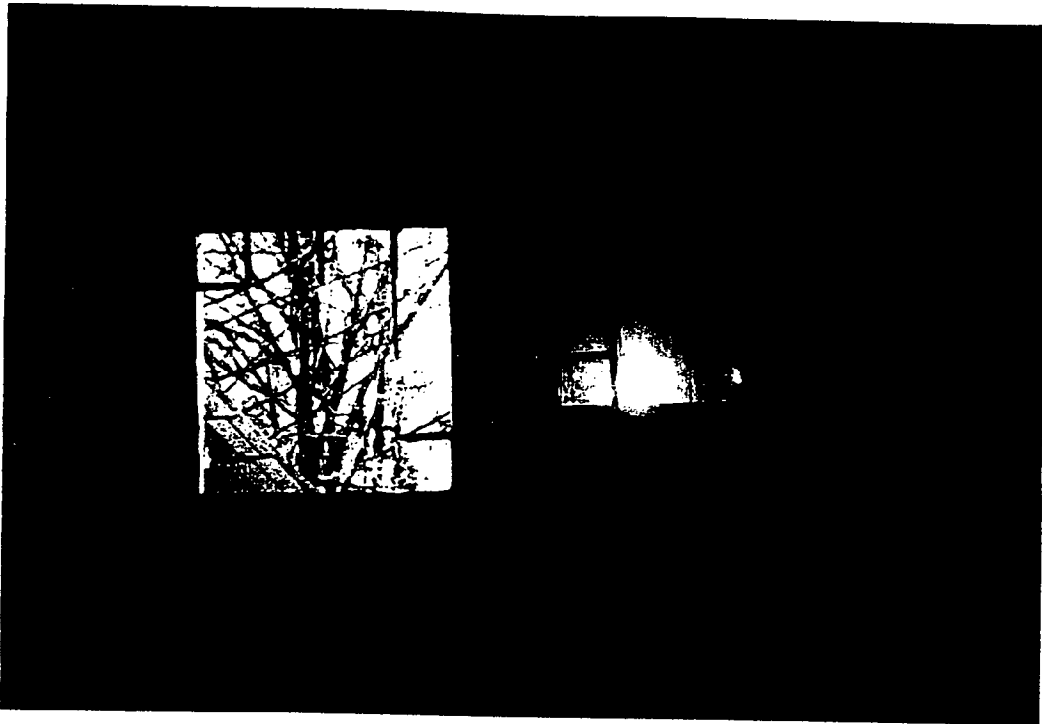
Right Gable End

#27: Damaged  
Muntins + glass  
broken

#26: Replace

Action: repair,  
if possible

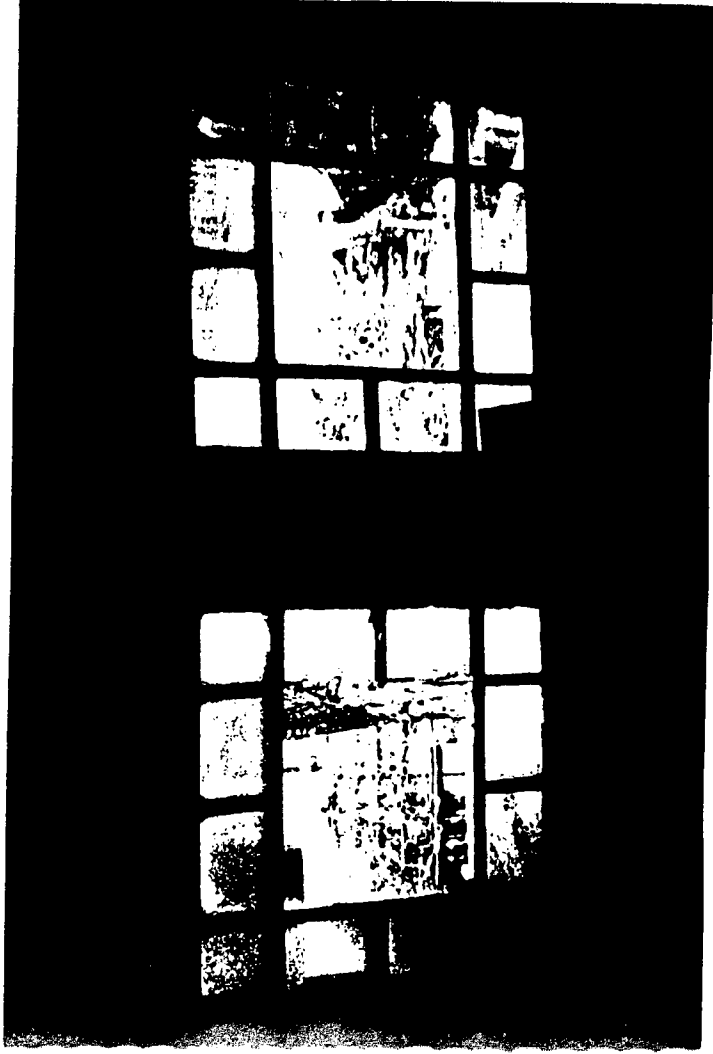
Left Gable

# 31 (left)
