10 Pine Avenue, Takoma Pk.
Preliminary Consultation

HISTORIC PRESERVATION COMMISSION STAFF REPORT

Address: 10 Pine Avenue

PROPOSAL: Demolish garage/build new garage

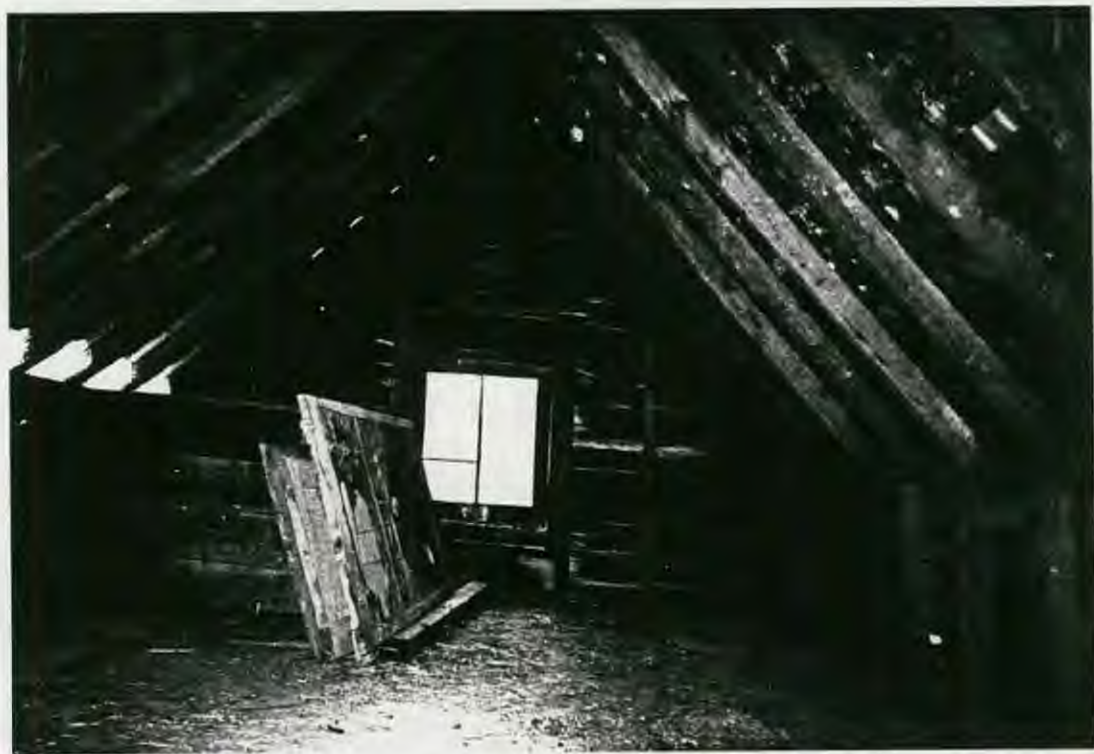
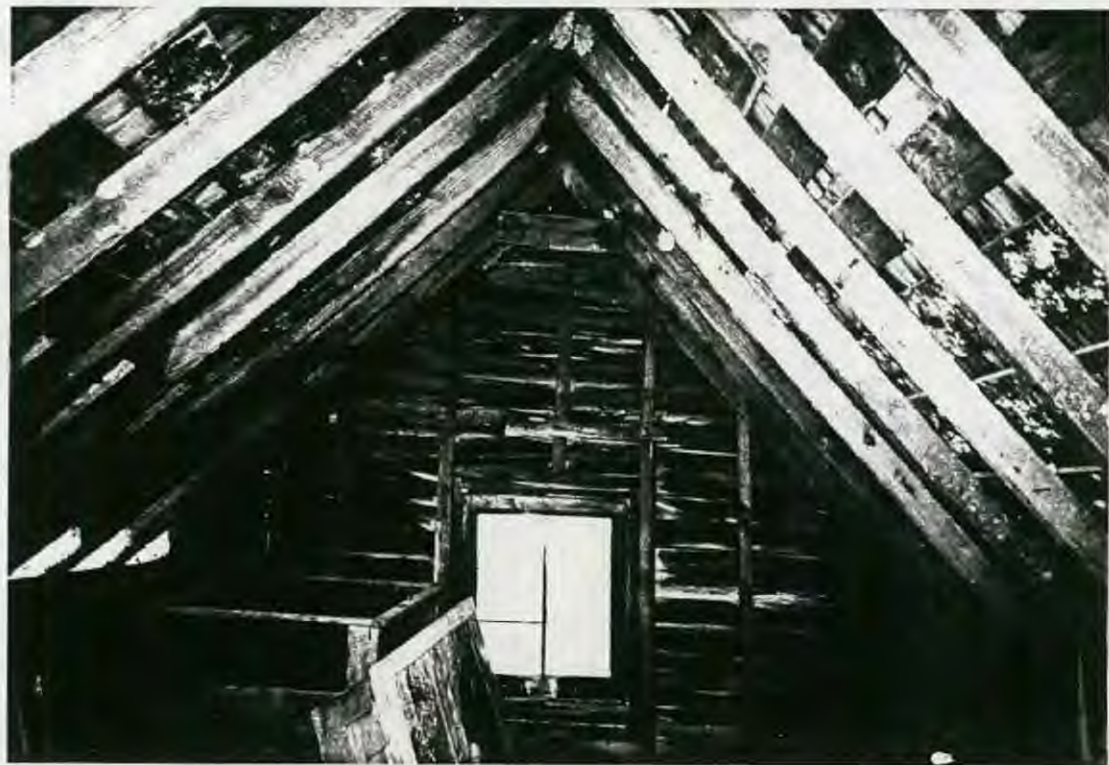
SE corner of structure
(1950 - 1951)
1000 ES

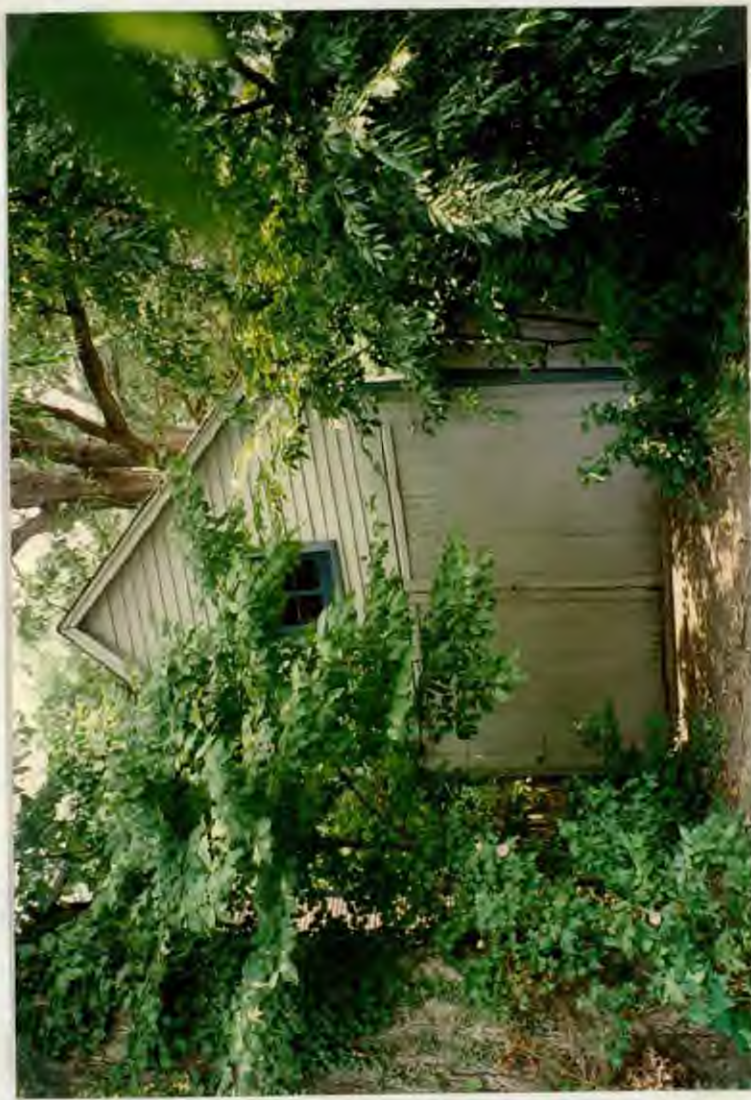
①

West →
exterior

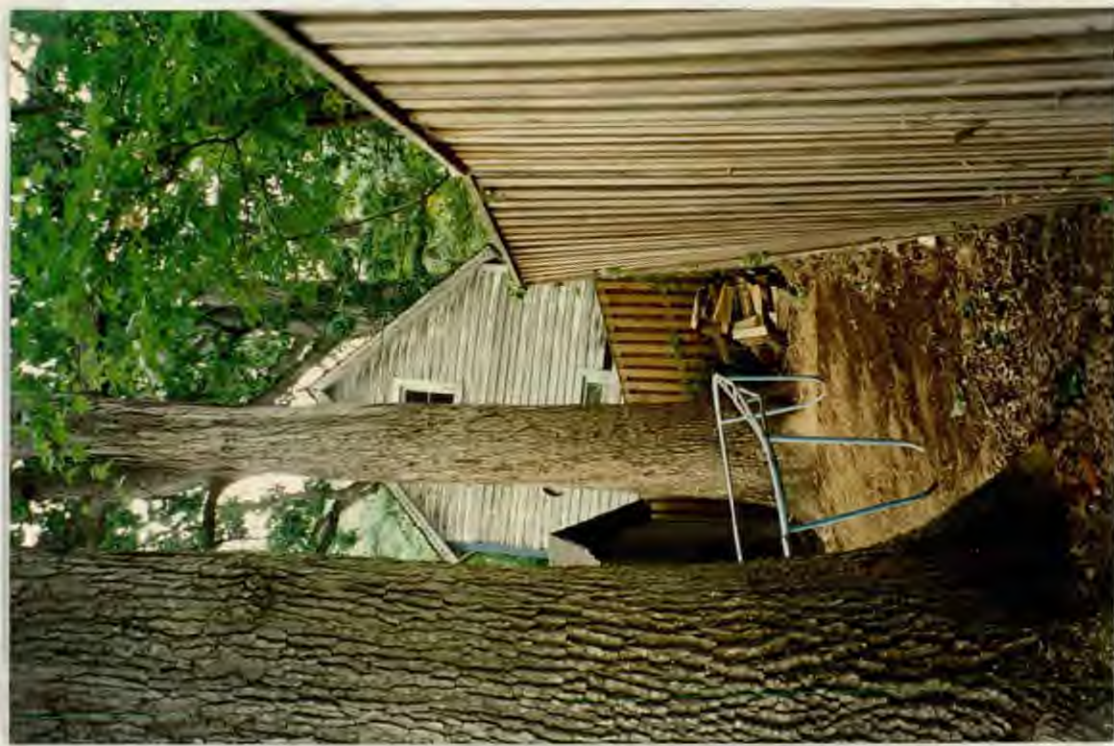
②

East →
exterior

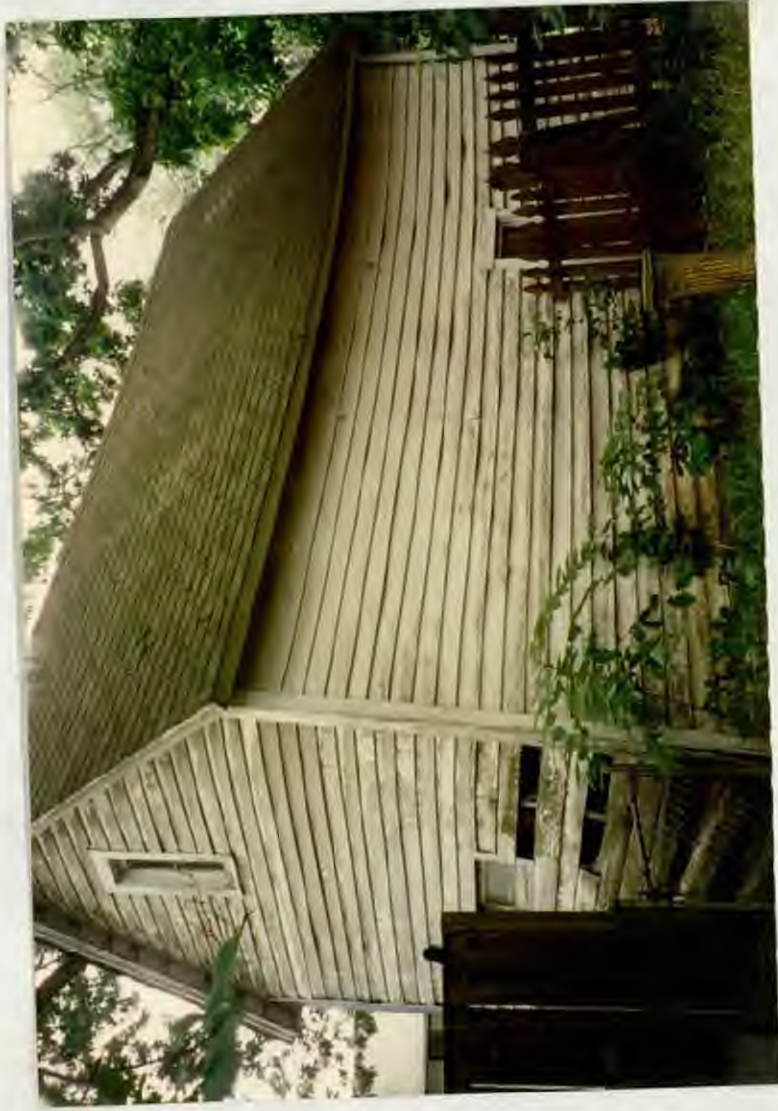
③

NE →
corner

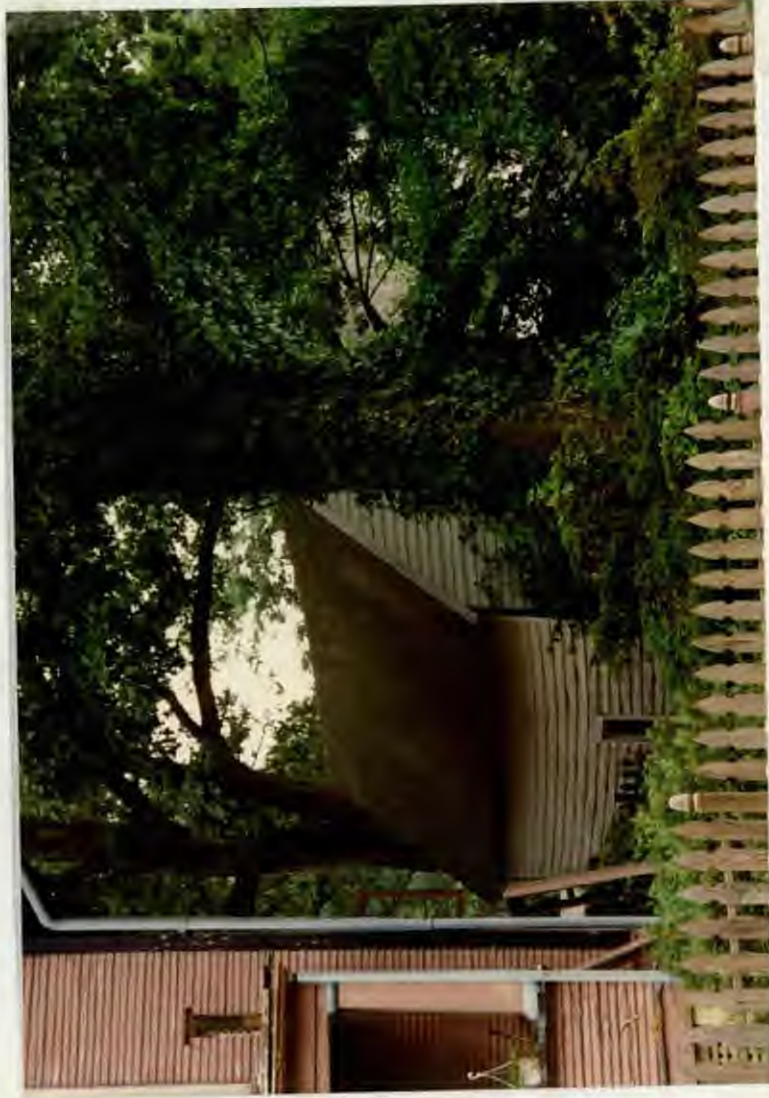
④

NW →
corner

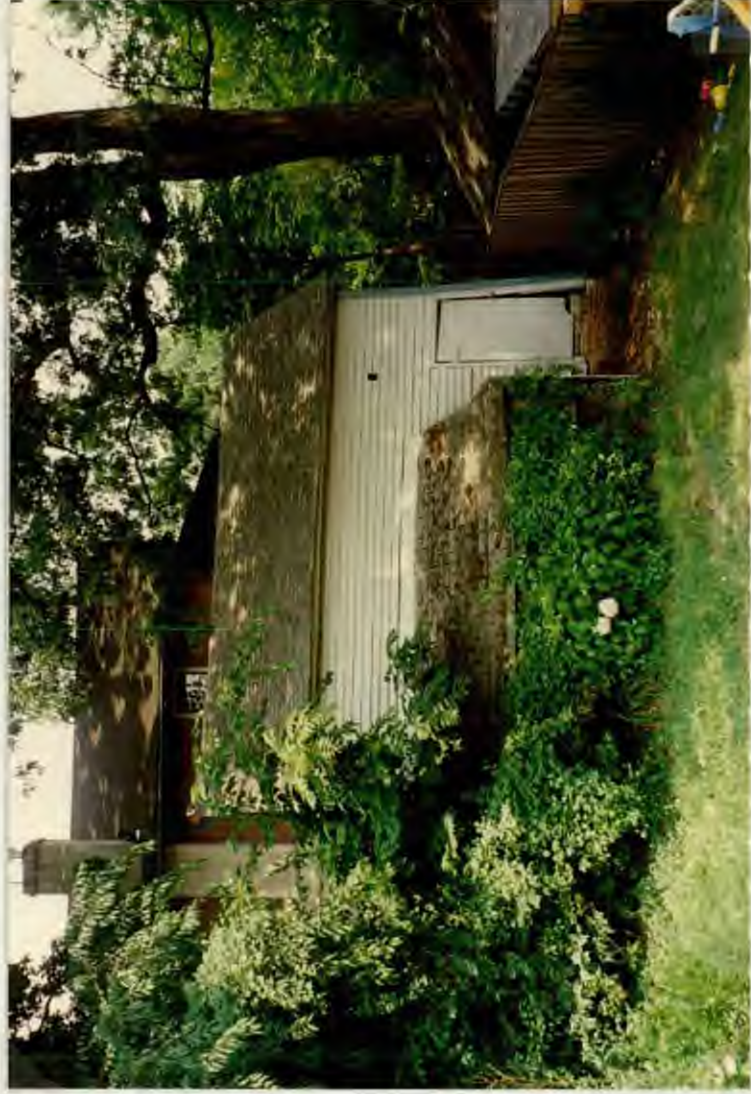
⑤

South
exterior →

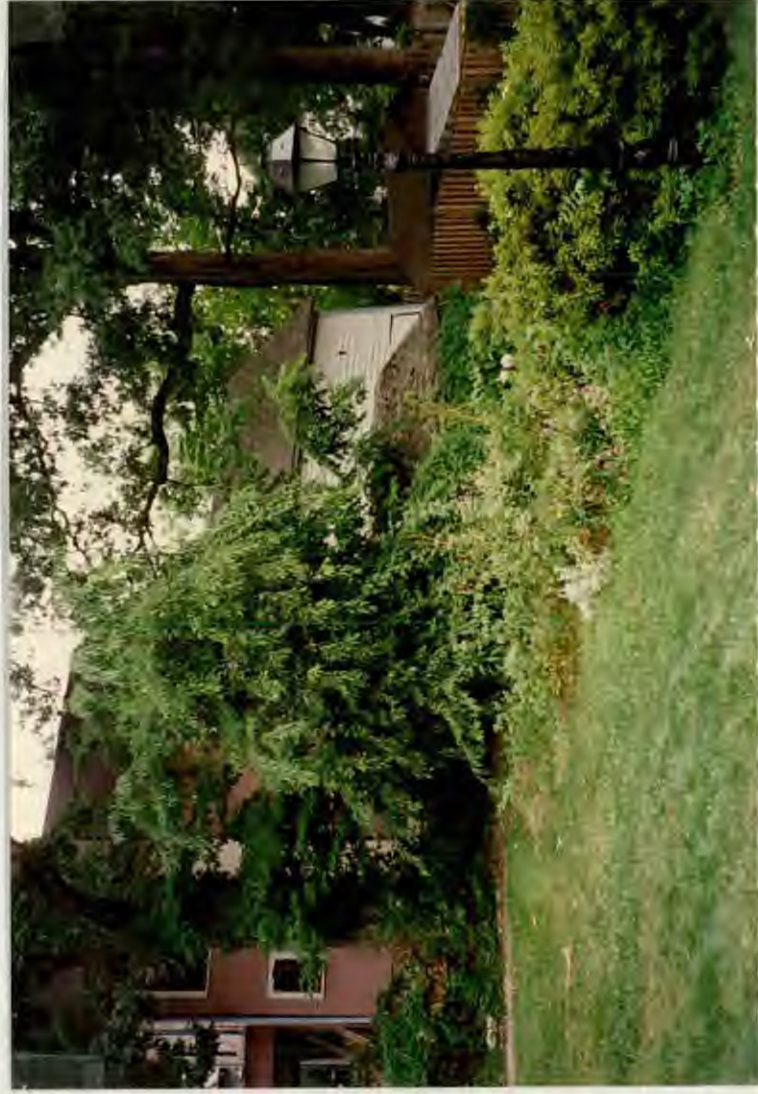
⑥

View from
SW →
(note
historic
garden)

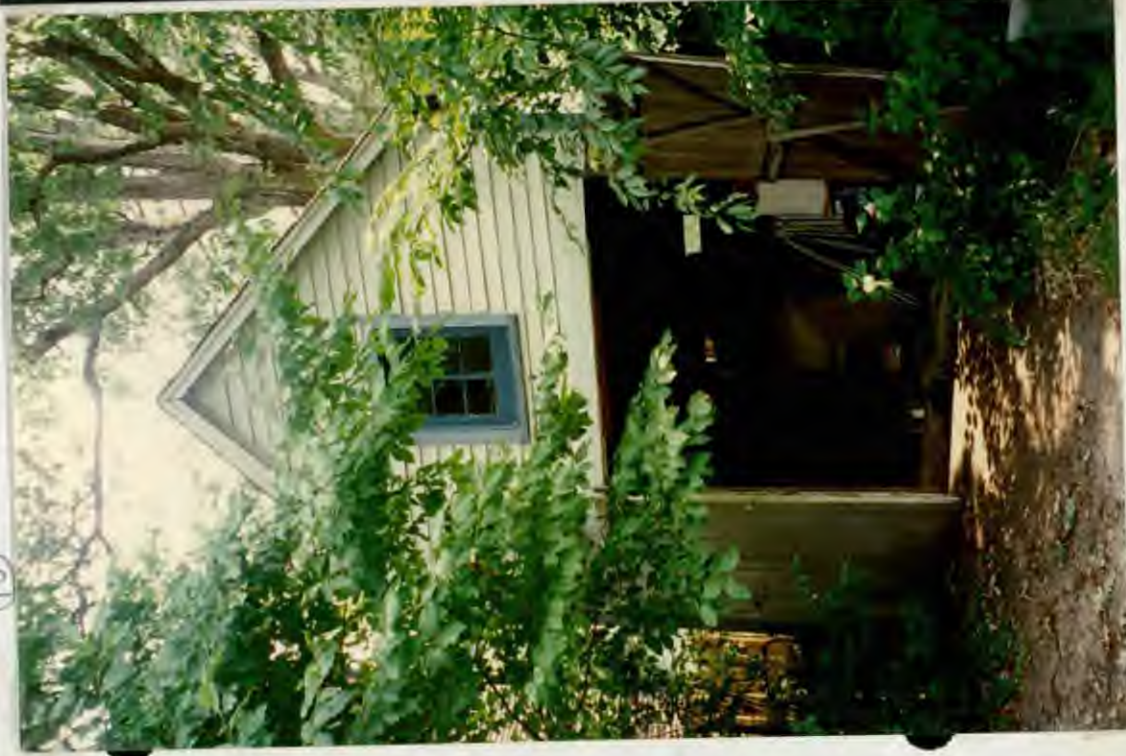
16

Interior of SW hinged door,

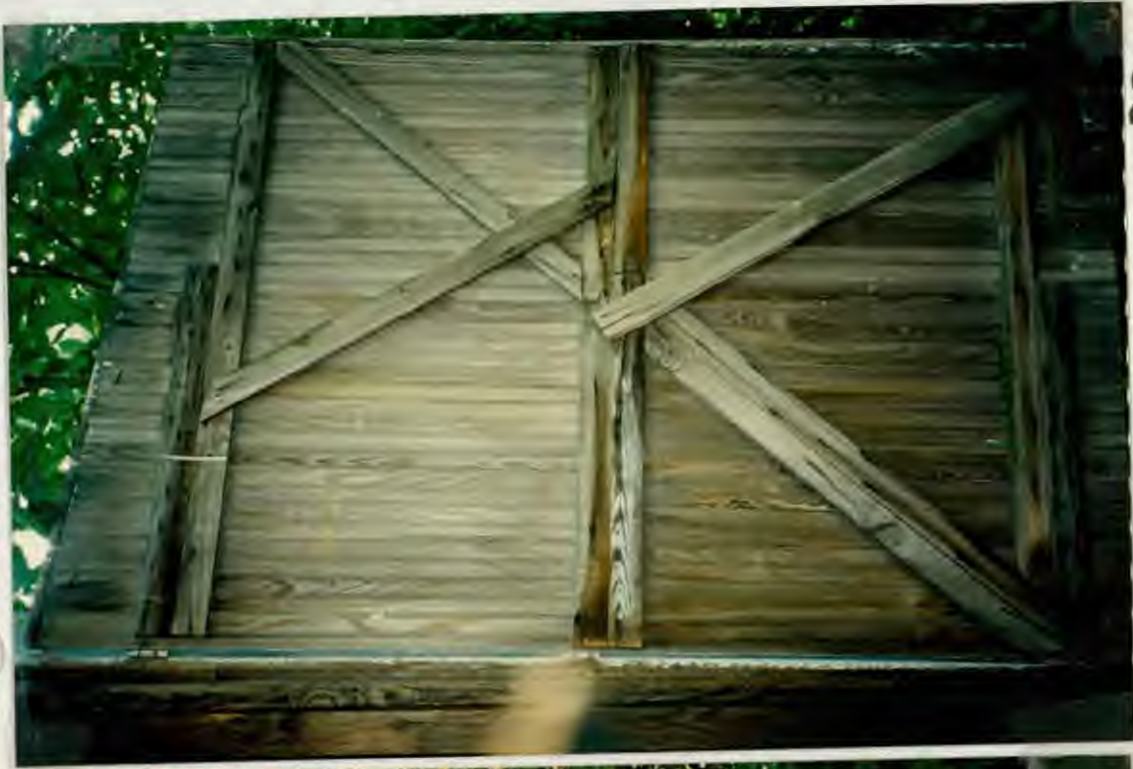
17

Exterior hinges

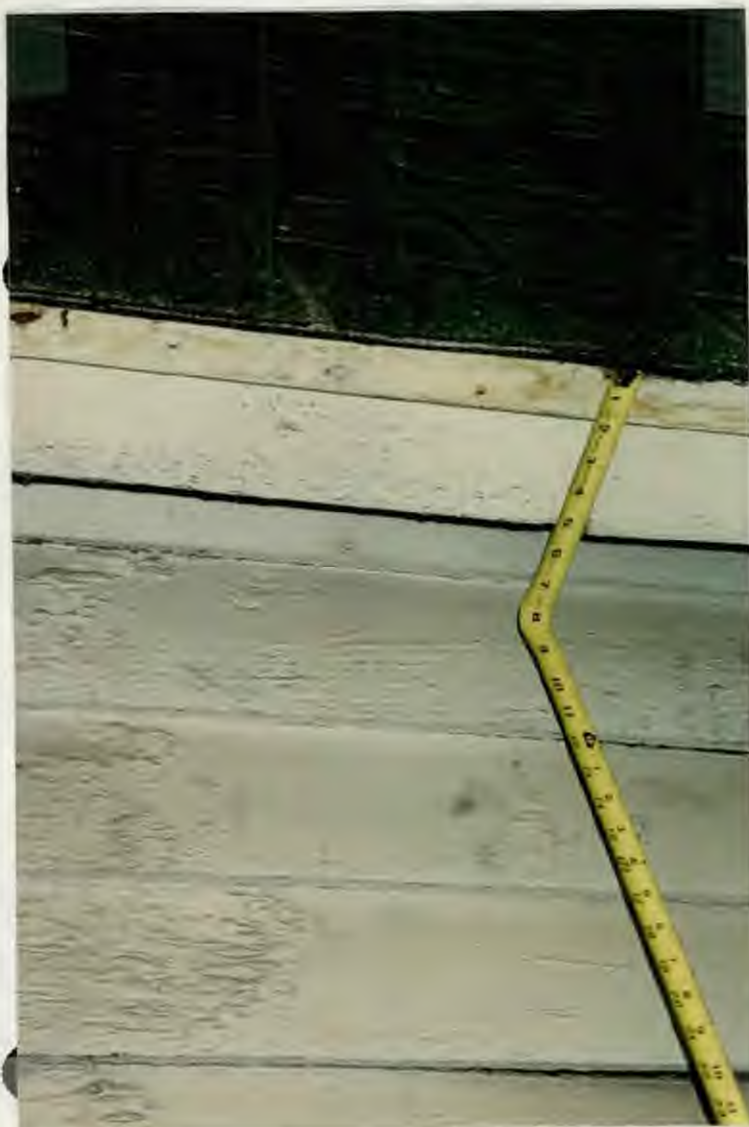
(22)

West exterior
window and eaves.

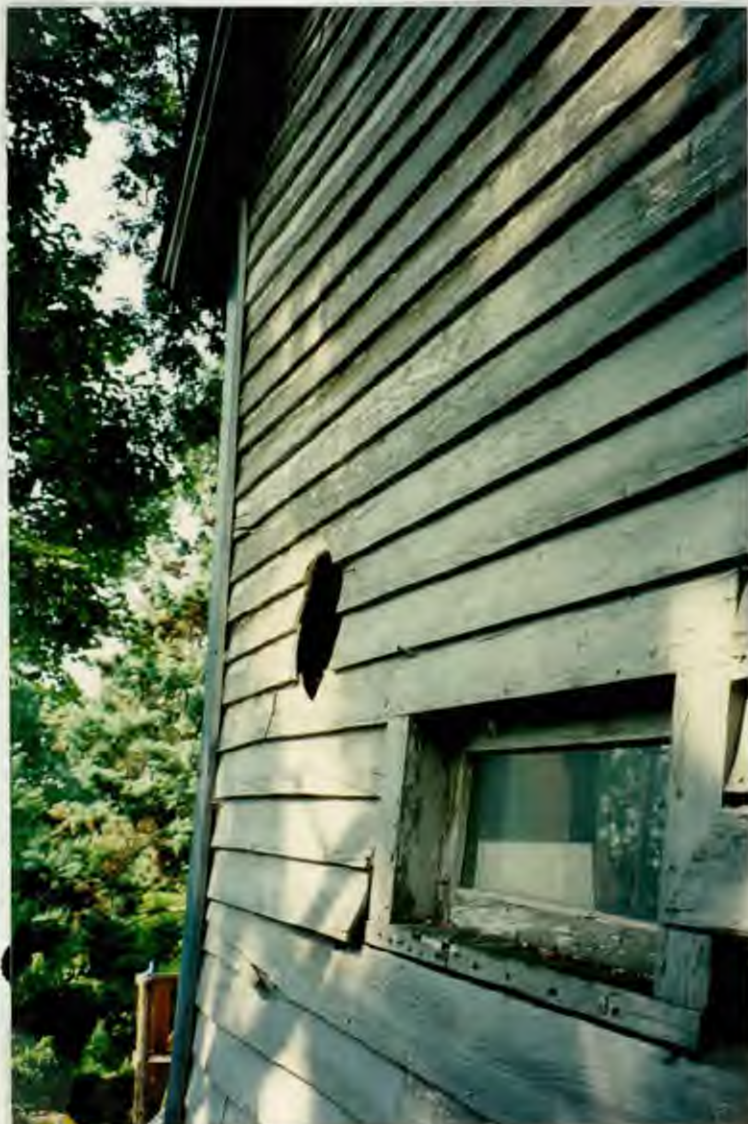
(25) East exterior
window and eaves.
↓

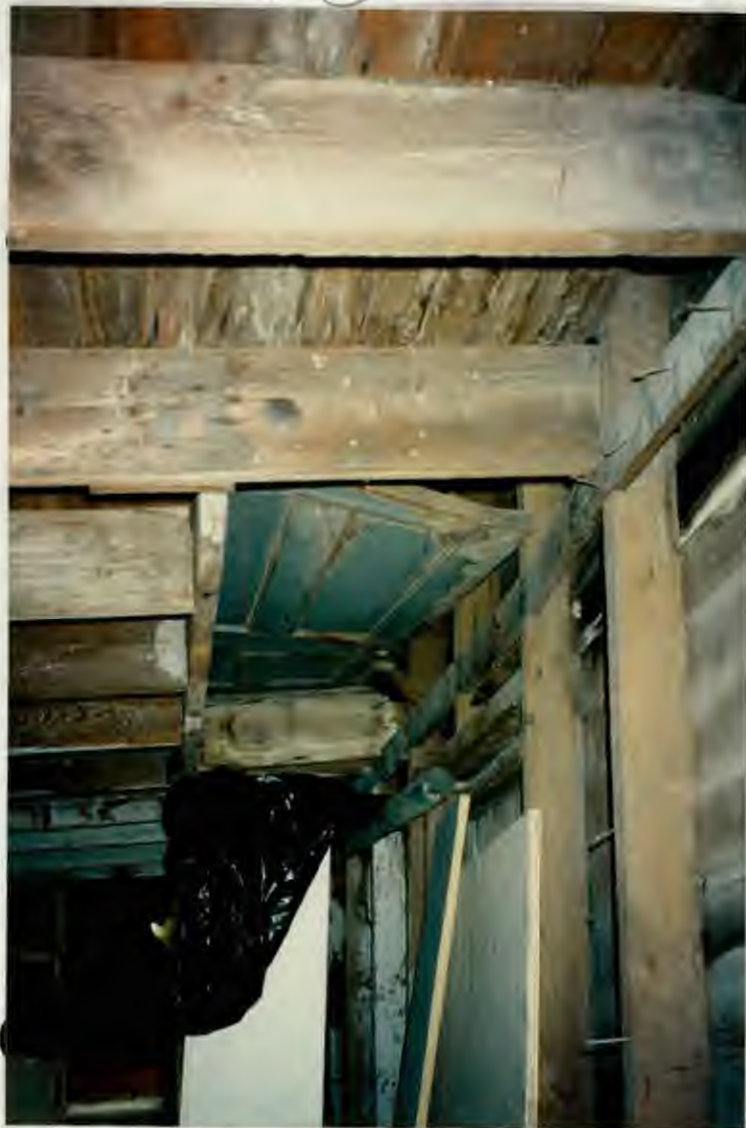
Interior of North wall and beams. (Note boarded up window). (31)

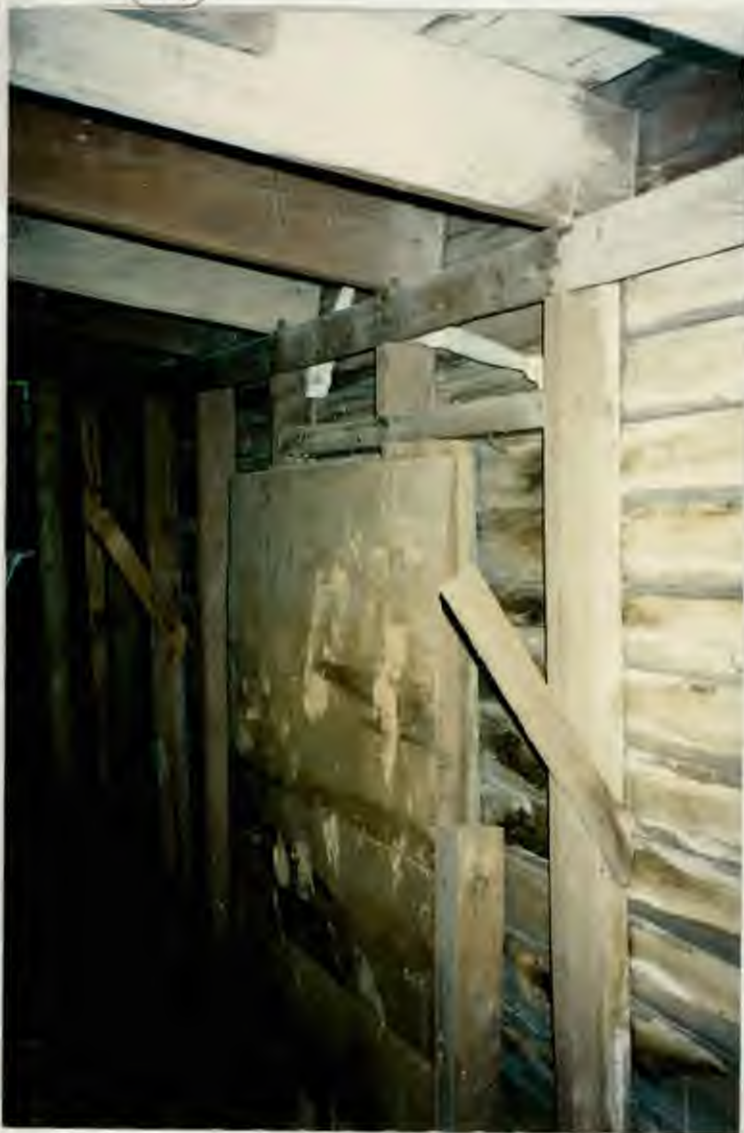
Stairs on east wall of

first floor interior. (Note covered slope
pipe hole) ↙

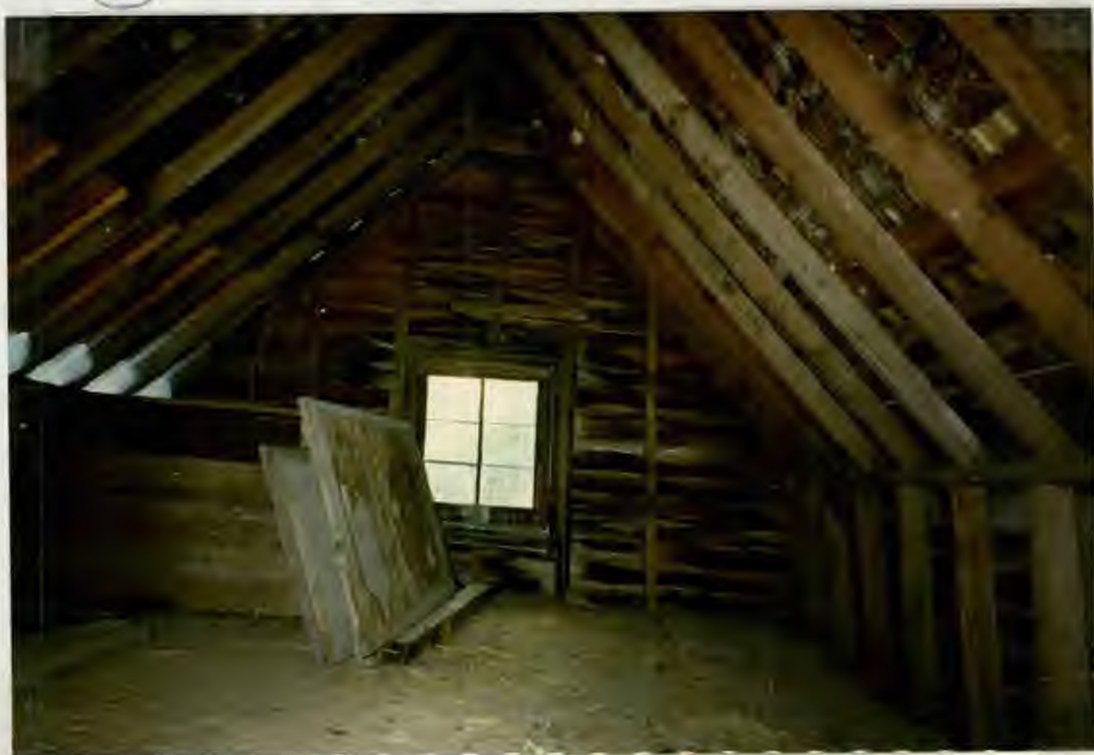
34

Interior of second Floor.
View from east to west.

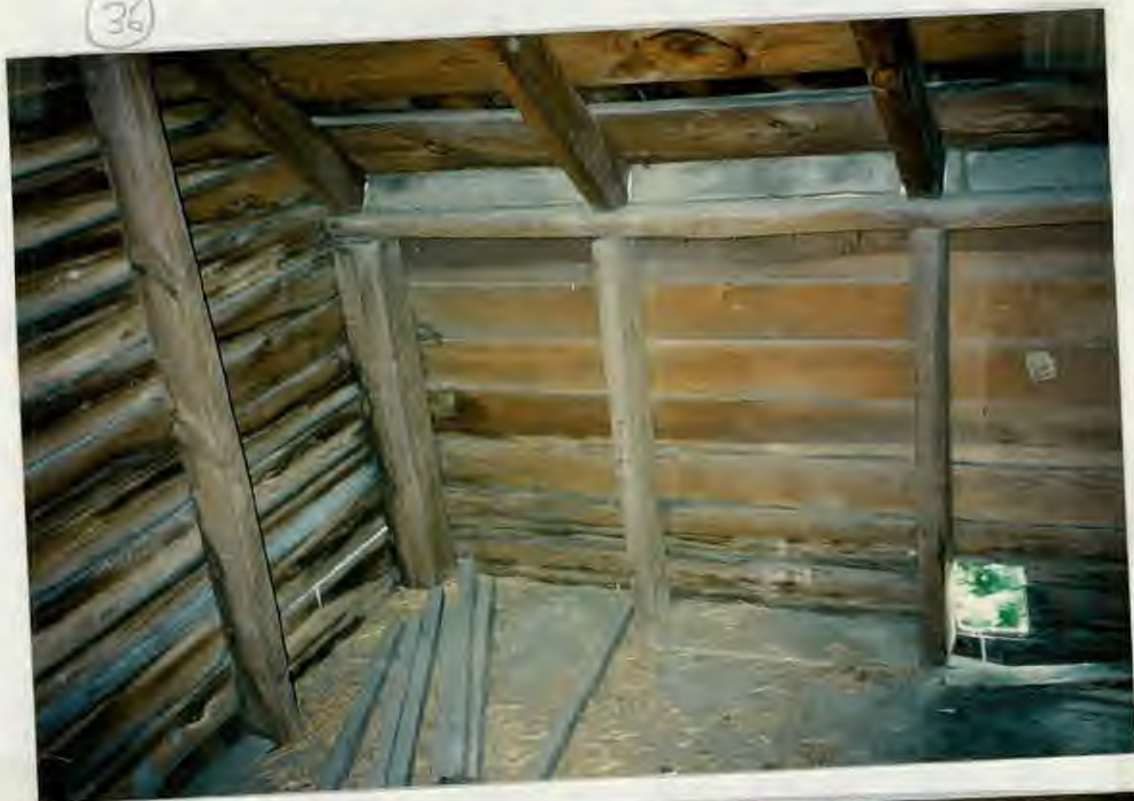
36

SE corner of second floor interior
(Note square hole in south wall)

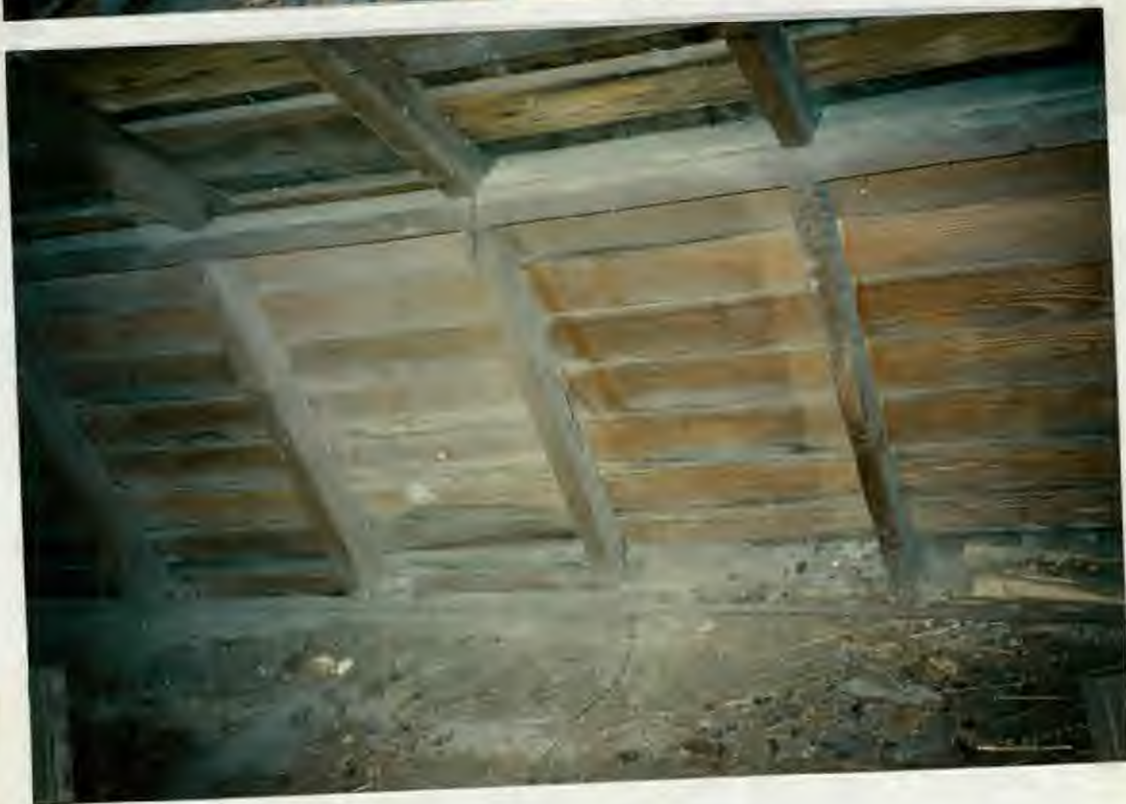
37

North wall
knee
wall. →

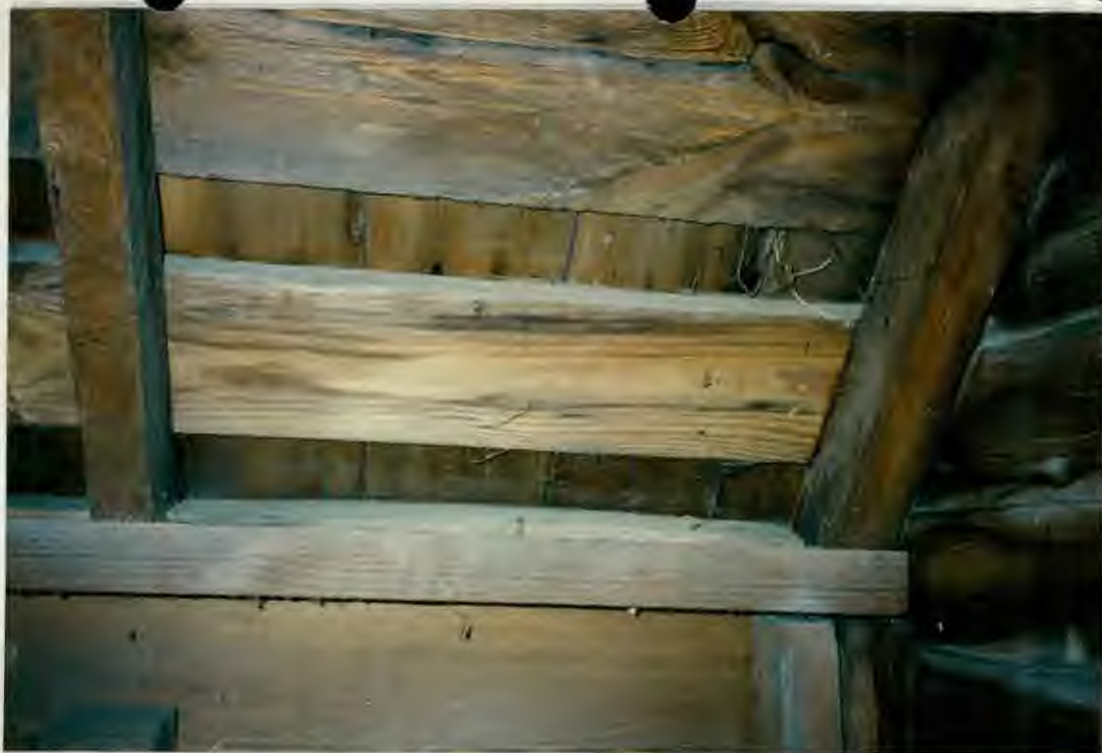
(38)

Roof near
west wall
of second
floor
interior.
→

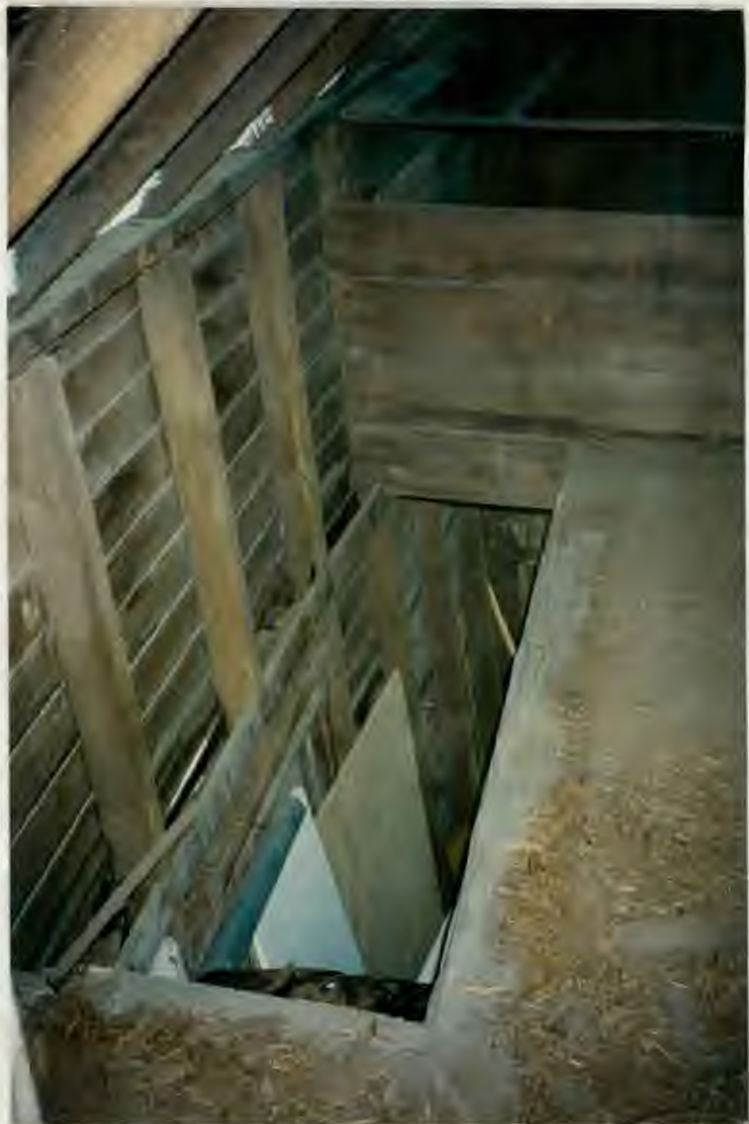
(39)

View of hole in
floor near south
wall (viewed from
second floor). →

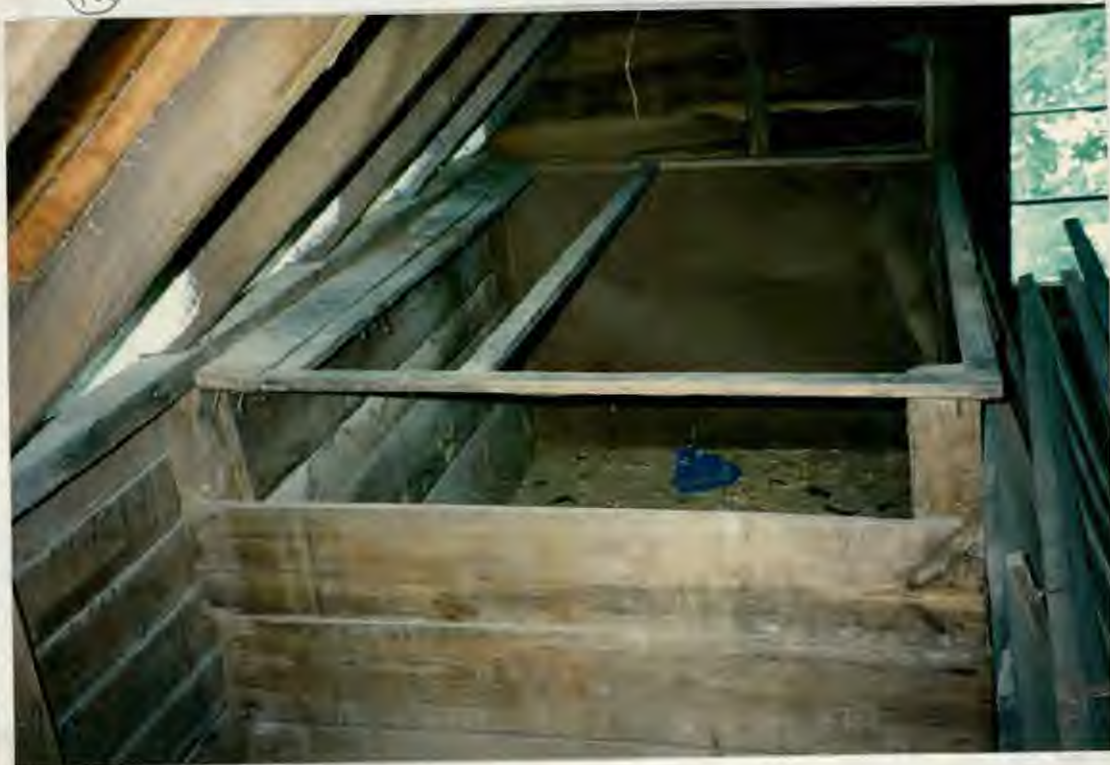
(42)

Remains of bin in SW
corner of second floor. ↘

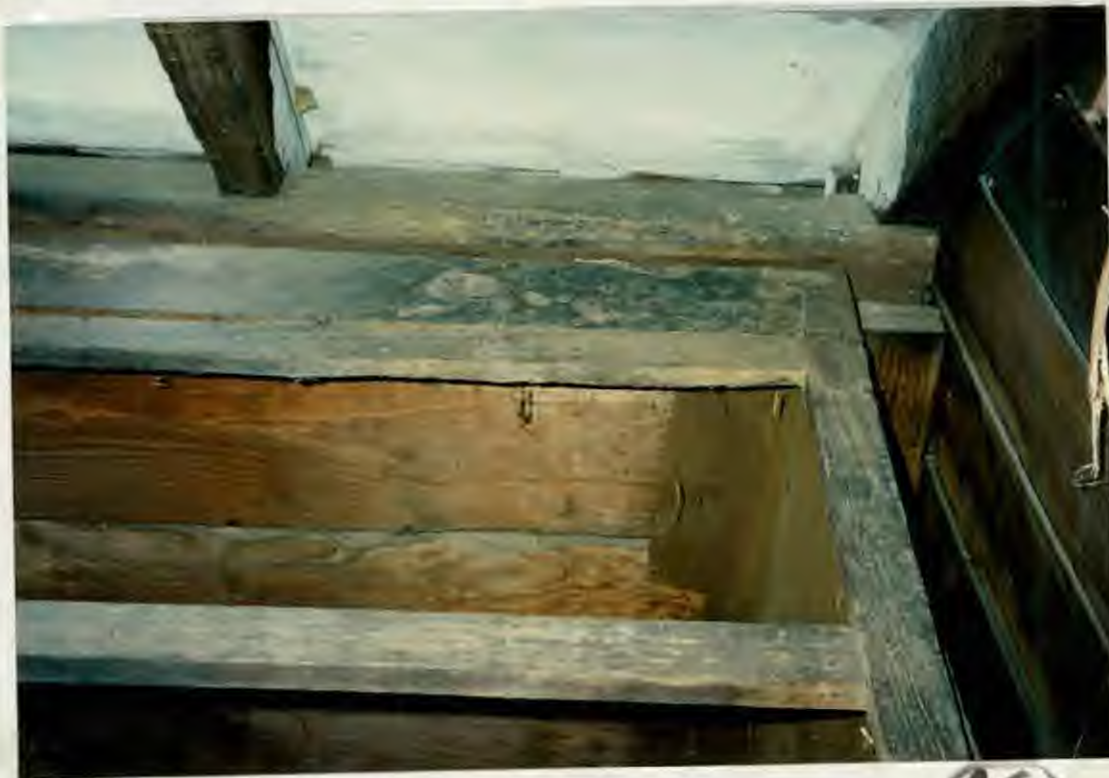
(43)

Top of
bin frame.

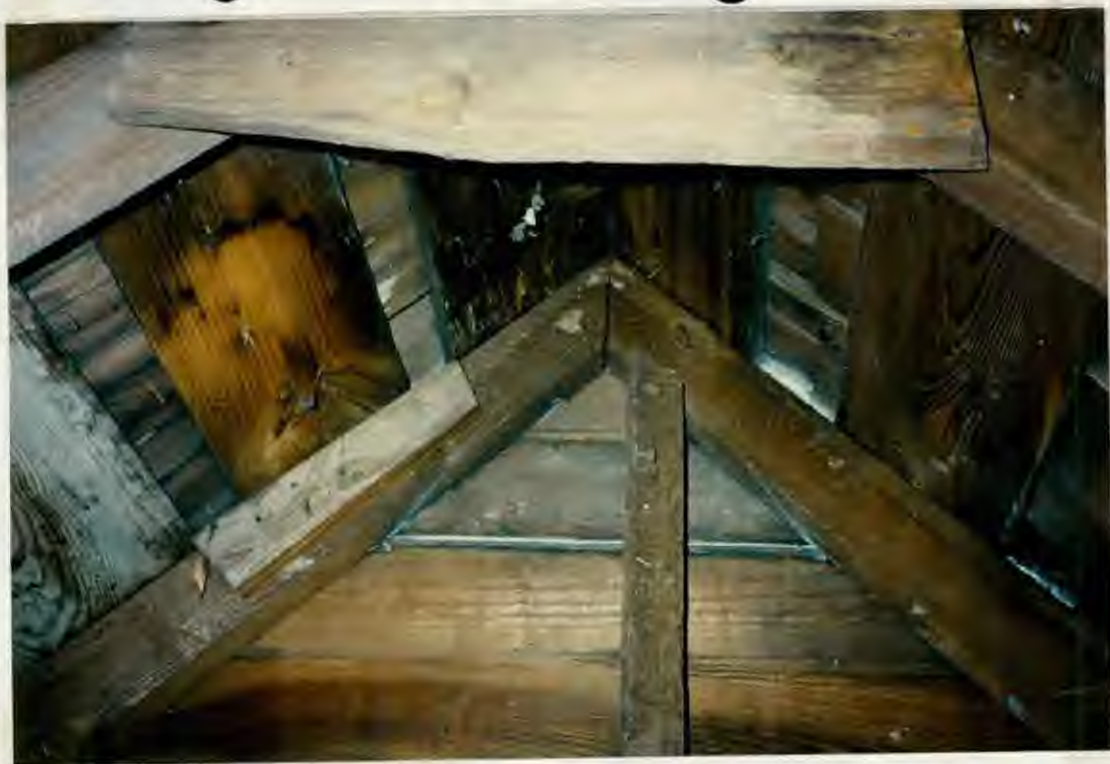
(44)

Ceiling
and top
of east
wall -
2nd floor
interior.

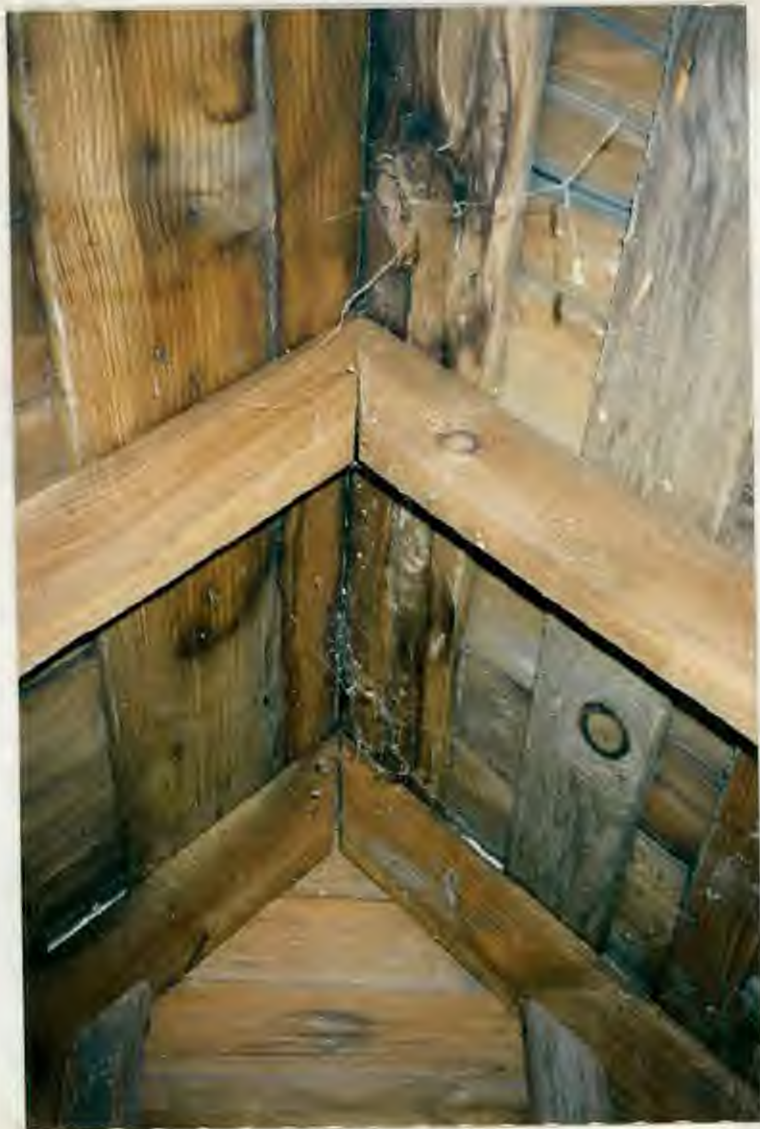
(45)

Ceiling
and top
of west
wall -
2nd floor
interior.

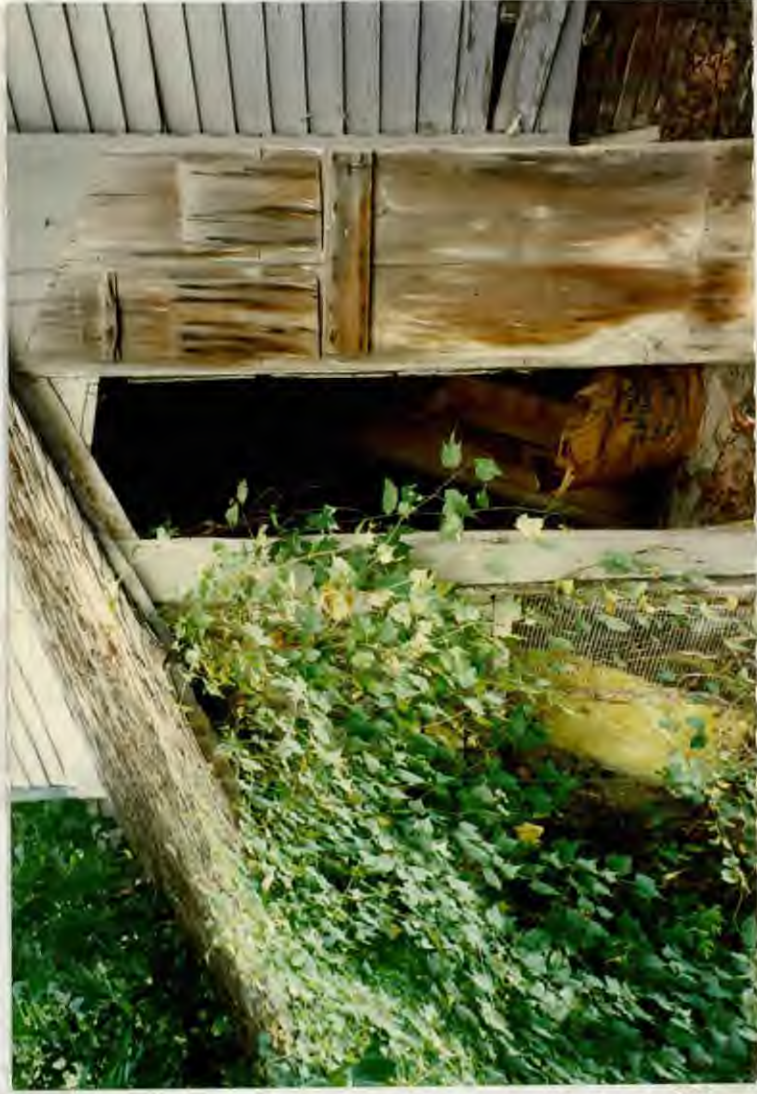
46

Shed on
south exterior -
door closed,

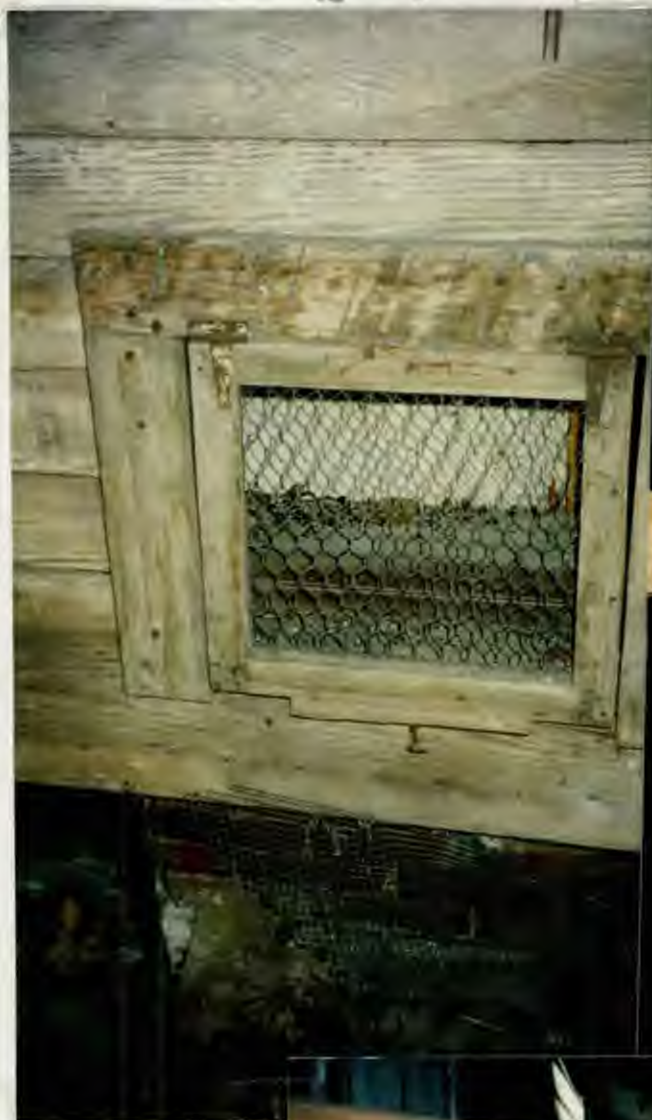
(49) Boarded door on wall between shed + main structure. ↓

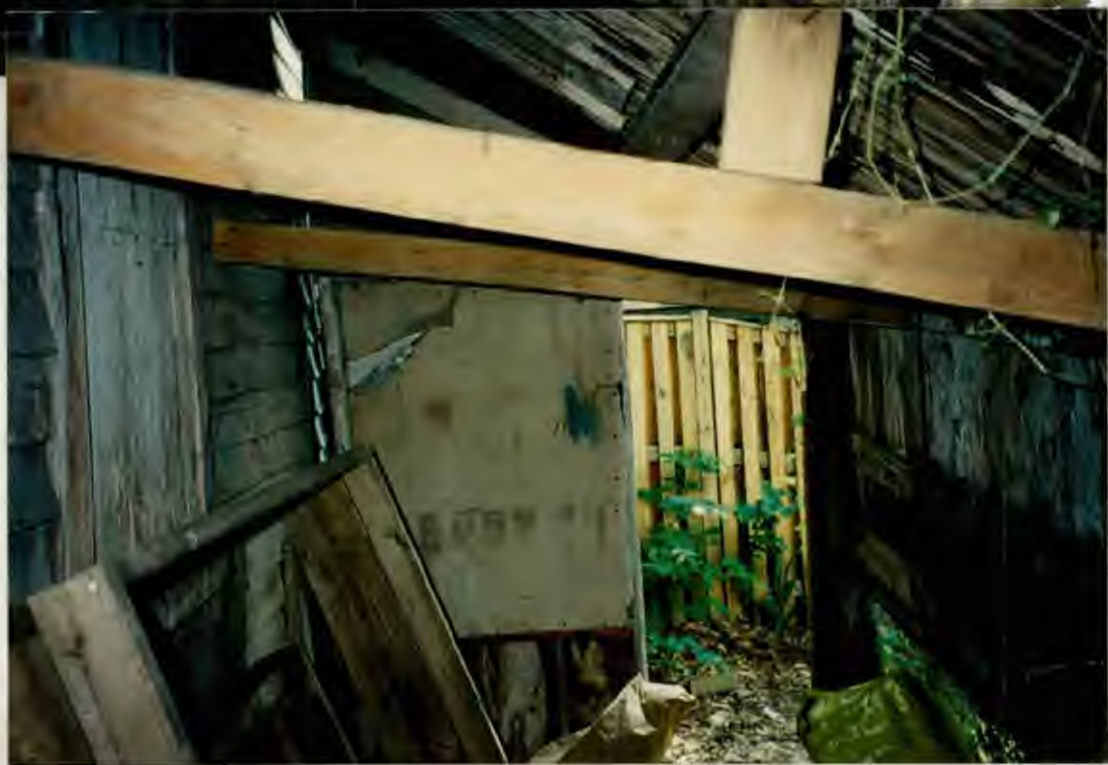
(50)

Shed interior viewed from west to east - looking out the door.

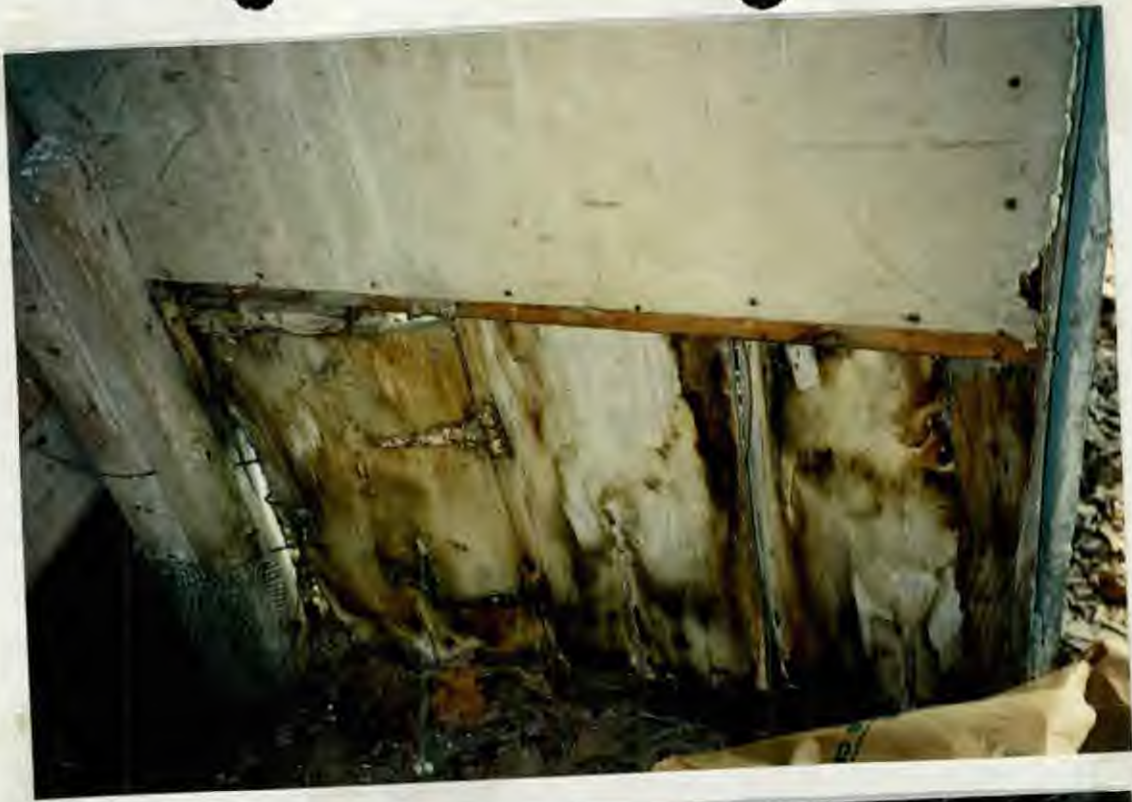
↑
Shed interior -
base of east wall,
(Note small 1' x 2"
hinged door)
