10 Pine Avenue, Takoma Pk.
Preliminary Consultation

HISTORIC PRESERVATION COMMISSION STAFF REPORT

Address: 10 Pine Avenue

PROPOSAL: Demolish garage/build new garage

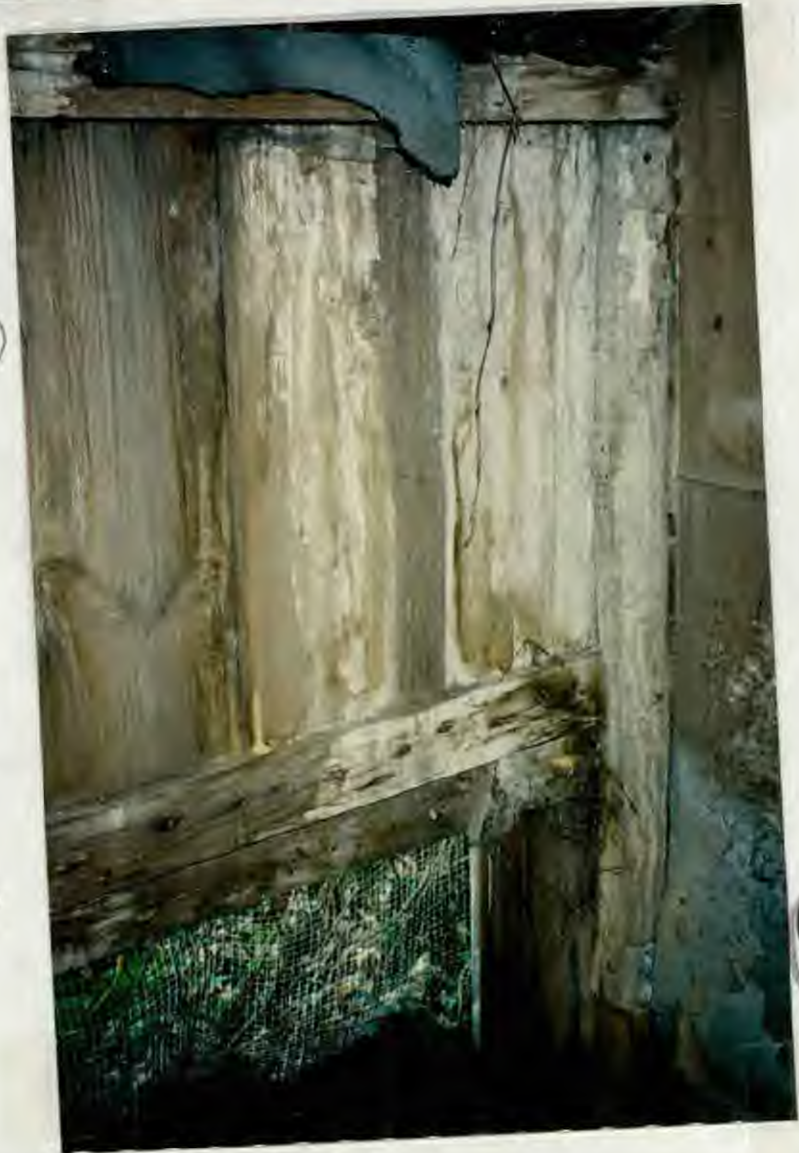
(52)

Shed interior -
south wall near
SW corner,
